RED LBP PRE-PURCHASE REPORT

PRE-PURCHASE

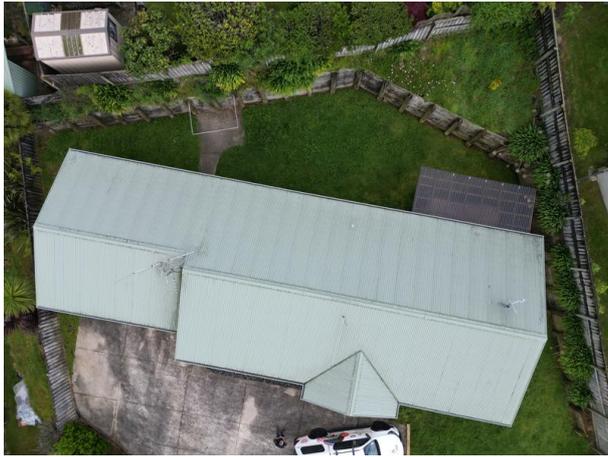
Photo 22

Condition of roofing material coating - Areas of deterioration to the coating, refer to the photos below.

Profiled metal gable roof construction with nail fixings. Note: deterioration of paint coating visible.

Considering the age of the roof, it appears to be in a reasonable condition. To preserve its condition and extend its lifespan, it is recommended to prioritise the maintenance of the paint coating. This should be undertaken in the near future.

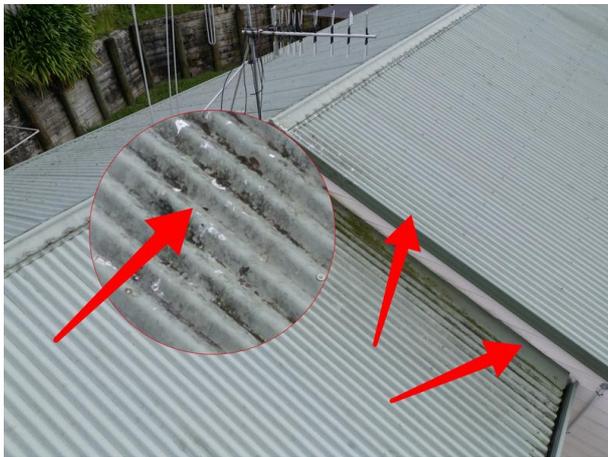
Photo 24

Profiled metal roof, barge and apron flashing. Note: areas of moisture staining visible, this is caused by bird droppings.

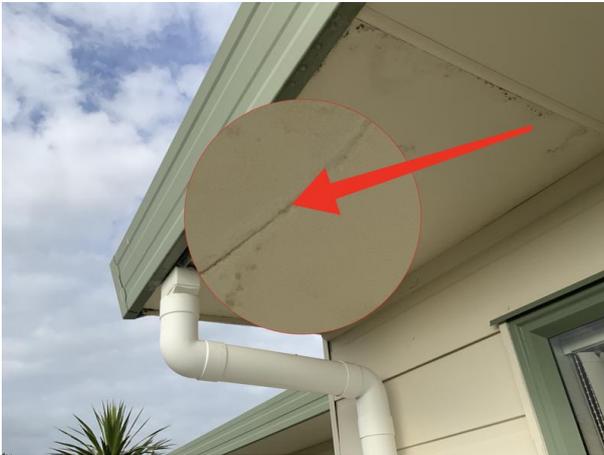
Photo 26

Gutter system, east side. Note: crack visible on fibrous cement sheet soffit.

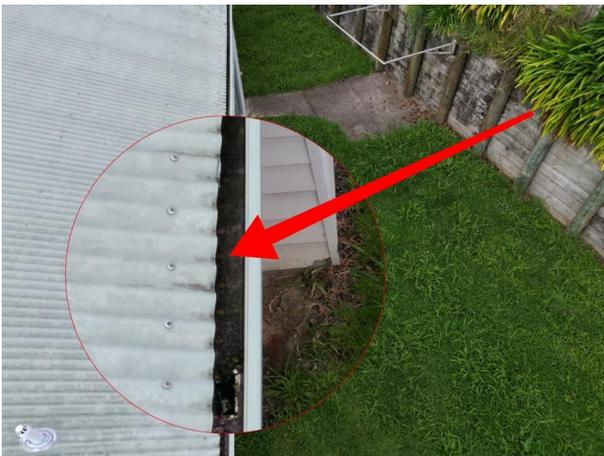
Photo 27

Gutter system, west side. Note: debris visible in gutter, cleaning required.

Recommend clearing gutters. It is important to keep the gutters clear of debris to ensure proper drainage. Clogged gutters can cause water to overflow and pool on the roof or into other elements of the building, leading to potential water damage, leaks, and structural issues.

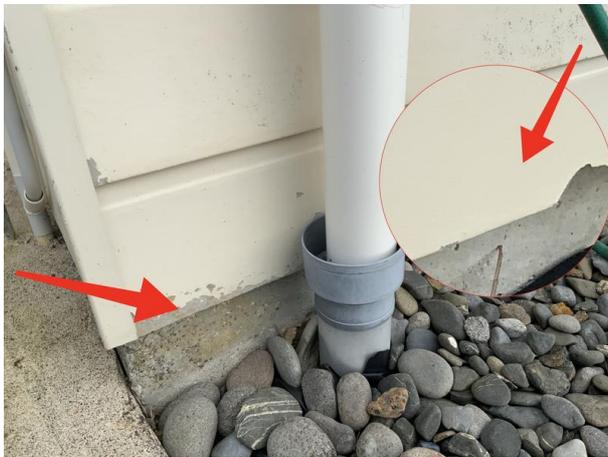
Photo 29

Damage and paint flaking, east side.

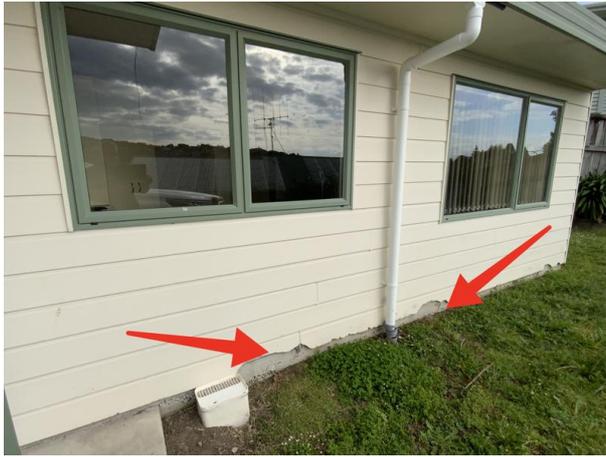
Photo 31

Weatherboard, east side. Note: damage visible.

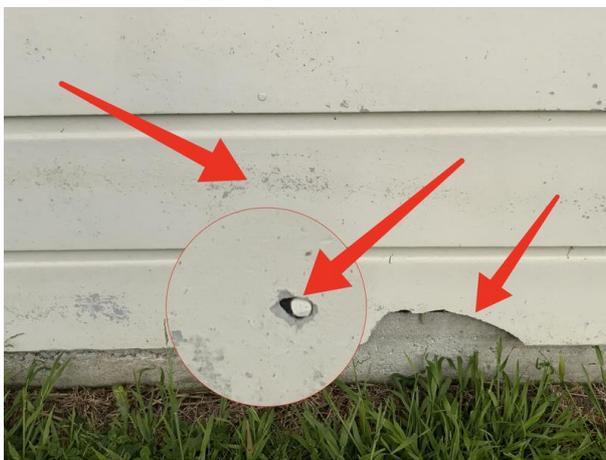
Photo 32

Paint flaking, damage and popped fixing visible, east side.

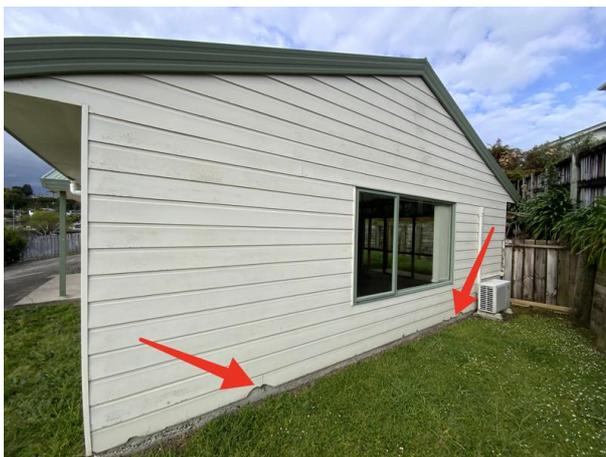
Photo 33

Weatherboard, north side. Note: damage visible.

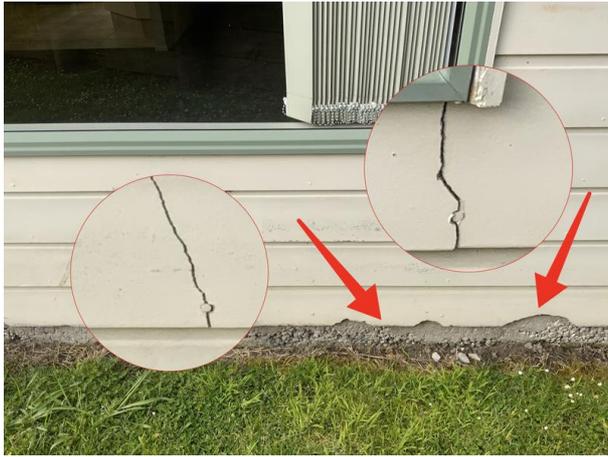
Photo 34

Cracked weatherboards and damage visible, north side.

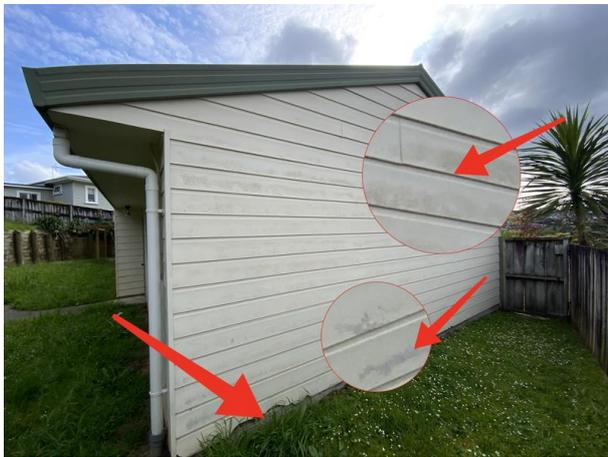
Photo 35

Weatherboard, south side.
Note: paint flaking, moisture staining and damage visible.

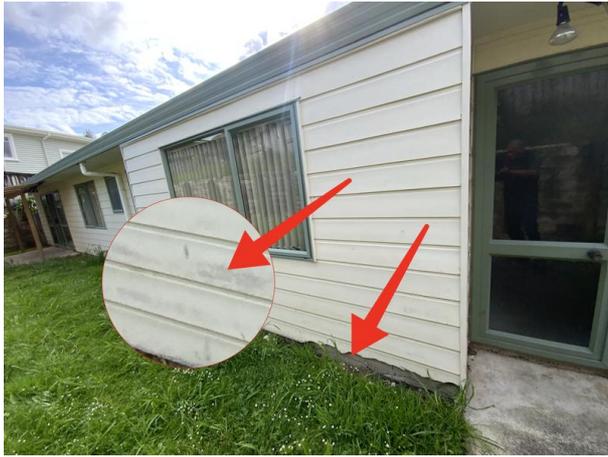
Photo 37

Weatherboard, west side.
Note: paint flaking and damage visible.

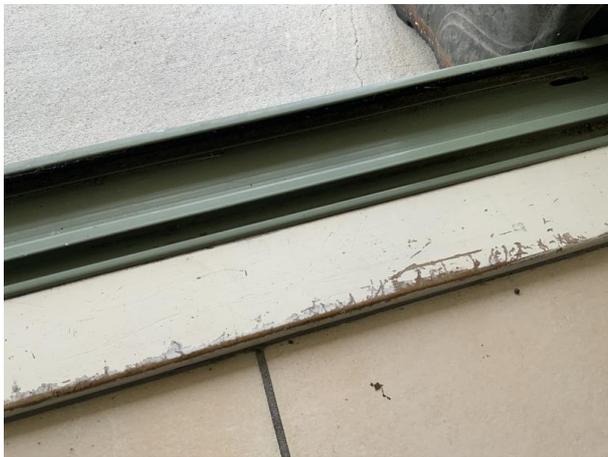
Photo 43

Paint wear visible on timber reveal, located on entrance door.

Keep tracks, drainage channels & weep-holes clear of debris. The paint is flaking on the sills, this may allow moisture to be absorbed into the timbers causing deterioration, correct preparation and decoration is required.

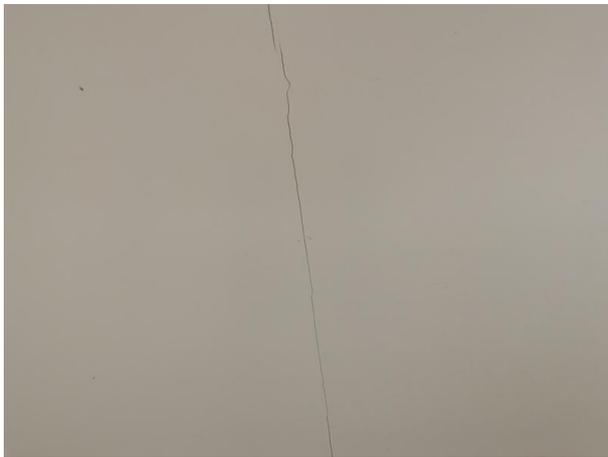
Photo 46

Ceiling defects - Cracking.

Sheet join crack visible on ceiling lining.

1. Remove the existing jointing material.
2. Apply tape to the joints.
3. Use gypsum plaster stopping compound to stop the cracks.
4. Sand the area.
5. Finally, re-paint or re-wallpaper the repaired section.

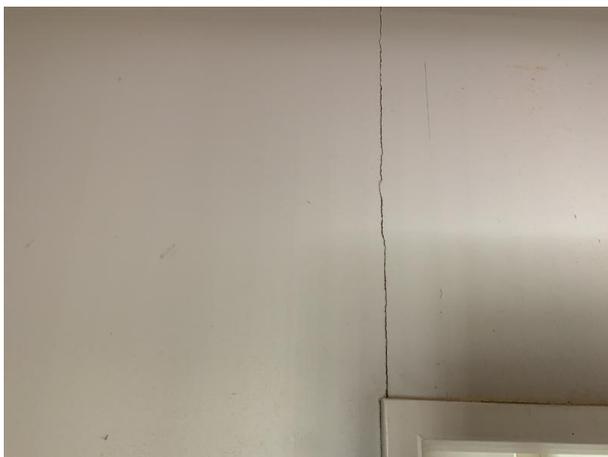
Photo 47

Wall defects - Cracking.

Sheet join crack visible on wall lining.

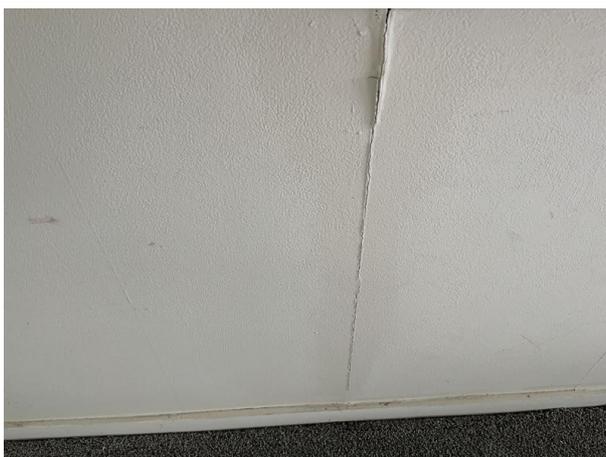
Photo 49

Sheet join crack visible on wall lining.

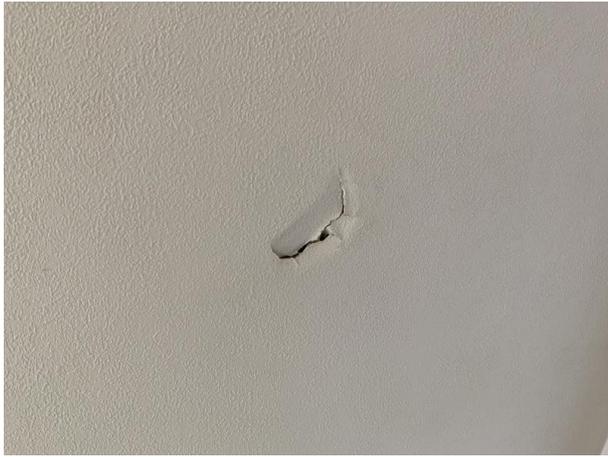
Photo 50

Damage visible on wall lining.

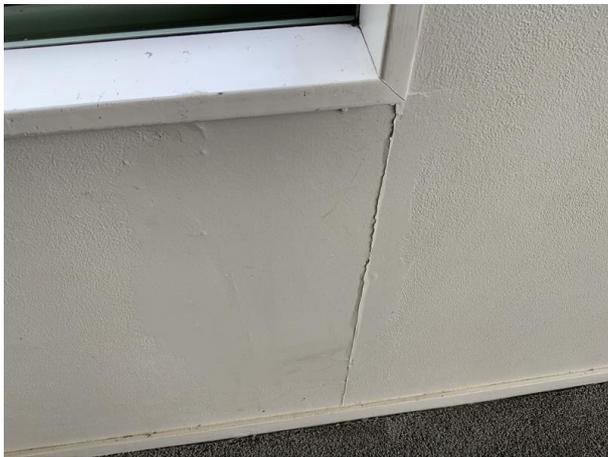
Photo 52

Sheet join crack visible on wall lining.

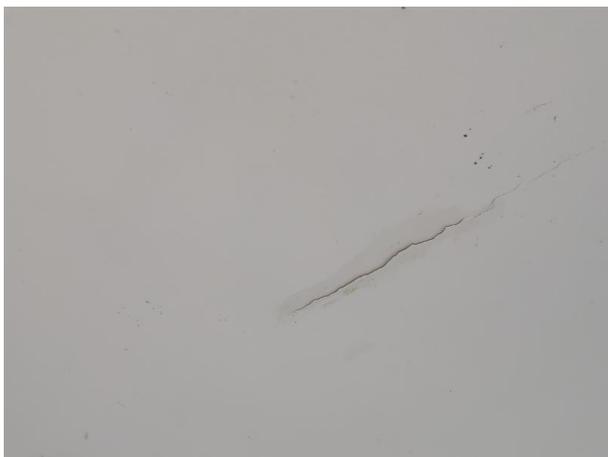
Photo 53

Paint flaking visible on ceiling lining.

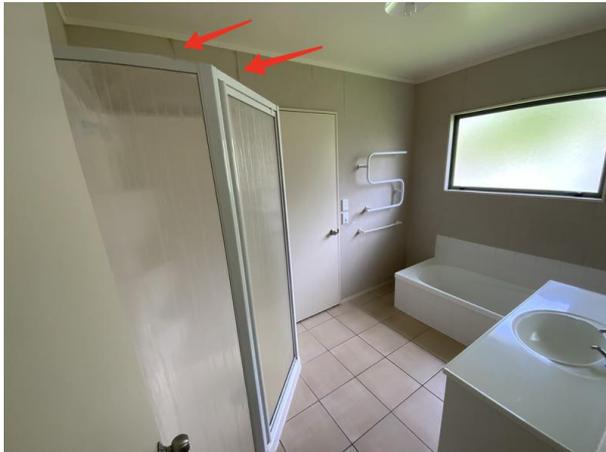
Photo 56

Bathroom. Note: areas of wallpaper peeling visible.

There is no externally vented mechanical ventilation system installed in the bathroom. It is recommended to install a suitable system for the rooms requirements.

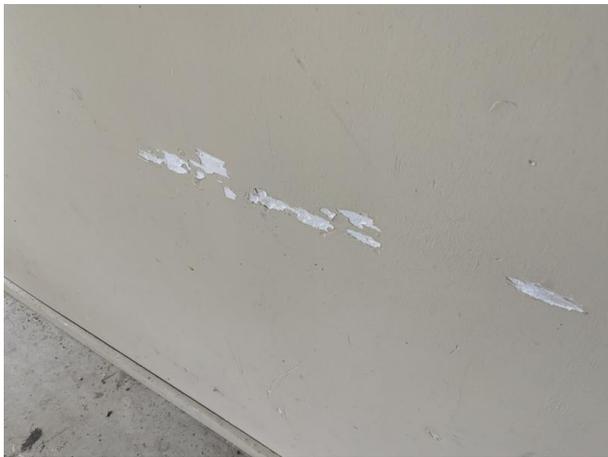
Photo 59

Minor damage visible on wall lining.

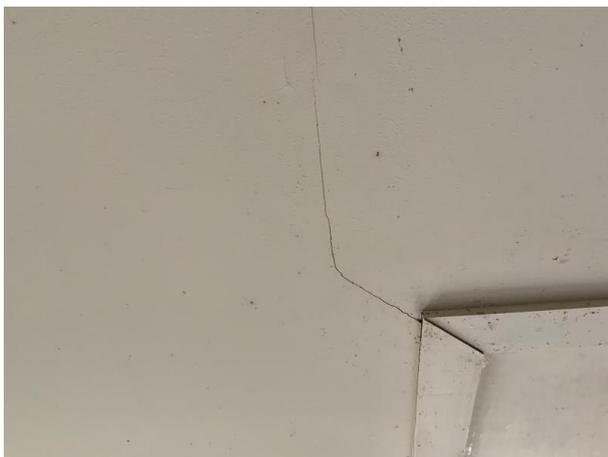
Photo 60

Crack visible on ceiling lining.

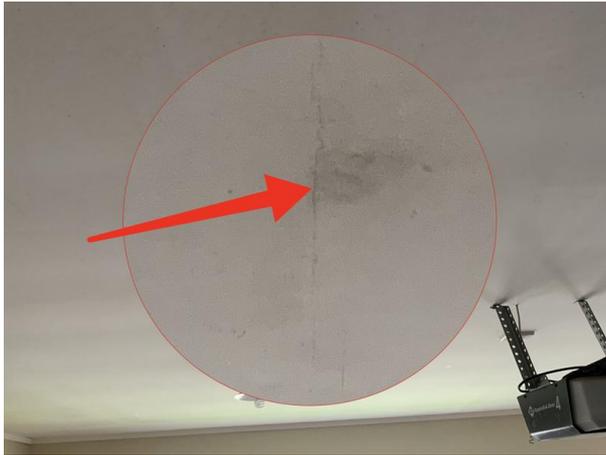
Photo 61

Ceiling defects - Cracking and dampness and moisture staining.

Areas of sheet join cracks and moisture staining visible.

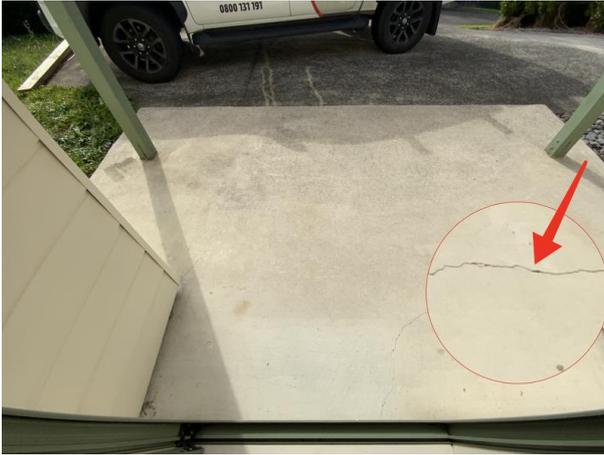
Photo 78

Concrete patio, east side for front entrance. Note: cracking visible.

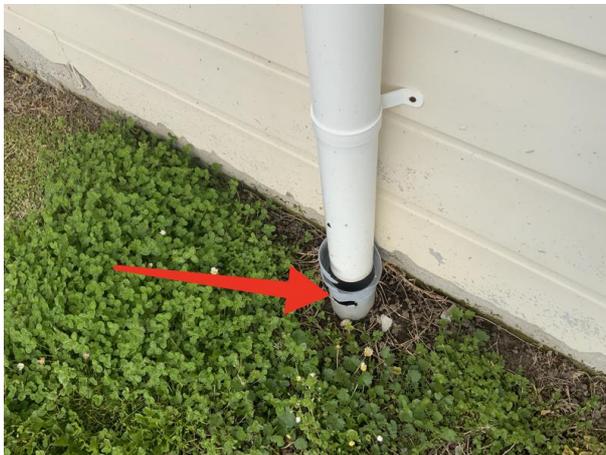
Photo 81

Downpipe and riser connection, east side. Note: damage to riser connection visible.

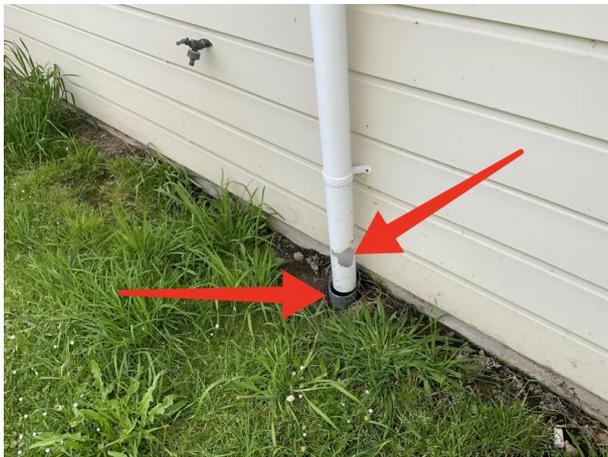
Photo 86

Downpipe and riser connection, west side. Note: damage visible on downpipe and riser drain.
