## RED LBP PRE-PURCHASE REPORT

# PRE-PURCHASE BUILDING REPORT

<b>Property Address</b>	14A Hastings Street, Te Puke 3119
<b>Client</b>	Jonny Menzies
<b>Date of Inspection</b>	20th August 2025
<b>Time</b>	8:30 am
<b>Inspector</b>	Brennan Rapira National Certificate in Carpentry, Licensed Building Practitioner
<b>LBP Number</b>	138160
<b>People Present</b>	Inspector
<b>House Occupied</b>	Staged

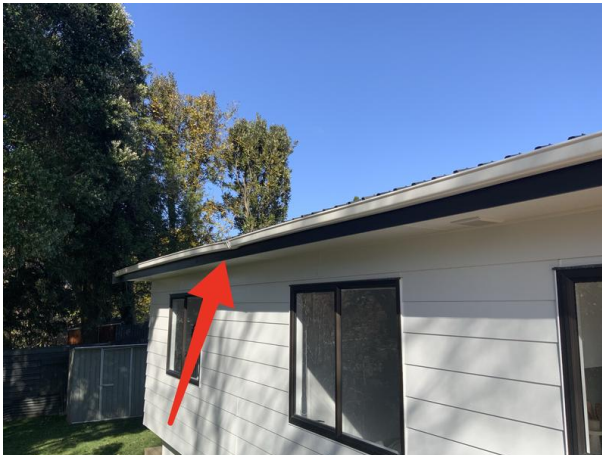
**Photo 9**

Dip in gutter system visible, east side.  
Note: this should be adjusted to eliminate ponding after heavy rain.

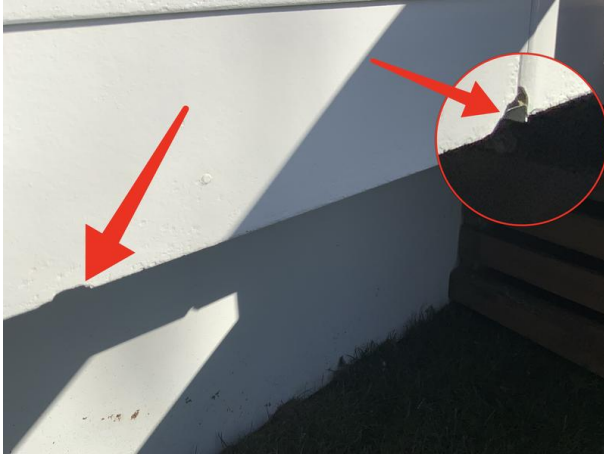
**Photo 11**

Damaged bottom edges of weatherboard, east side.

The bottom edge of the cladding has not been painted, leaving the timber exposed to moisture and deterioration. To prevent further water ingress (some sheets potentially need replacing), timber rot, and premature weathering, it is recommended that the bottom edges be properly sealed with quality exterior paint or primer.

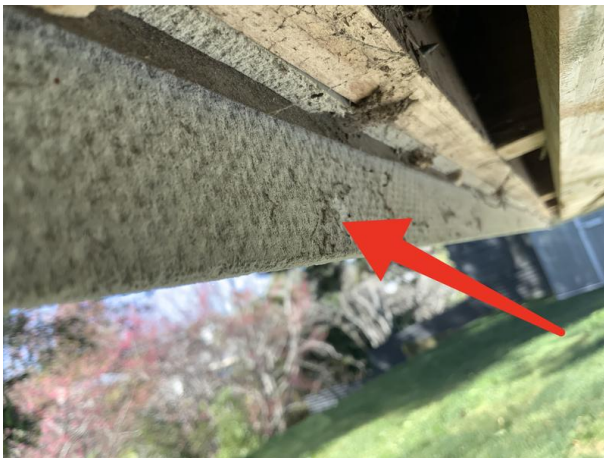
**Photo 12**

Back of bottom weatherboard not sealed, east side. Note: sealing the back of the bottom weatherboard stops moisture and keeps the integrity of the weatherboard from chipping or breaking.

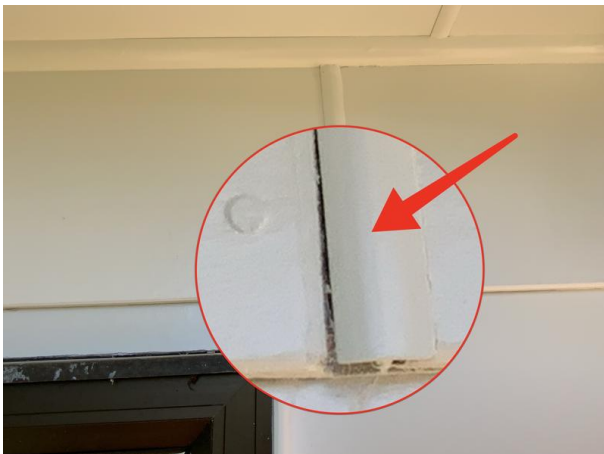
**Photo 13**

PVC jointer requires adjustment to close joint, east side of lounge.

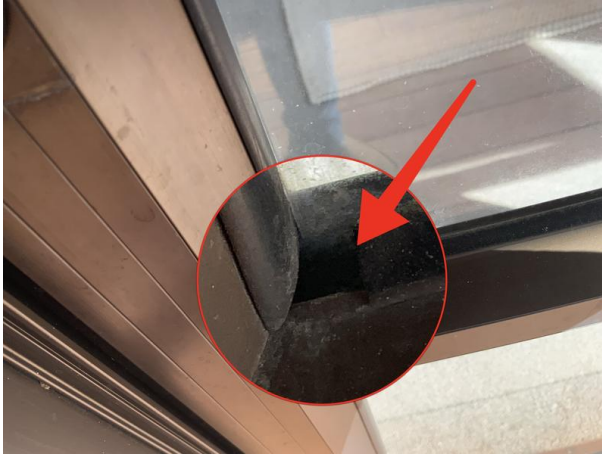
**Photo 15**

Rubber seal short from corner on aluminium sliding door, east side of lounge.

To prevent water & draughts from entering, it is recommended to replace or properly re-seat the rubber seals on the exterior of the joinery. By doing so, you can ensure a tight seal that effectively safeguards against water & draught ingress.

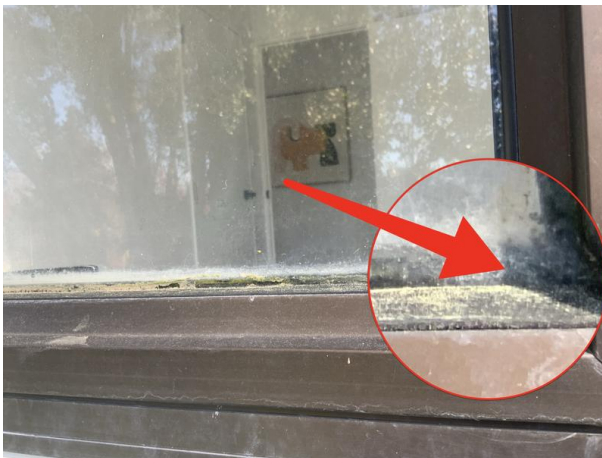
**Photo 16**

Rubber seal short from corner on aluminium joinery, east side of bedroom 1.

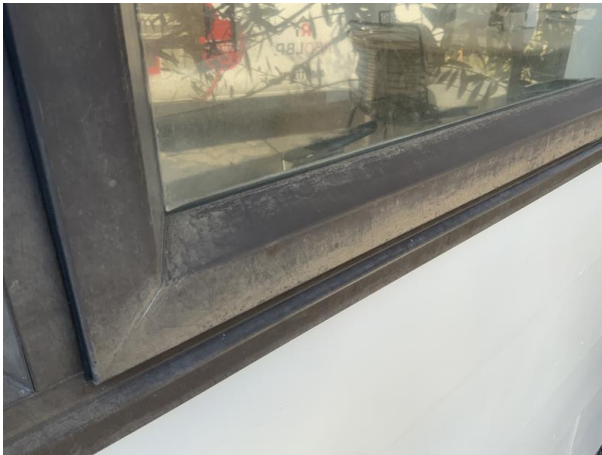
**Photo 17**

Oxidation visible on aluminium joinery, west side of lounge.

Make sure paint is maintained and moisture is kept at a minimum.  
This type of older aluminium joinery does not have weepholes or condensation trays that prevent moisture/condensation from running directly onto the timber reveals.

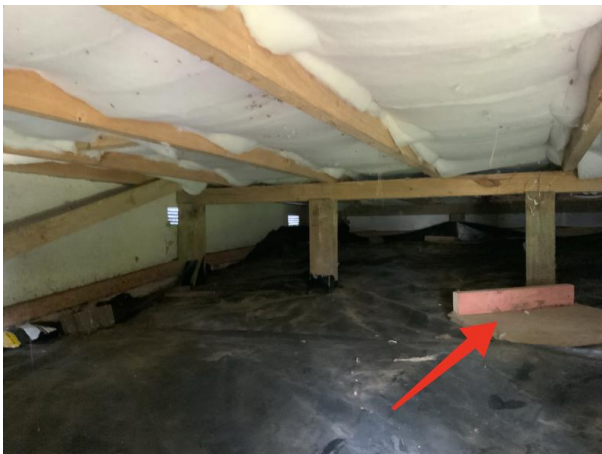
**Photo 21**

Suspended timber subfloor construction, timber piles, polyester insulation and polythene ground moisture barrier. Note: building materials visible.

Remove all building materials from the subfloor area, as their presence can attract vermin and create a breeding ground for pests. Keeping the subfloor clean and free of obstructions is essential to maintaining proper ventilation and reducing the risk of pest infestations or damage to the building structure.

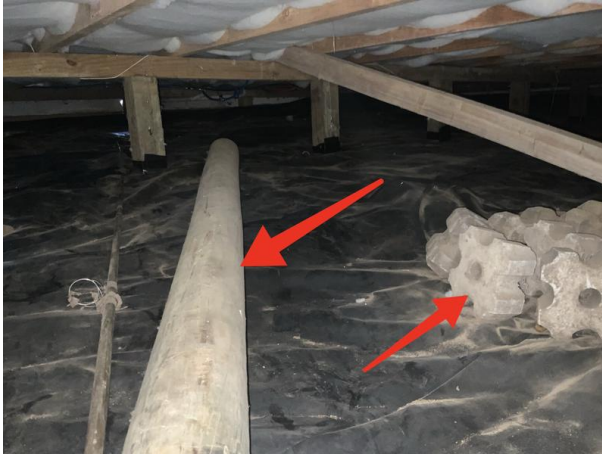
**Photo 22**  
Building materials stored in subfloor space.

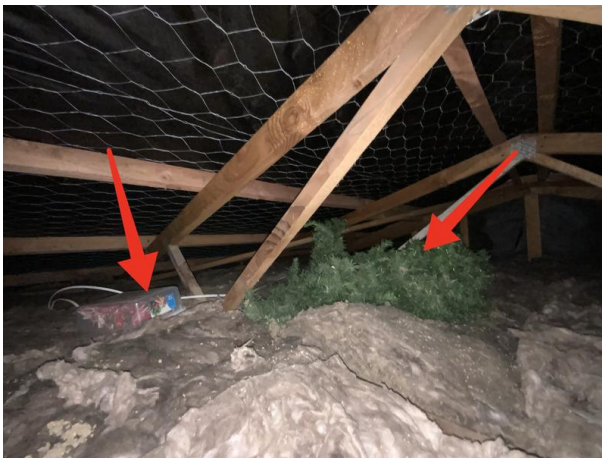
**Photo 25**

Stored items visible.

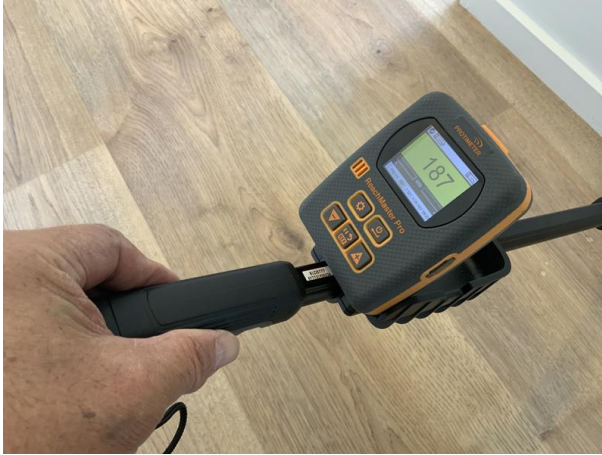
**Photo 27**

The indications of elevated moisture readings to the hallway by cupboard door could indicate a failure of weathertightness, further investigation is recommended to establish the reasons for indications of elevated moisture. Followed by suitable remediation work as required.

Indications of elevated moisture readings were detected. 'Supplementary' moisture testing photos are a representative sample of the comprehensive testing conducted.

Hallway internal wall by cupboard door.  
RISK 187. Refer to water heating in non structural systems.

It is recommended to engage a Plumber to further investigate the ho water cylinder, that seems to be leaking.

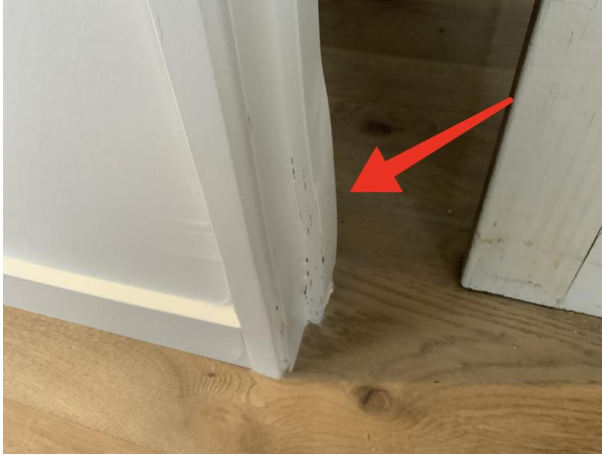
**Photo 61**  
Swelling visible on hallway cupboard  
timber door stop.

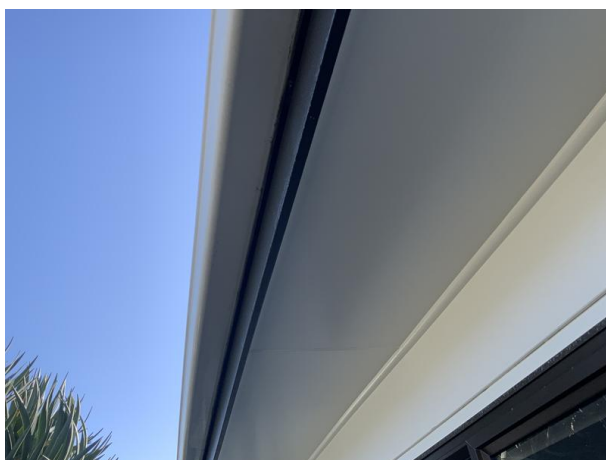
**Photo 71**

Fibrous cement sheet soffit.

Have this tested for asbestos before undertaking any invasive works, such as drilling, cutting or sanding.

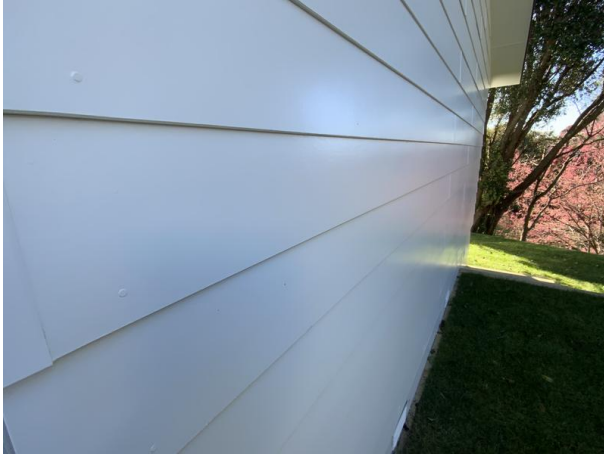
**Photo 72**

Fibrous cement weatherboard board.

Have this tested for asbestos before undertaking any invasive works, such as drilling, cutting or sanding.
