Building Inspection

Home Inspection Report

14 Nairn Street, Spreydon, Christchurch, 8024

Inspection prepared for: Aaron and Tammy Lorenzen Hart
Date of Inspection: 3/5/2021 Time: 10:30 AM
Age of Home: 1930s Size: 110m²
Weather: Fine

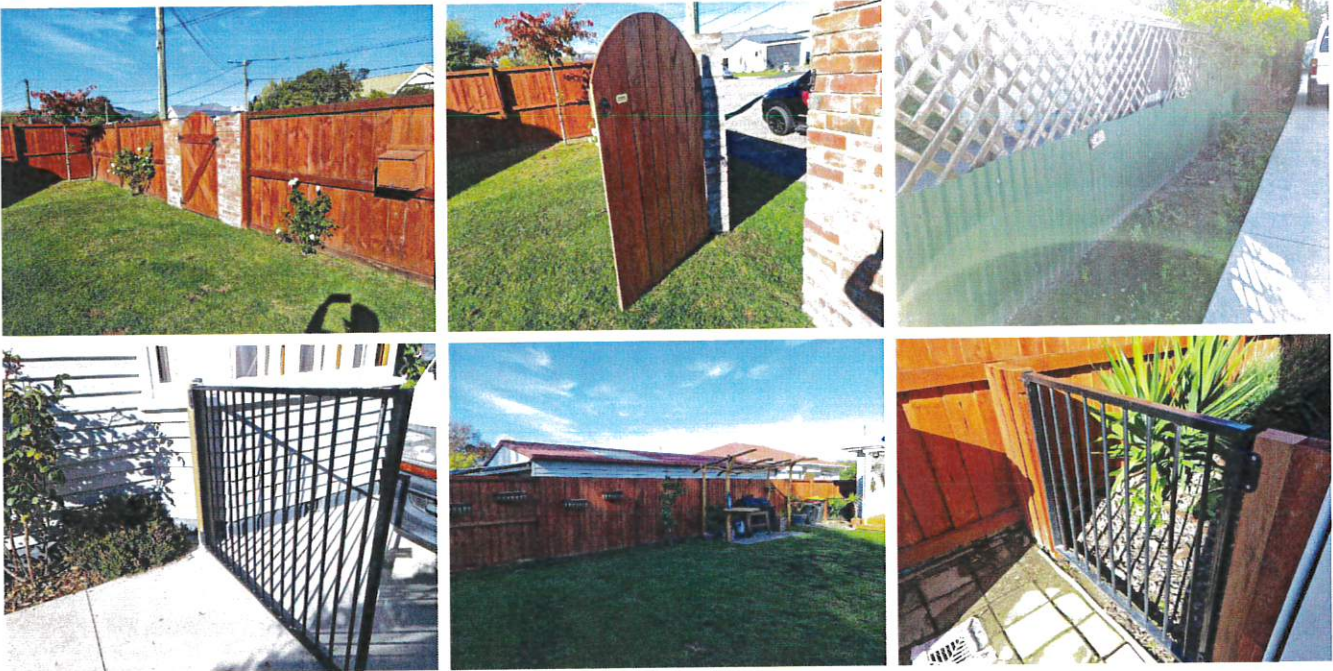
- Timber, iron and brick in good condition

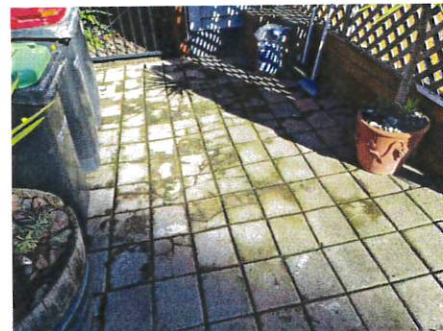
- Concrete driveway in good condition
- Pavers, cracked but not a safety issue

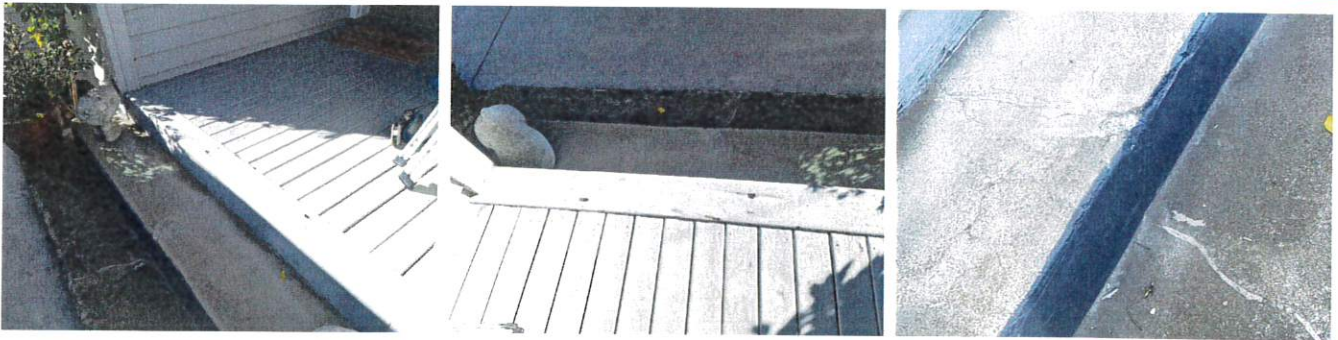
- Concrete and wooden, crack in concrete has been epoxy filled

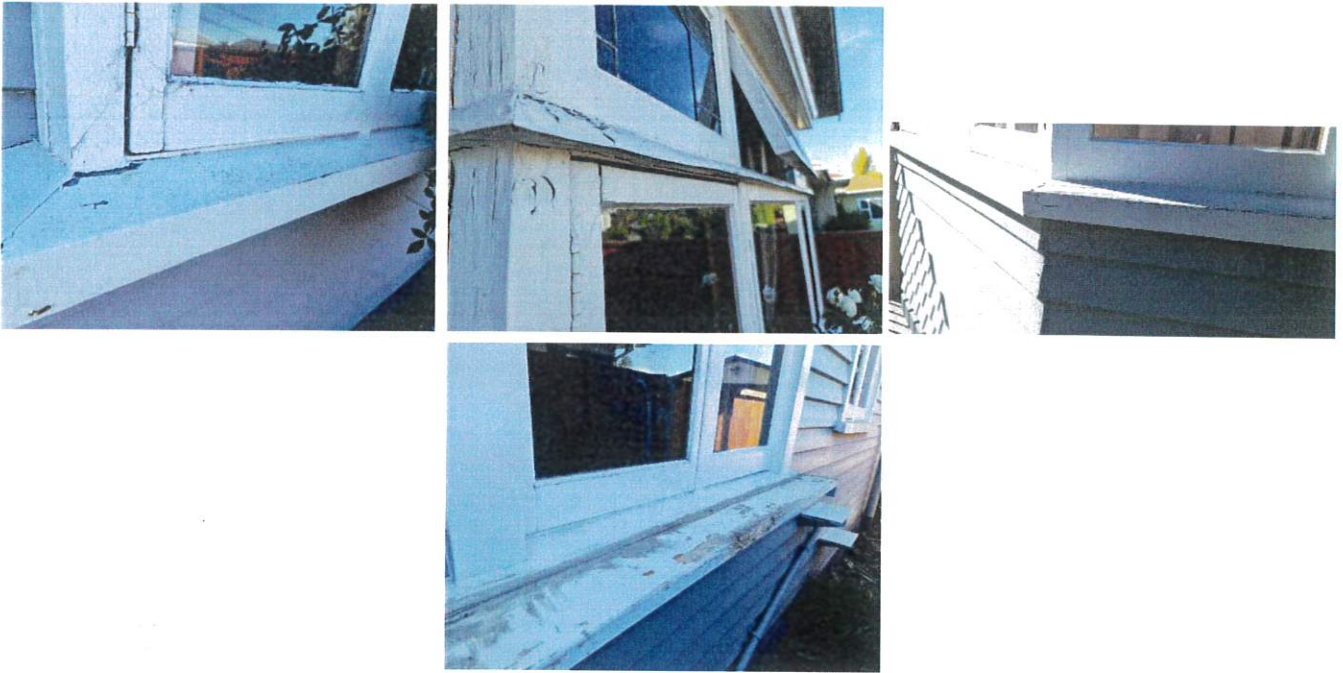
2. Sash, facings and trim condition

Page 11 Item: 2	Sash, facings and trim condition	• Surface deterioration
Heat transfer system

- Surface deterioration

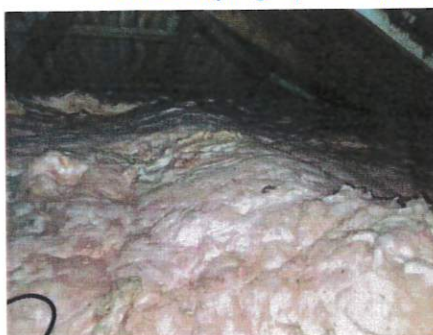
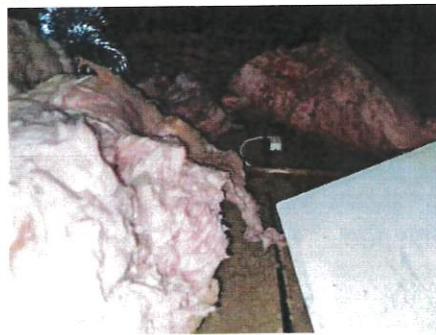
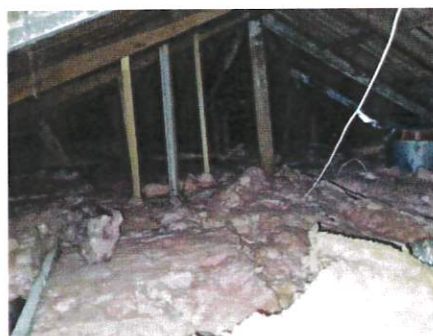
3. Coverage

- Needs tidying up or replacing in some areas

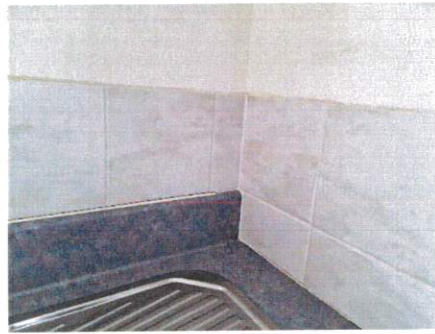
7. Tiles

- Ceramic tiles, need regrouting

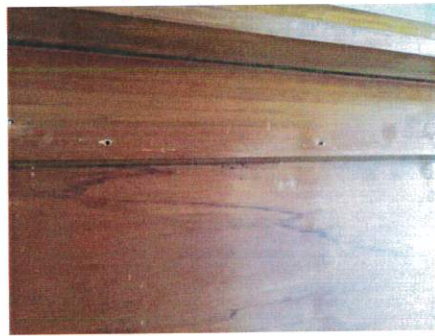
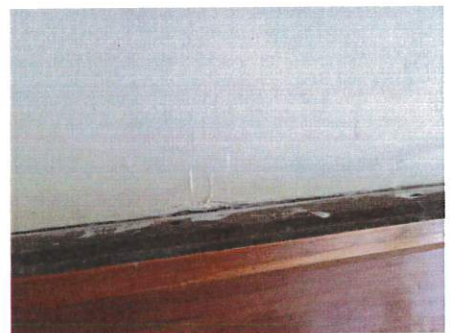
3. Walls

- Painted plaster board requiring minor repairs
- Wooden paneling requiring minor repairs

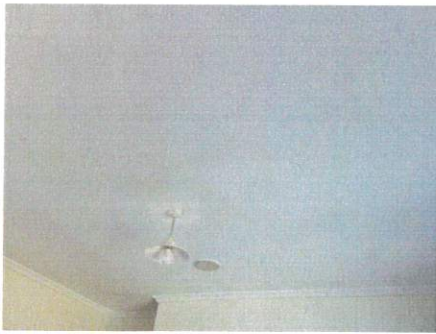
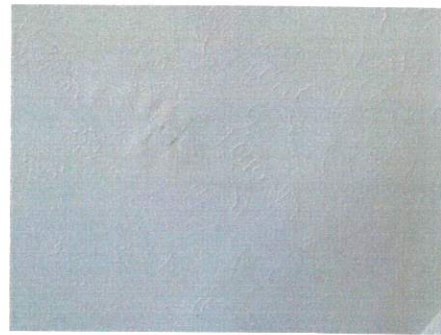
2. Ceiling

- Textured ceiling requiring minor repairs

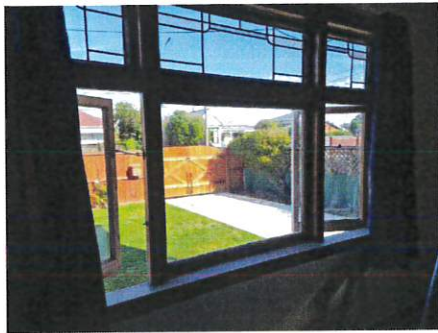
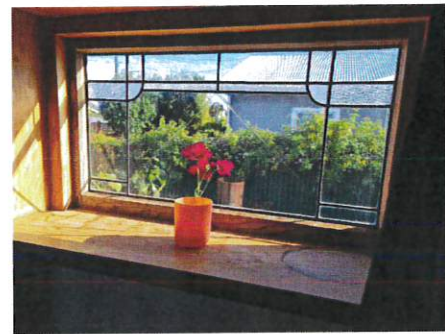
6. Windows

- Wooden in good condition
- Some water staining noted to sills

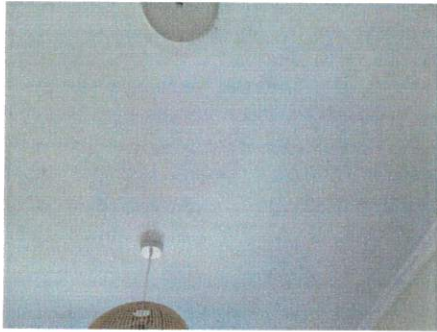
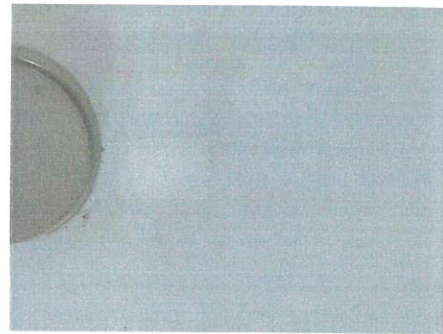
2. Ceiling

- Painted plaster board requiring minor repairs

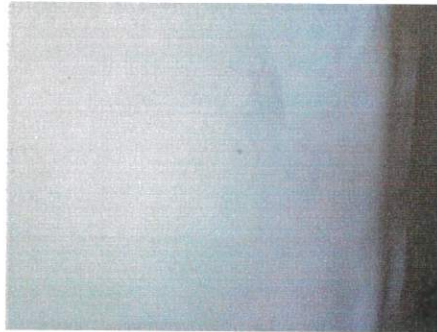
3. Walls

- Painted plaster board requiring minor repairs

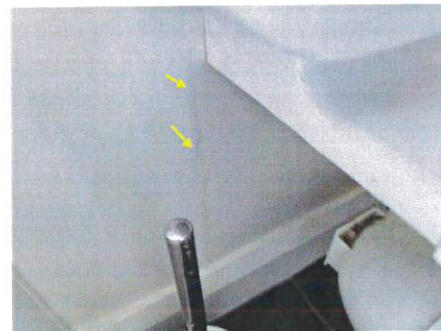
3. Walls

- Painted plaster board requiring minor repairs

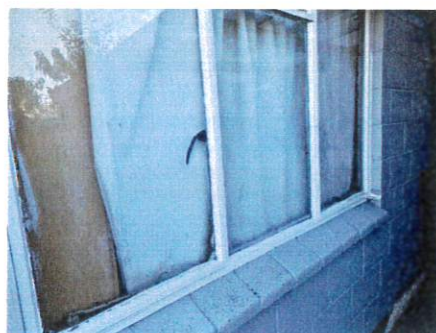
8. Windows

Page 62 Item: 8	Windows	• Aluminum, appear to be painted closed

- Aluminum, appear to be painted closed

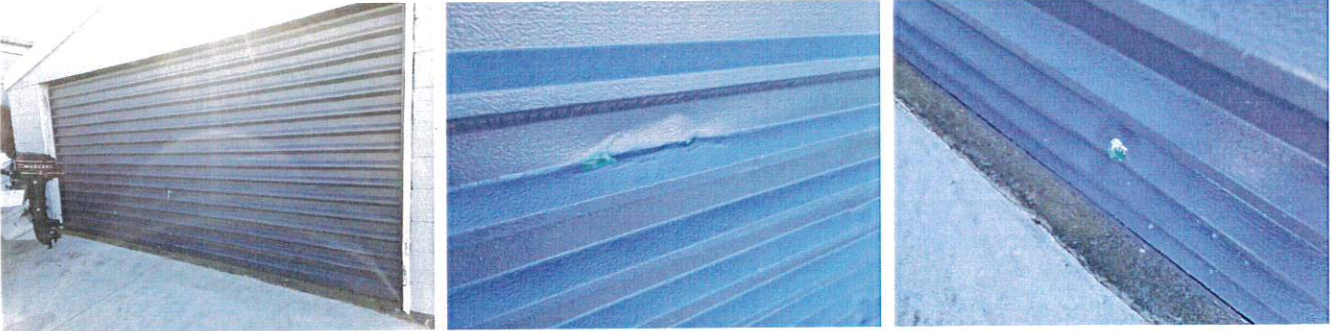
9. Garage door

- Unable to access to check for functionality. Some minor damage noted
