# Subdivision Suitability Report

**Section 39 SO 13711**

Prepared for Tauranga Bay Holdings Ltd  
510402

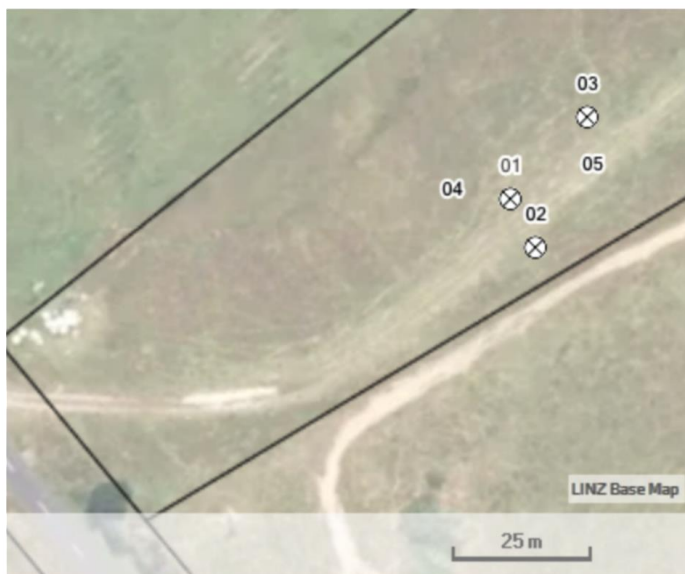
**Figure 3. Approximate locations of the 5 tests undertaken within Area A**

Figure 3 below illustrates the test locations which were undertaken within area A. Scalas 01 and 02 encountered very firm ground from 0.1m and 0.3m below the existing ground level respectively. There was soft bearing above this, which we anticipate being the overlying silty topsoil before encountering firm iron pan. Scala 03 encountered firm bearing at 0.2m before likely encountering iron pan at 0.3m below existing ground level.

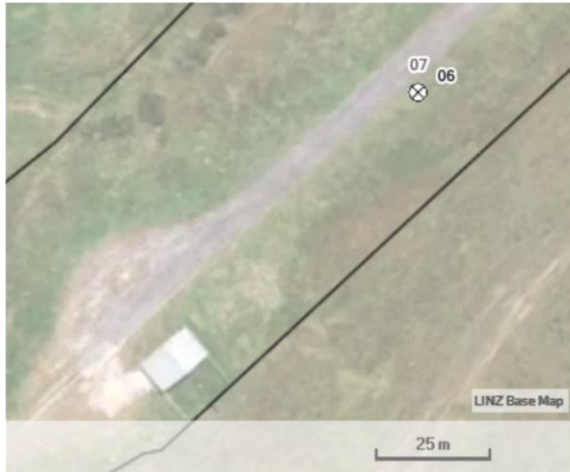
**Figure 4. Approximate locations of the 2 tests undertaken within Area B**

Scala 07 encountered firm bearing capacity consistent with iron pan at a depth of 0.3m below the existing ground level.

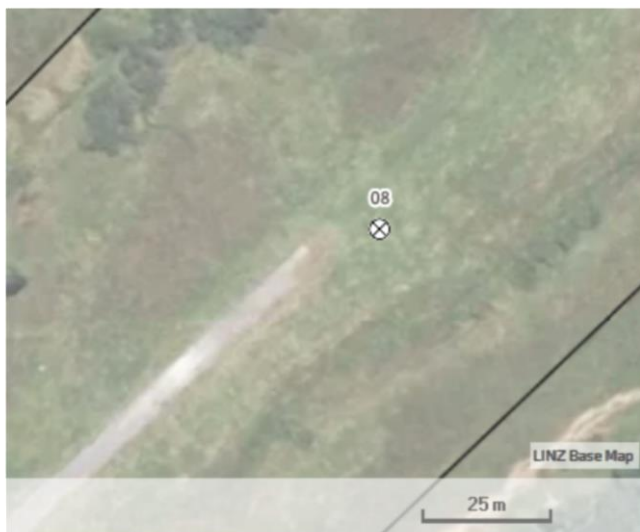
**Figure 5. Approximate locations of the test undertaken within Area C**

Figure 5 below illustrates the test locations which were undertaken within area C. The scala undertaken in area C encountered soft bearing capacity before it increased at 0.5m before becoming very firm at 0.6m below existing ground level.

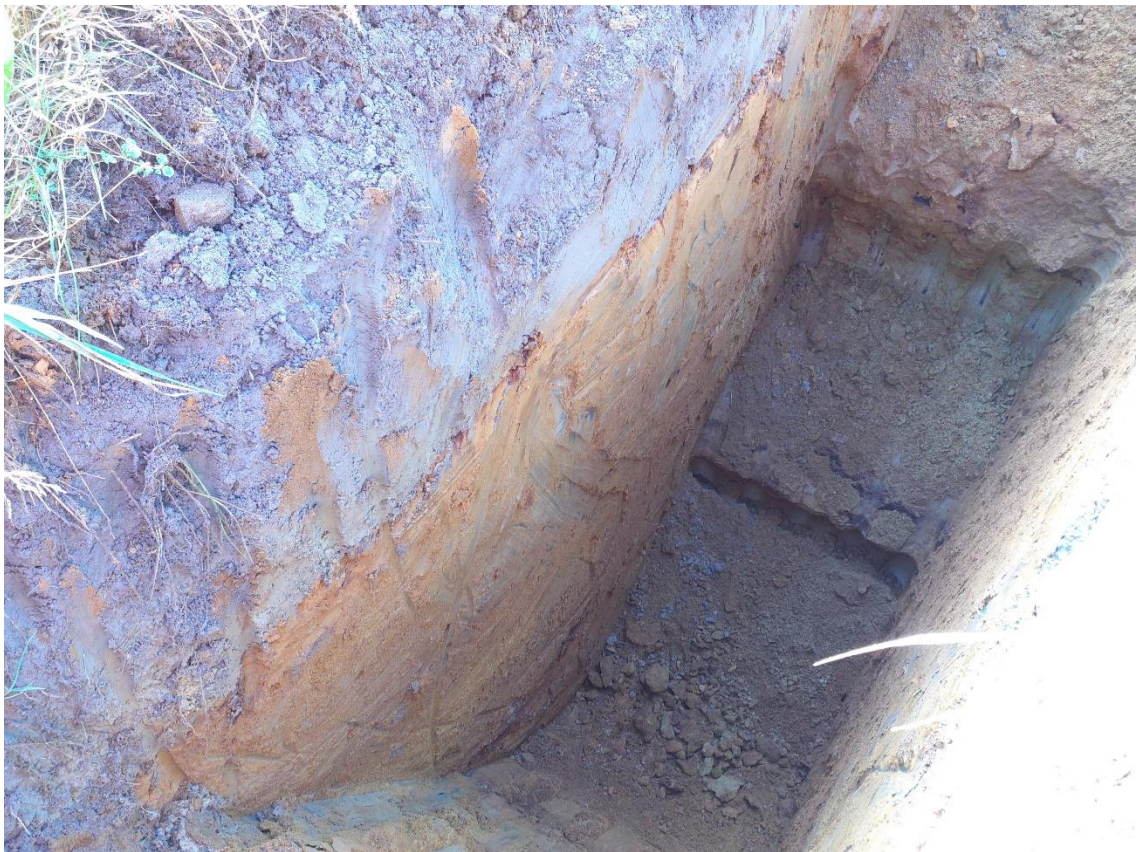
The test pit undertaken at location 04 encountered silty topsoil over silt with minor sand. At a depth of 0.5m a firm iron pan was encountered, over firm fine to medium coarse bound sandstone. The test pit was terminated at a depth of 2.0m and did not encounter ground water.

**Figure 2. Shallow iron pan over sandstone encountered at test pit 04.**

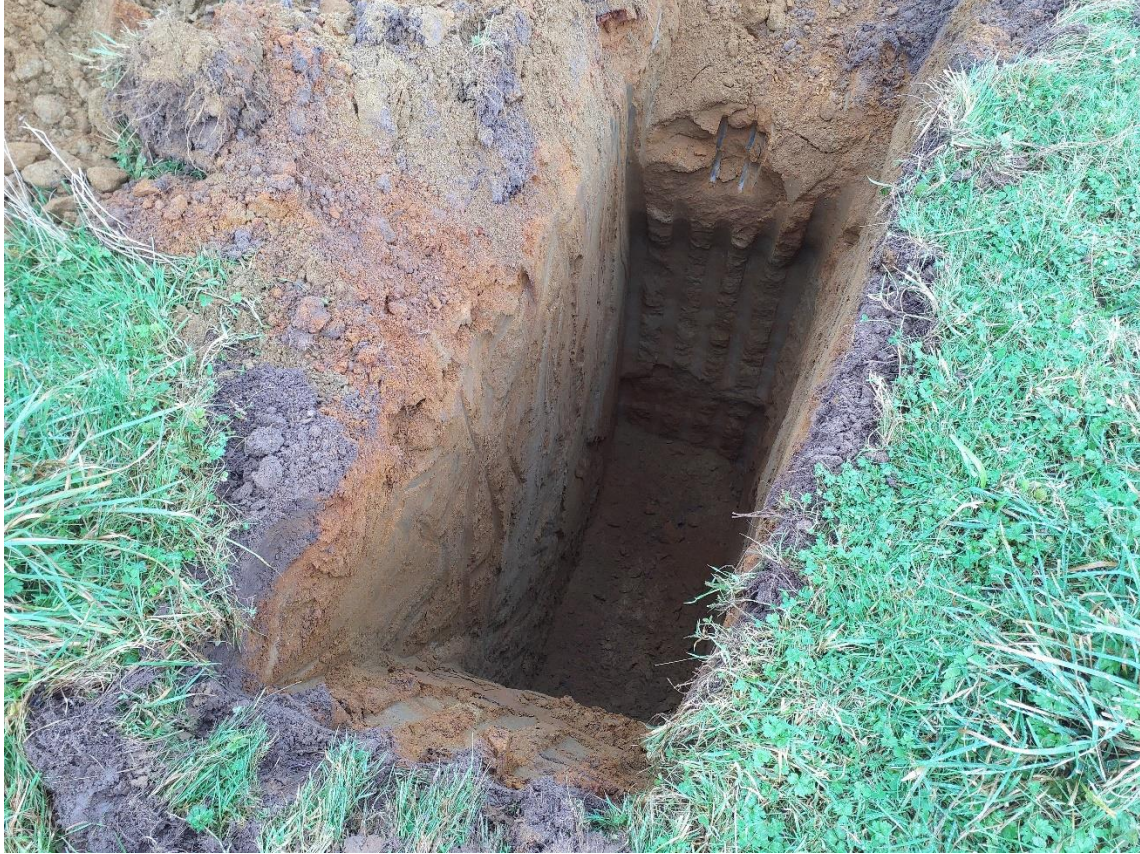
The test pit undertaken at location 05 encountered the iron pan layer under silty topsoil at a depth of 0.2m. below this was orange bound firm sandstone. At a depth of around 1.2m, there was a layer change and the sand continued to be firm but became less bounded. The test pit was terminated at a depth of 3.0m and did not encounter groundwater.

**Figure 3. Test pit 05 in area A.**

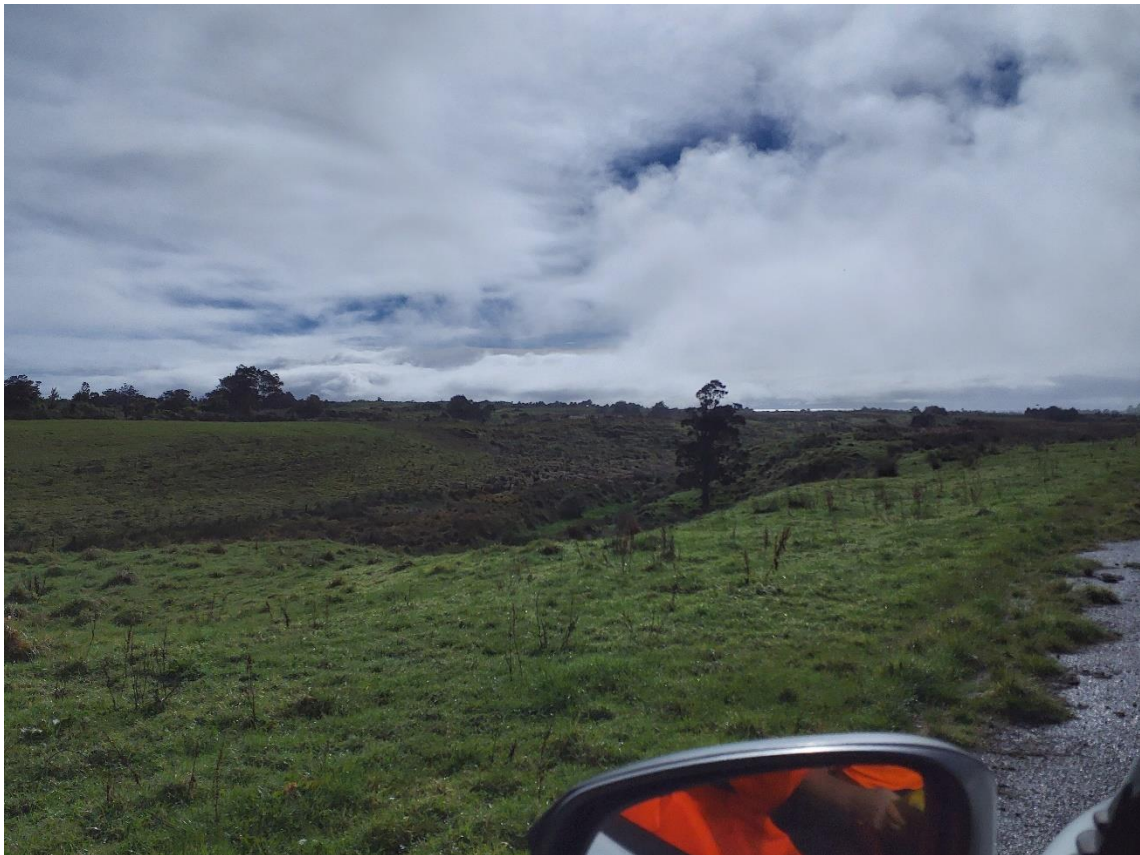
**Figure 4. Gully adjacent to the historic runway.**

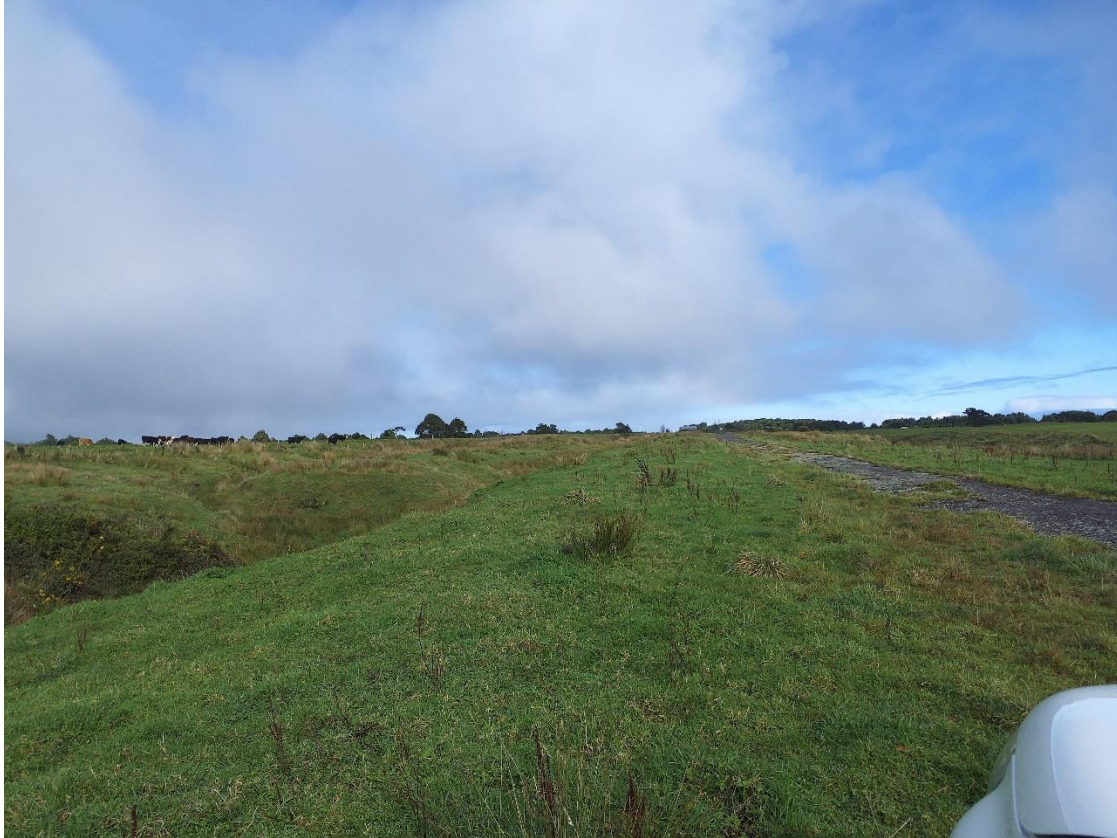
**Figure 5.** Facing south-west towards Wilsons Lead Road, showing the historic runway and undulations towards the southern boundary of the site by area B.

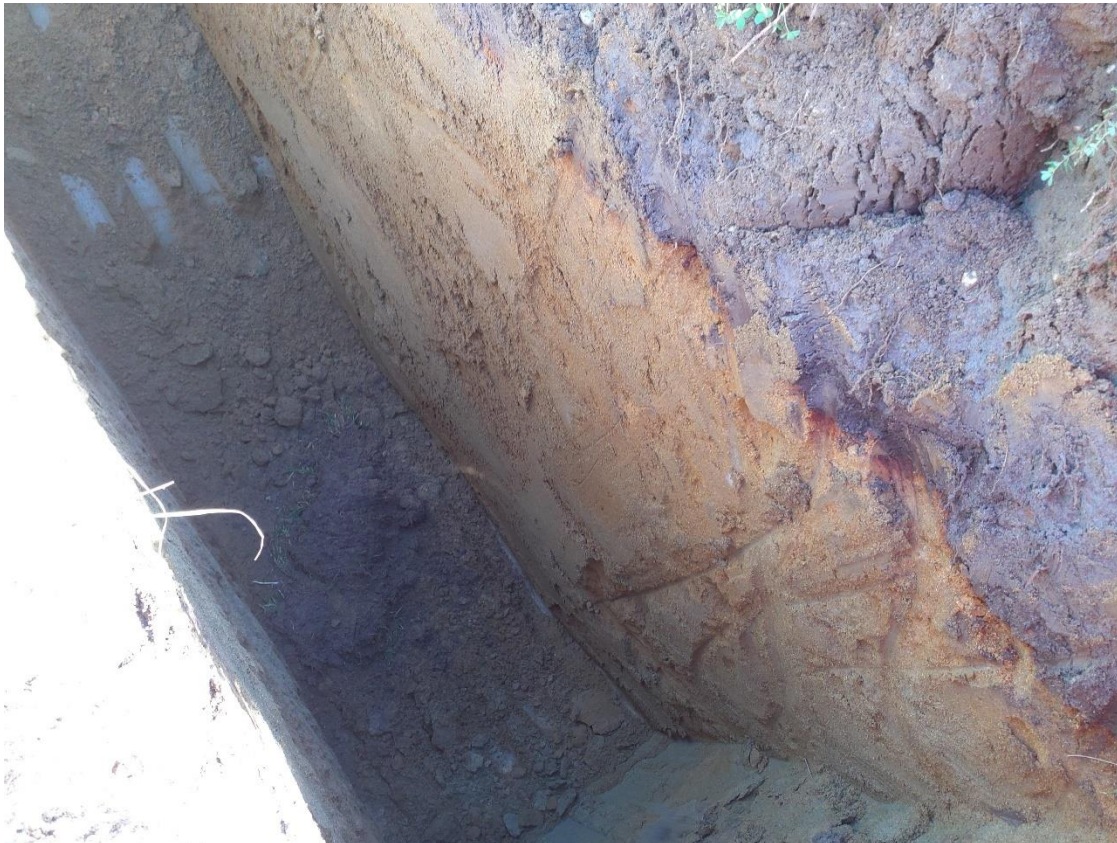
Figure 4 below illustrates the test locations which were undertaken within area B. Test pit 06 was undertaken in Area B and encountered a 600m thick layer of silty topsoil before reaching an iron pan layer. Below this was firm orange brown sandstone before the test pit was terminated at a depth of 1.9m without encountering groundwater.

**Figure 6.** Test pit 06 undertaken in area B.
