**10 PIONEER CRESCENT, OMOKOROA**

# Land Information Memorandum

# **Kaimai Views Subdivision Development, Omokoroa**

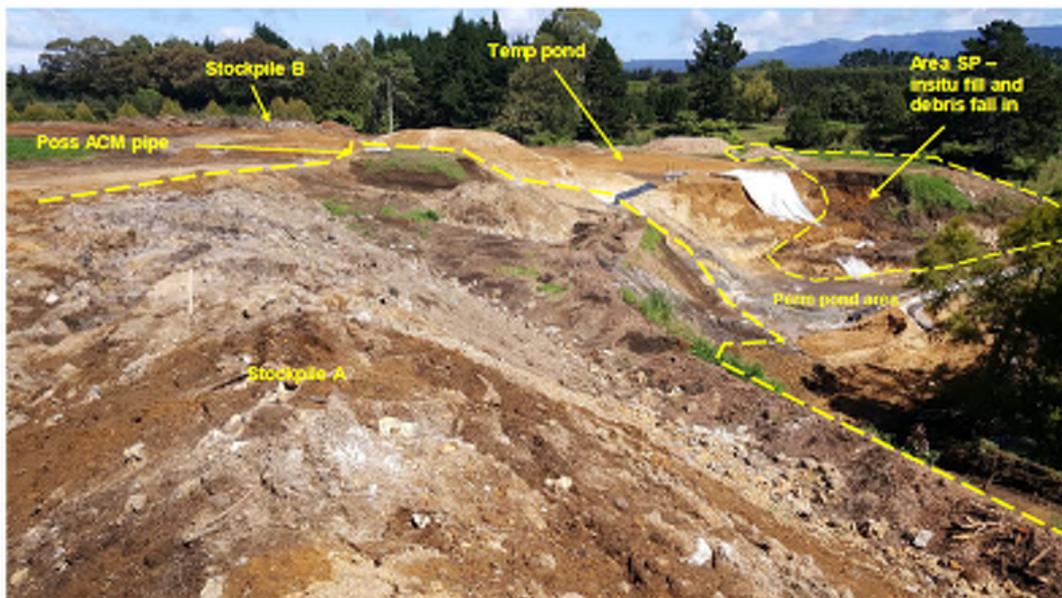
Figure 1: Panorama of works from Stockpile A (Aurecon, 14 March 2017)

Aurecon's Senior Environmental Geologist identified visible ACM fragments throughout Stockpile A, construction waste but no obvious ACM in Stockpile B and ACM fragments in fill that partially collapsed into the pond.

ACM was originally encountered during construction of a permanent stormwater pond below the main development landform. The ACM was identified within uncontrolled fill placed at the base of the gully in which the permanent pond is being constructed. The majority of the material excavated from the permanent pond area has been stockpiled at two locations, referred as Stockpile A and B (refer to Figure 1, plans in Appendix A and photos in Appendix B).

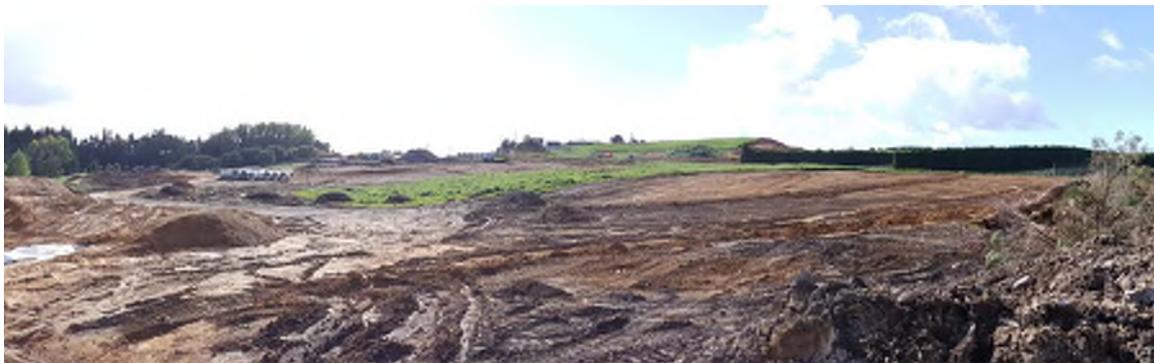
Figure 1 The southern terrace viewed from its western boundary, as observed 14 March 2017 (Aurecon)

The Subdivision is being constructed across two irregularly shaped terraces raised at a moderate to steep gradient ~6 m above a central drainage gully and across which a new land bridge has been constructed. The southern terrace, is bounded to the north, south, and west by the gully, and to the east by Omokoroa Road. The northern terrace is bounded to the north, and south by the gully, and to the east by the East Coast Main Trunk (ECMT) railway line. The new land bridge connecting the two terraces is formed of the clean material undercut from the creation of the encapsulation cell.

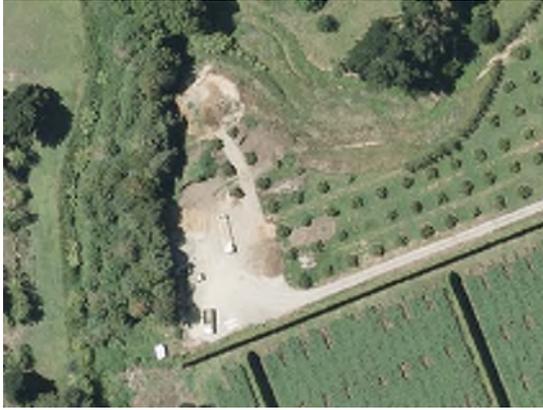
Figure 3 2007 Aerial photograph (WBOPDC)

Aurecon's review of historical aerial photographs showed that earthworks had been undertaken in the area that asbestos had been discovered. The earthworks occurred between 2007 and 2011, as evidenced by signs of soil disturbance activities and bare ground within aerial photographs sourced from Western Bay of Plenty District Council GIS (Figures 3 and 4).

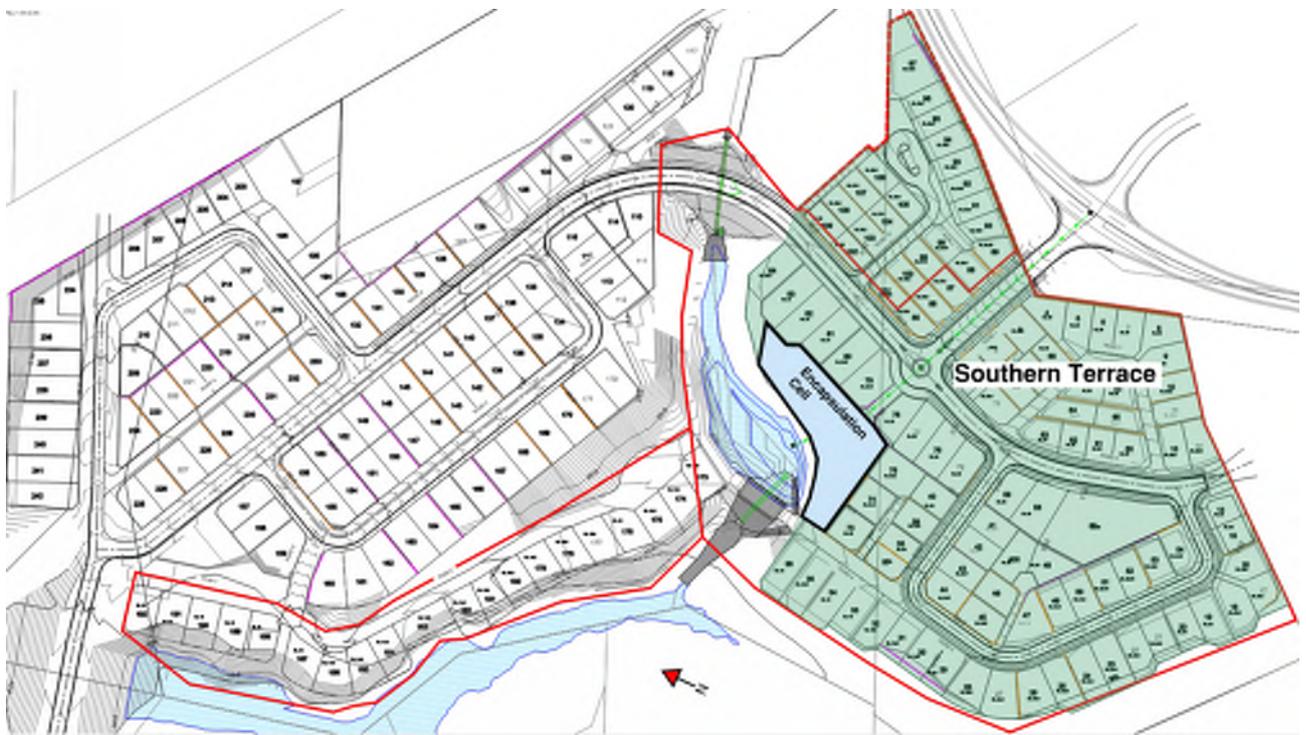
Figure 5 Location of the encapsulation cell within the subdivision layout

An on-site encapsulation cell was constructed within an area of proposed reserve on the northern boundary of the southern terrace, the location of which is shown on Figure 5, and Figure A2 Appendix A.

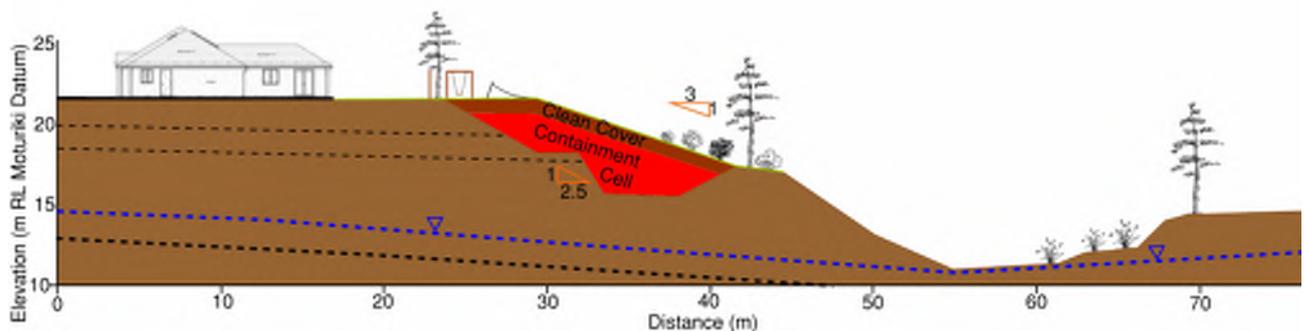
Figure 6 Idealised sketch cross section of encapsulation cell

A sketch cross section of the encapsulation cell is presented in Figure 6.

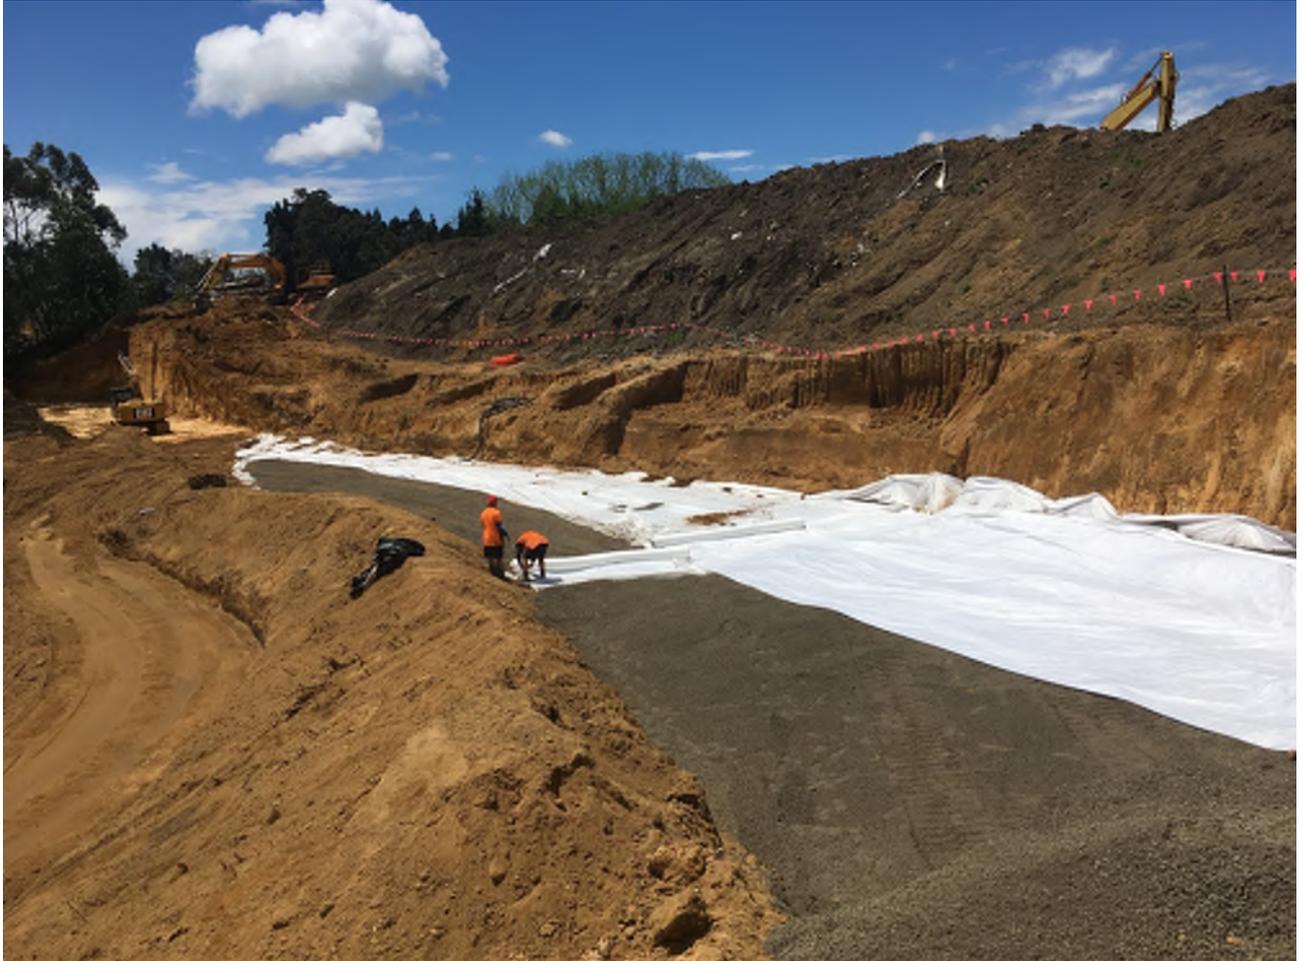
**Figure 7** Installation of drainage layer at base of lower tier of encapsulation cell

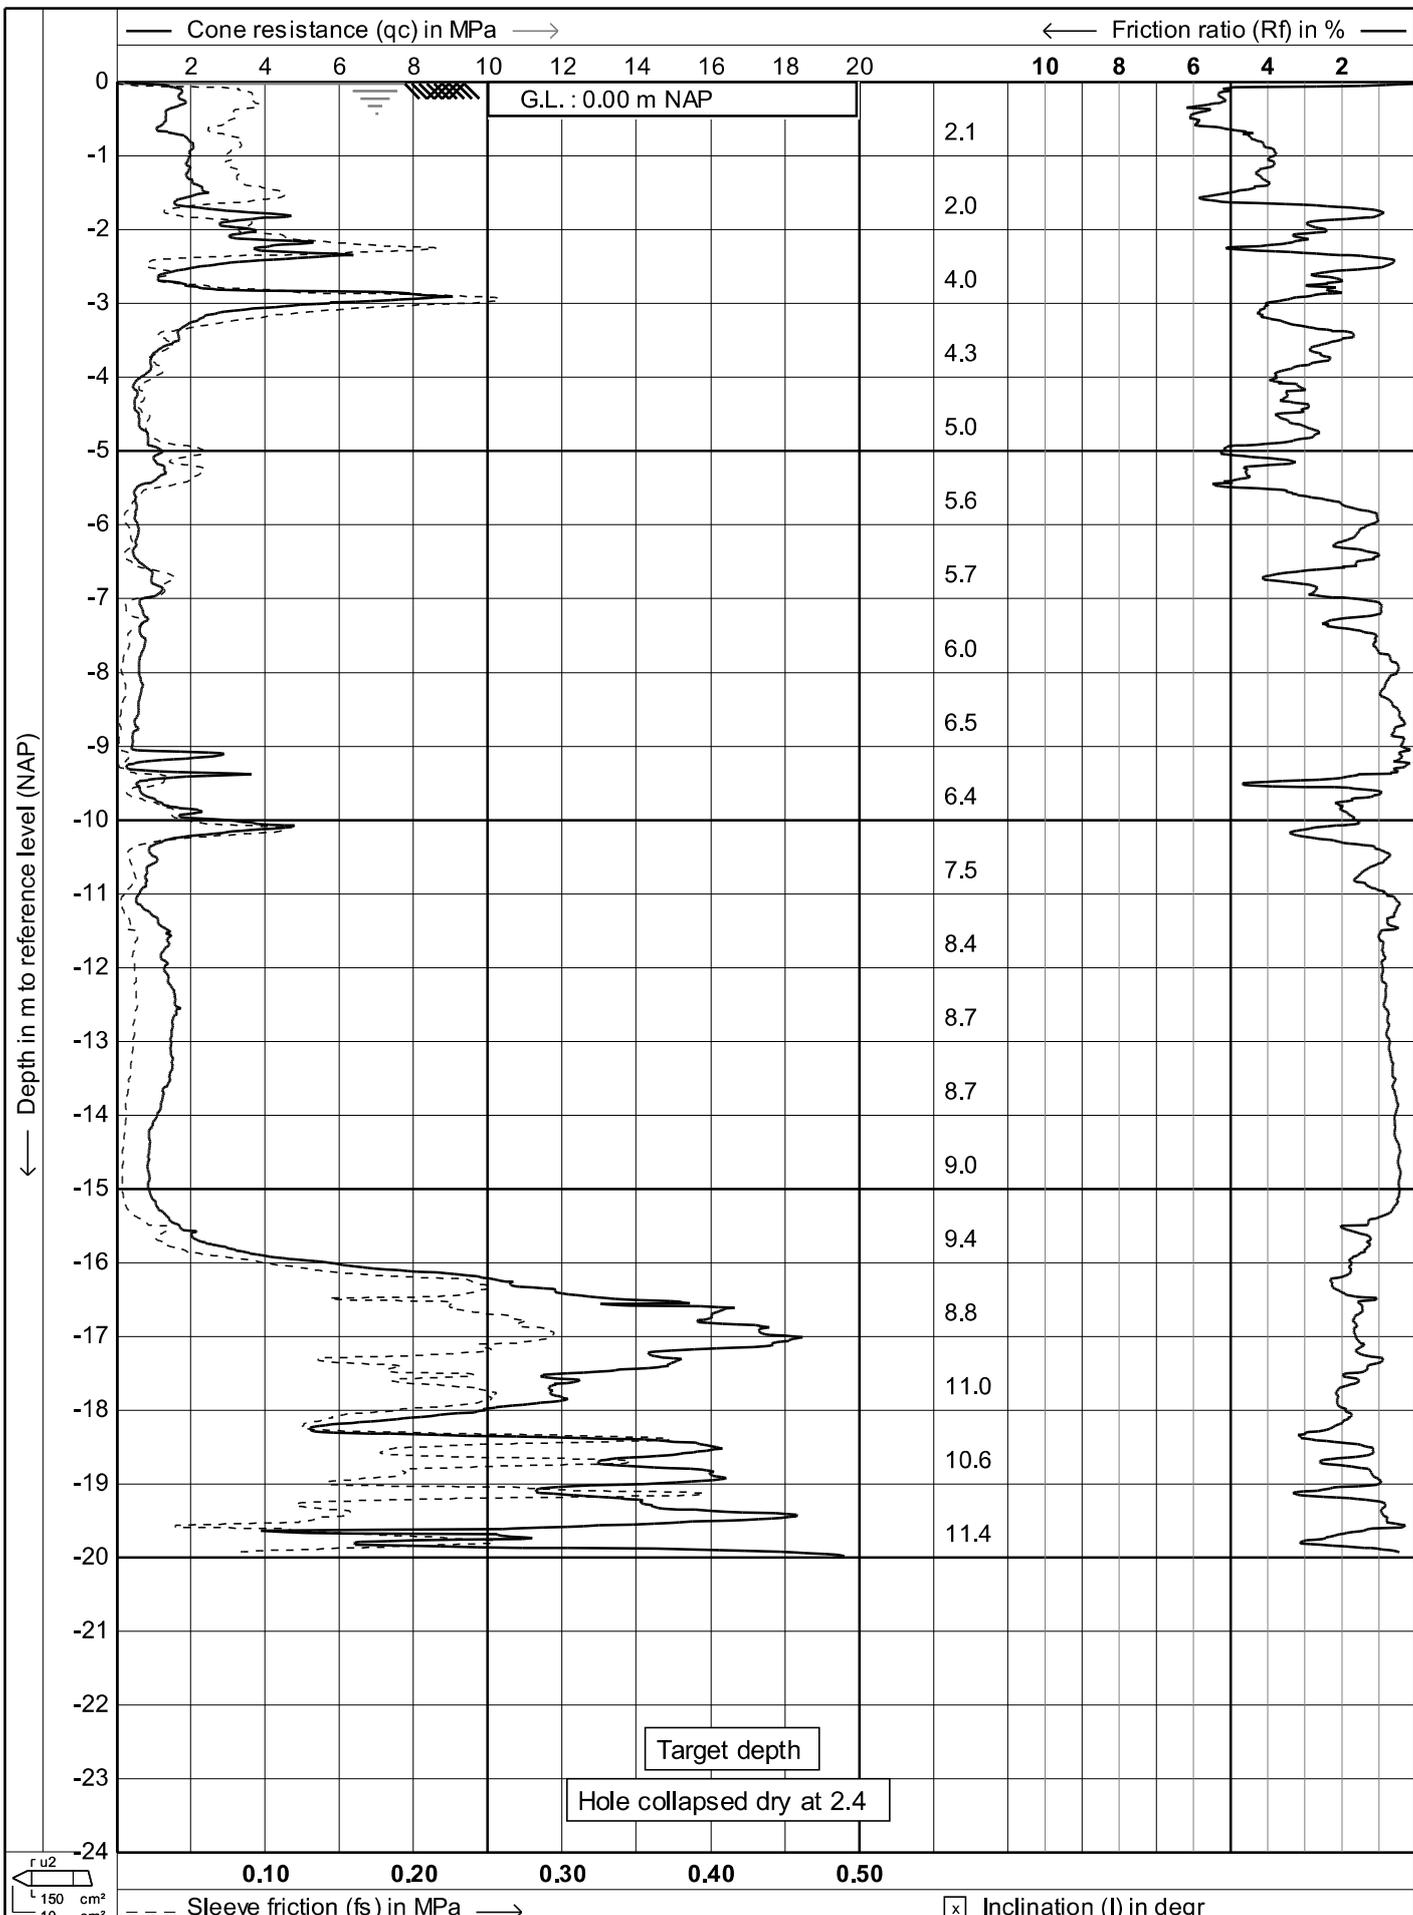
Test according A.S.T.M Standard D 5778-12		Date : 23-6-2016	
	Project : Site Investigations		Cone no. : C10CFIP.C13082	
	Location: 336		Project no. : 01CMW14	
	Position: 0, 0 RD		CPT no. : 10	1/14

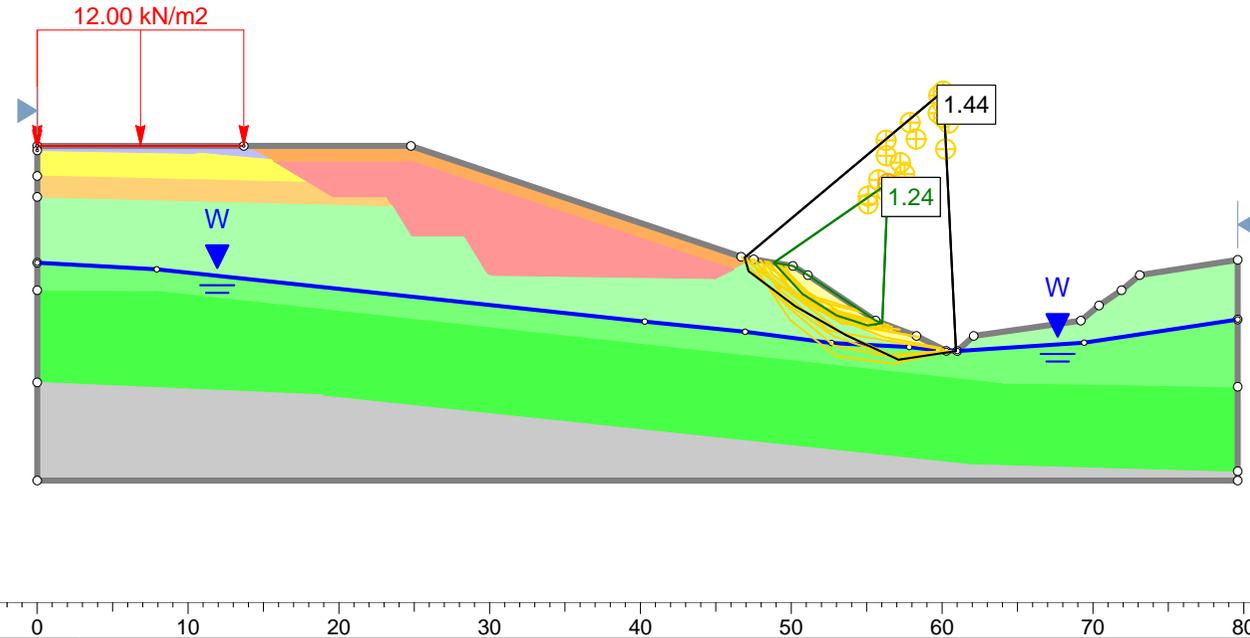
Project		
	Kaimai Views Subdivision - Fill Encapsulation		
	Analysis Description		
	Cross Section B-B - Proposed GL - Prevailing GW conditions		
Drawn By	Scale	Company	
	1:500	Classic Developments Omokoroa Ltd	
Date	File Name		
23/05/2017	Fill Encapsulation - Section B - Proposed profile prevailing GWL.slim

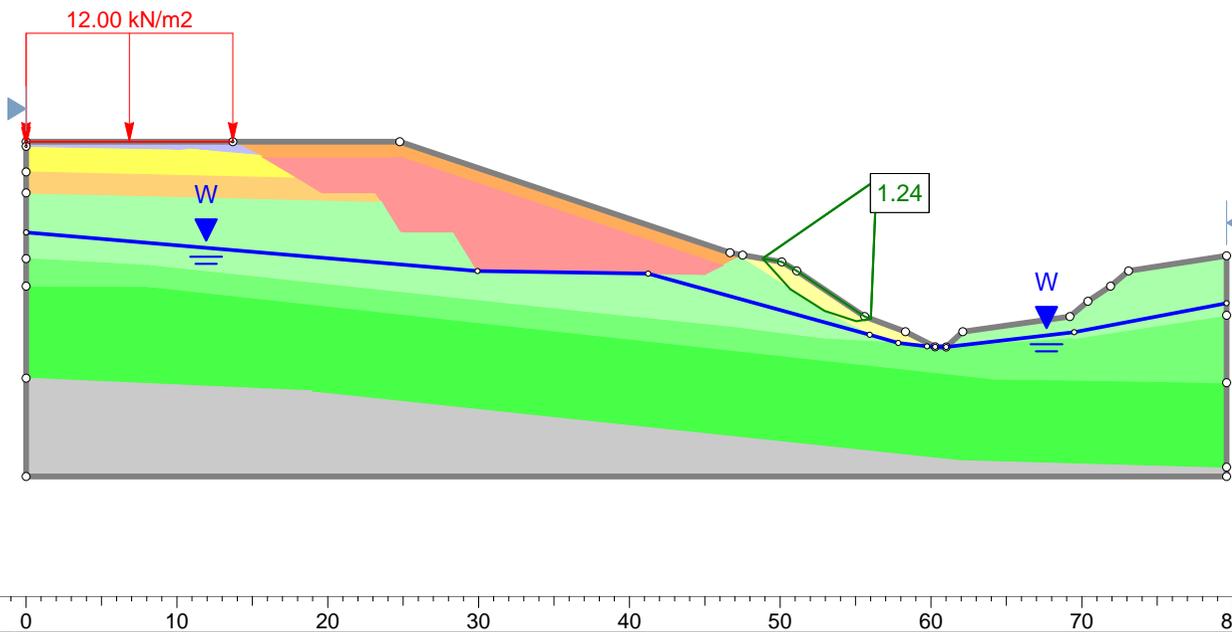
Project		
	Kaimai Views Subdivision - Fill Encapsulation		
	Analysis Description		
	Cross Section B-B - Proposed GL - Elevated GW conditions		
Drawn By	Scale	Company	
	1:500	Classic Developments Omokoroa Ltd	
Date	File Name		
23/05/2017	Fill Encapsulation - Section B - Proposed profile elevated GWL.slim

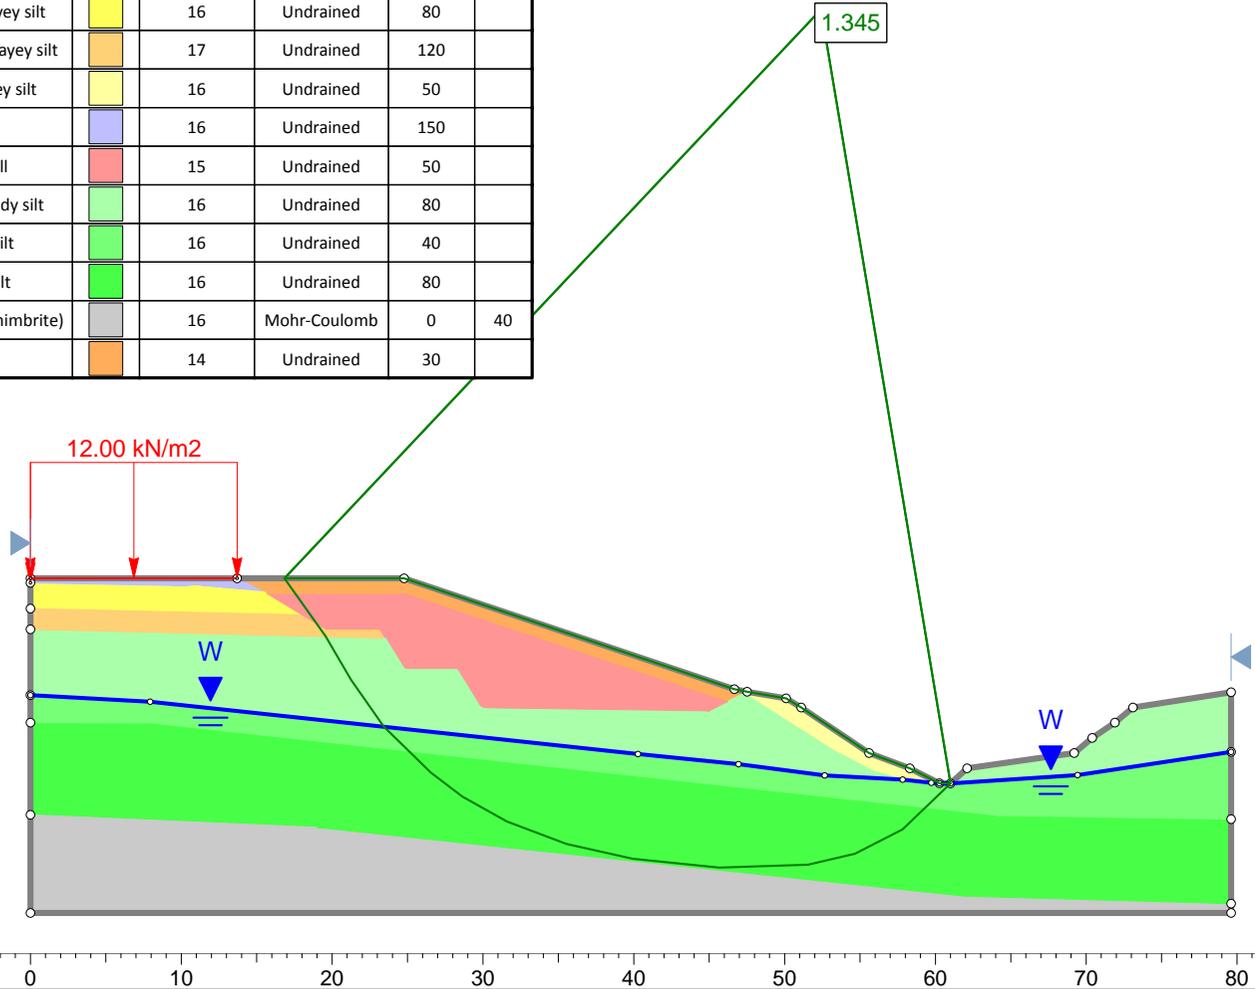
Material Name	Color	Unit Weight (kN/m <sup>3</sup> )	Strength Type	Cohesion (kPa)	Phi (deg)
Younger Ash: Stiff clayey silt	Yellow	16	Undrained	80	
Hamilton Ash: V. stiff clayey silt	Orange	17	Undrained	120	
Colluvium: Stiff clayey silt	Light Yellow	16	Undrained	50	
Engineered Fill	Light Blue	16	Undrained	150	
Tracked-rolled Fill	Red	15	Undrained	50	
MS: Stiff to V.Stiff sandy silt	Light Green	16	Undrained	80	
MS: Firm clayey silt	Green	16	Undrained	40	
MS: Stiff sandy silt	Light Green	16	Undrained	80	
Dense Sand (inferred Ignimbrite)	Grey	16	Mohr-Coulomb	0	40
Topsoil	Orange	14	Undrained	30

Project		
	Kaimai Views Subdivision - Fill Encapsulation		
	Analysis Description		
	Cross Section B-B - IL2 ULS Seismic Case		
Drawn By	Scale	Company	
	1:500	Classic Developments Omokoroa Ltd	
Date	File Name		
23/05/2017	Fill Encapsulation - Section B - IL2 ULS Seismic Case.slim

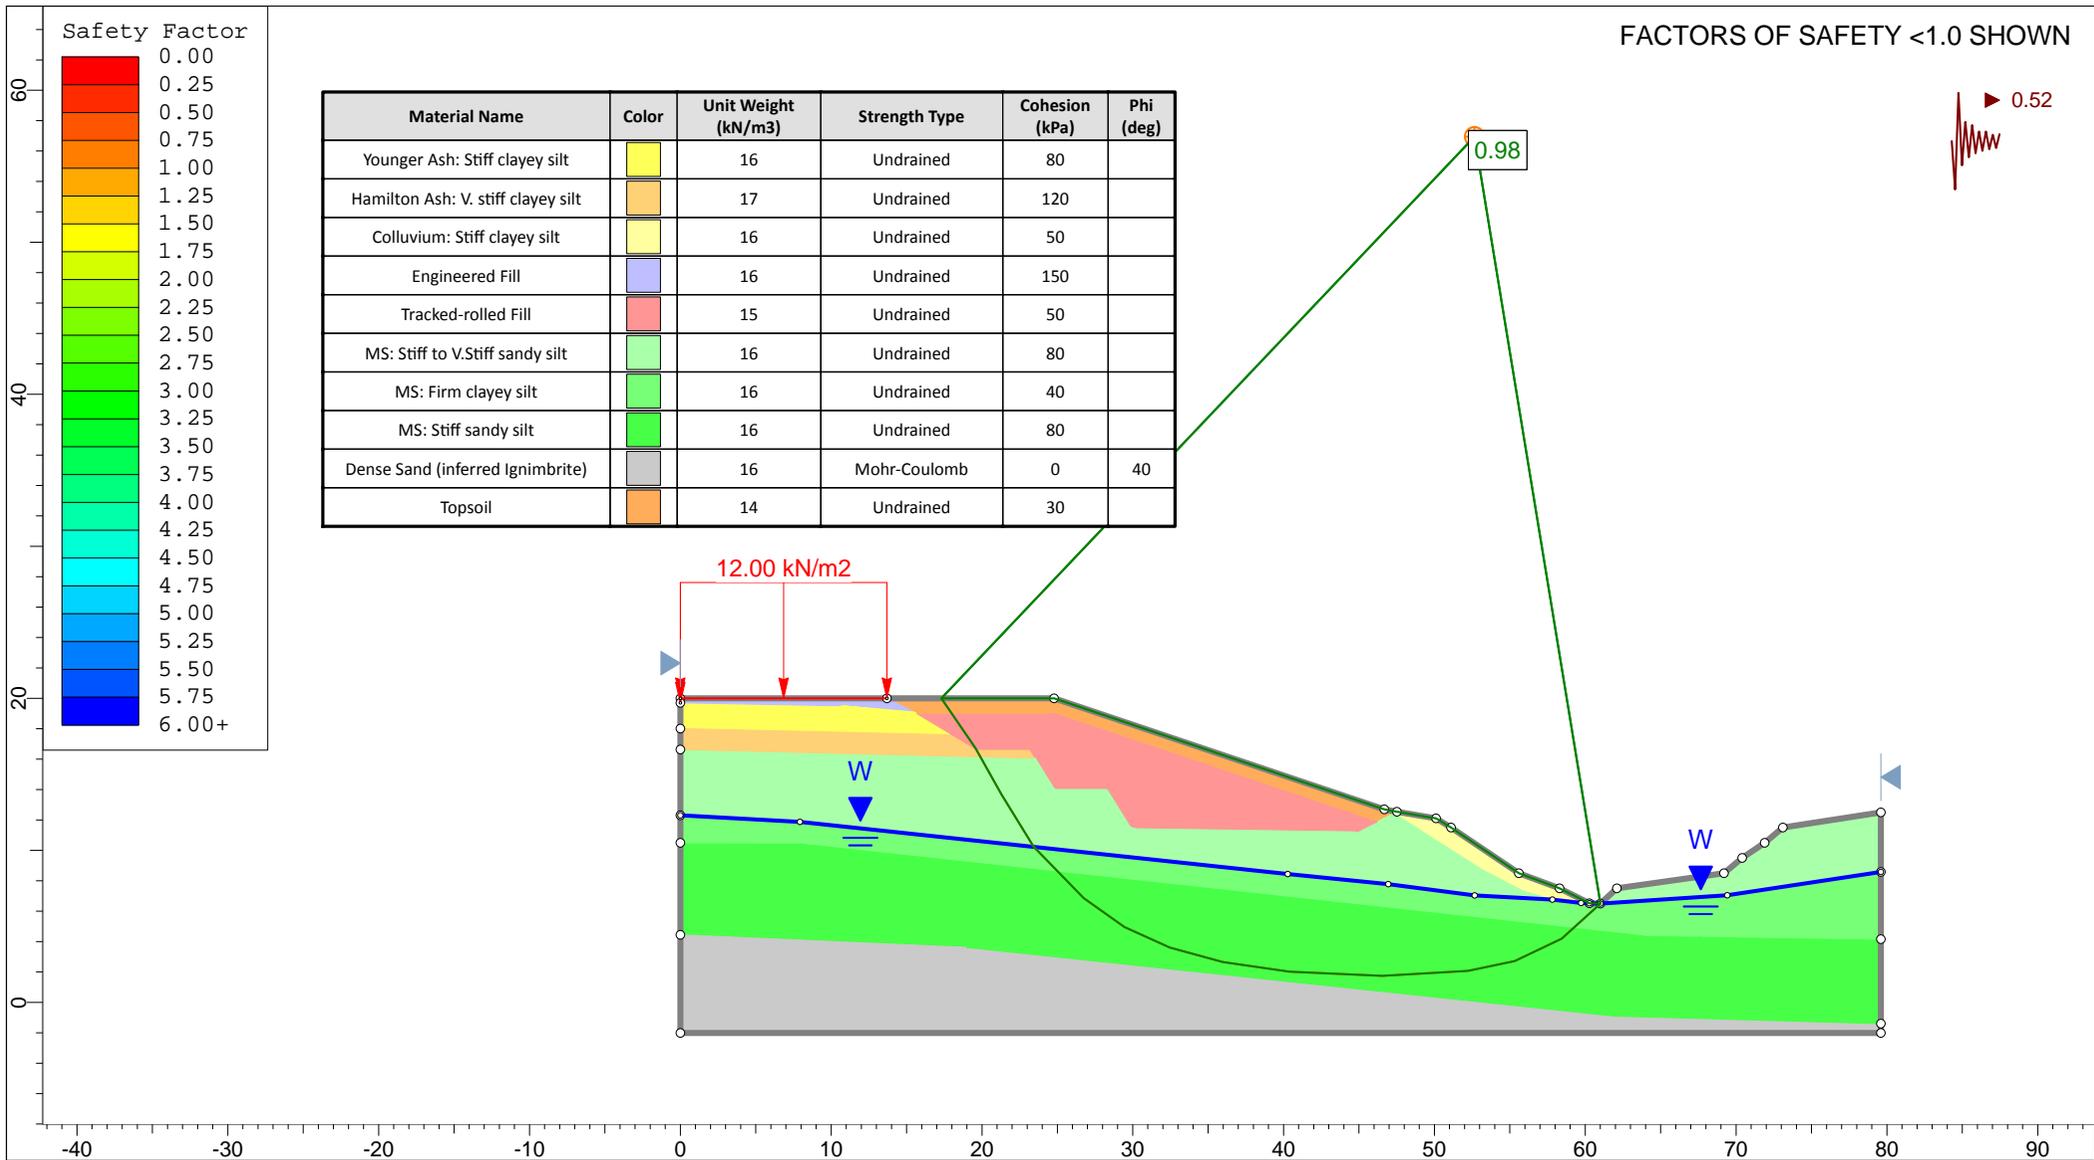
<b>Project</b> Kaimai Views Subdivision - Fill Encapsulation		
	<b>Analysis Description</b> Cross Section B-B - IL4 ULS Seismic Case		
	<b>Drawn By</b>	<b>Scale</b> 1:500	<b>Company</b> Classic Developments Omokoroa Ltd
	<b>Date</b> 23/05/2017	<b>File Name</b> Fill Encapsulation - Section B - IL4 ULS Seismic Case.slim

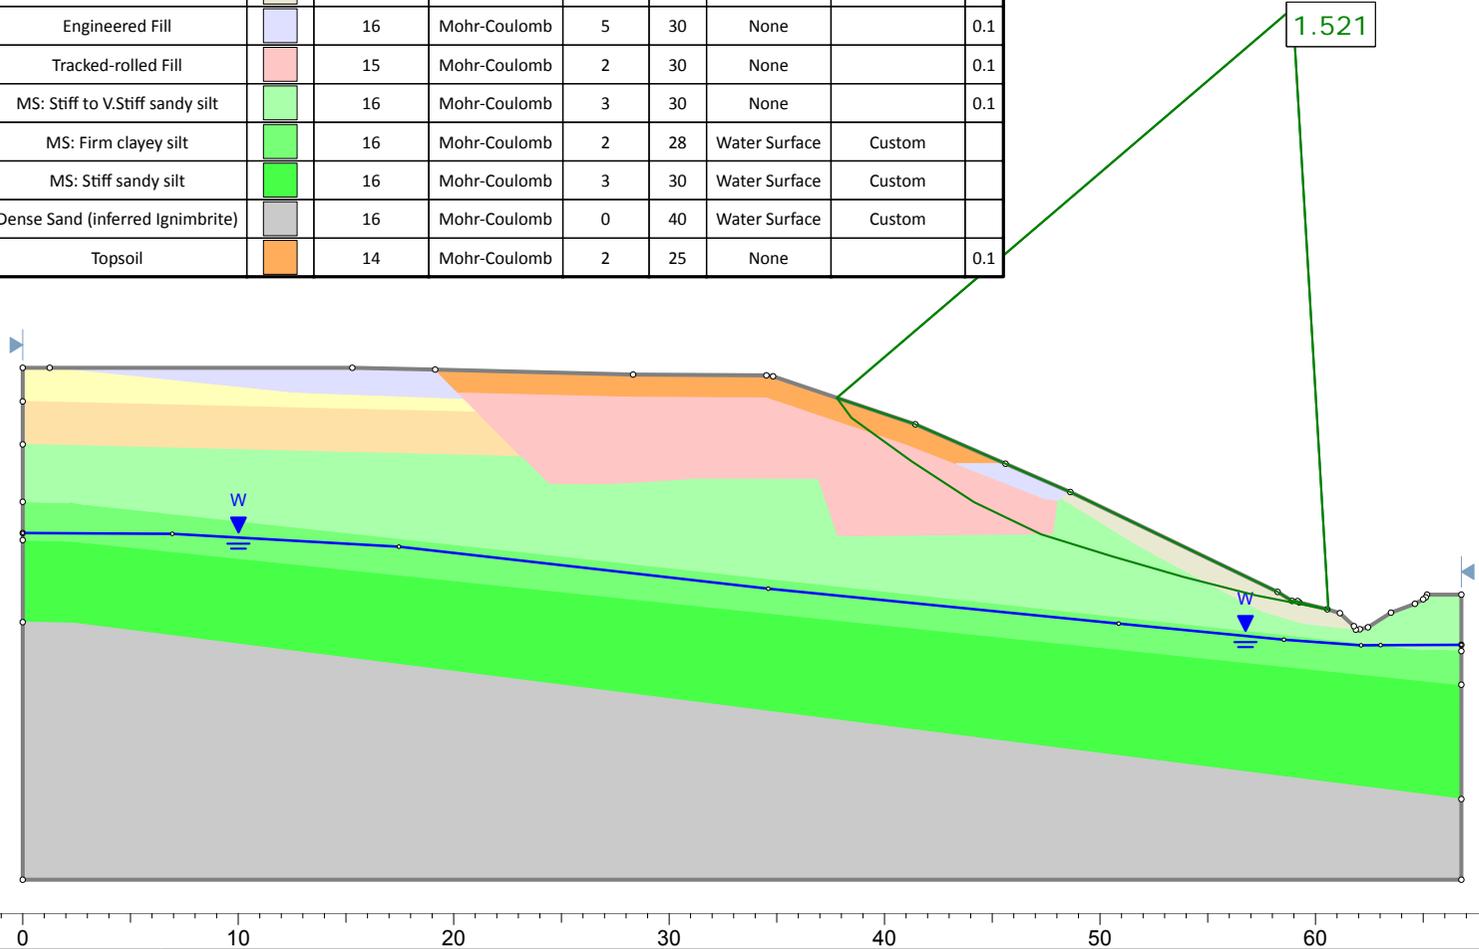
Project	Kaimai Views Subdivision - Fill Encapsulation	
	Analysis Description	Cross Section 3 - As-built GL - Prevailing GW conditions	
	Drawn By	Company	Classic Developments Omokoroa Ltd
	Date	31/01/2018	File Name

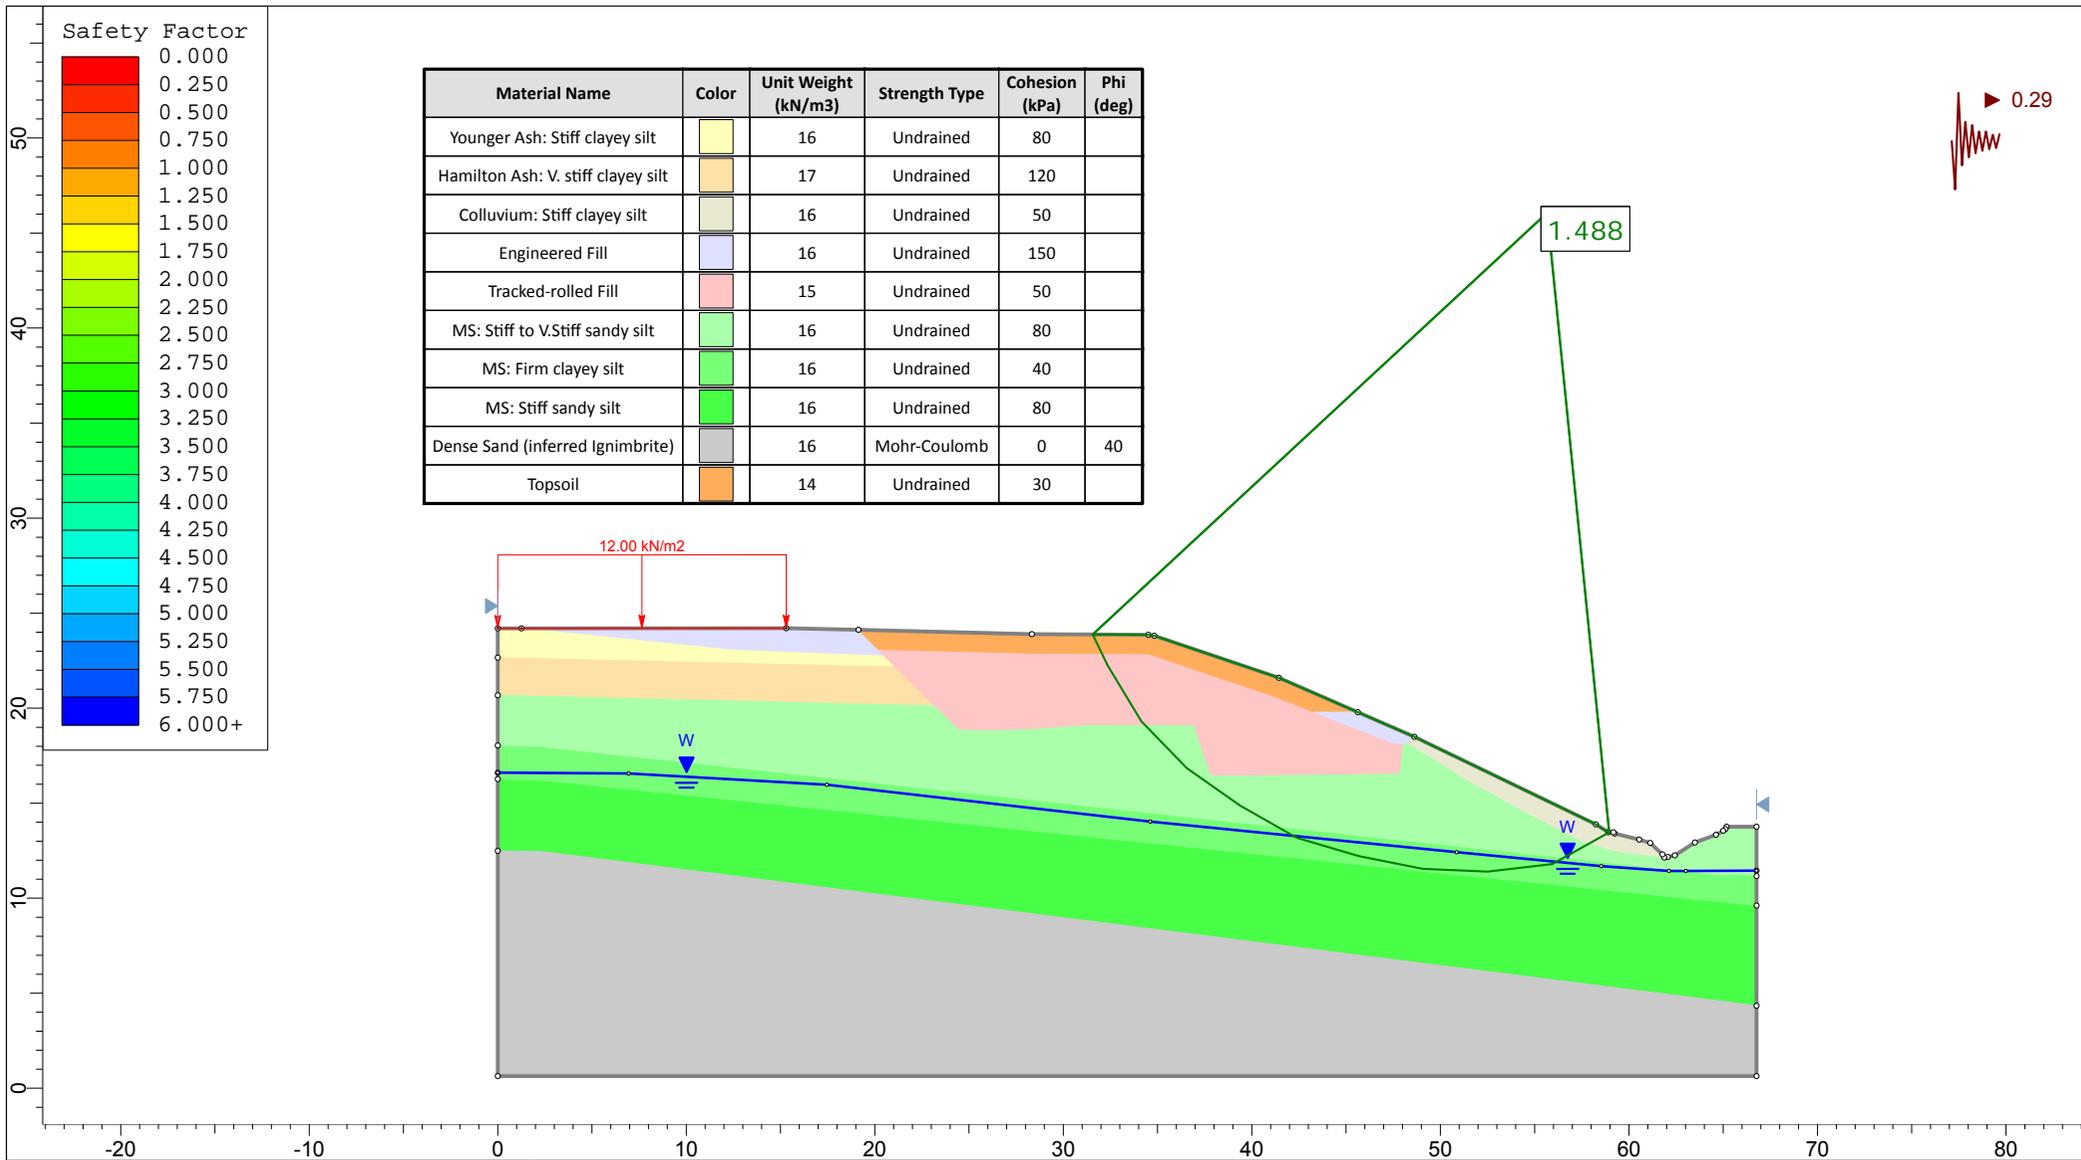
<b>Project</b> Kaimai Views Subdivision - Fill Encapsulation	
	<b>Analysis Description</b> Cross Section 3 - As-built GL - IL2 ULS case	
	<b>Drawn By</b>	<b>Company</b> Classic Developments Omokoroa Ltd
	<b>Date</b> 05/02/2018	<b>File Name</b> ACM Encapsulation - As Built Section 3 - ULS Seismic Case.slim

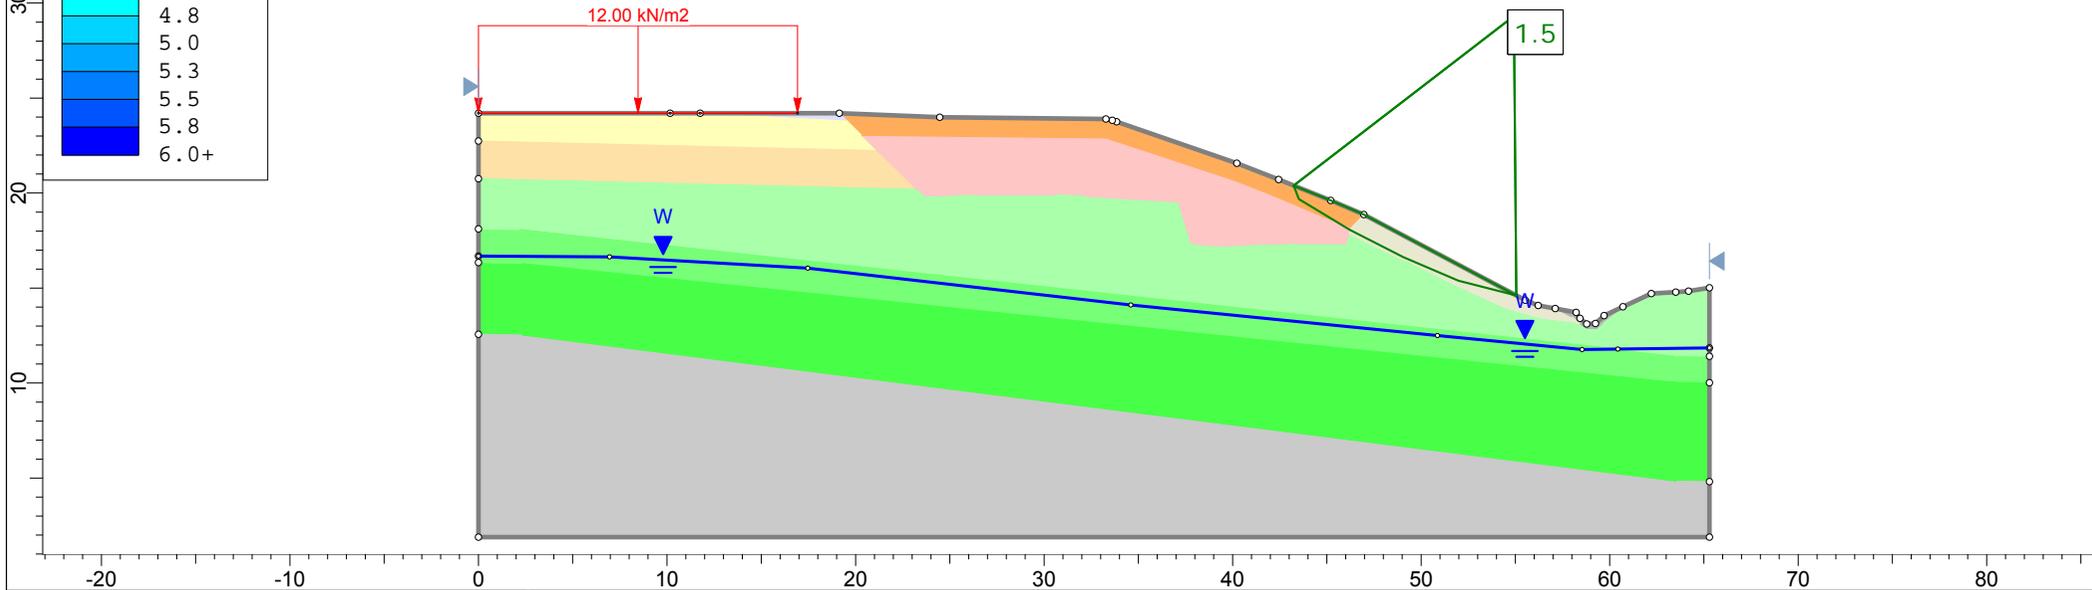
Project	Kaimai Views Subdivision - Fill Encapsulation	
	Analysis Description	Cross Section 4 - As-built GL - Prevailing GW conditions	
	Drawn By	Company	Classic Developments Omokoroa Ltd
	Date	09/02/2018	File Name

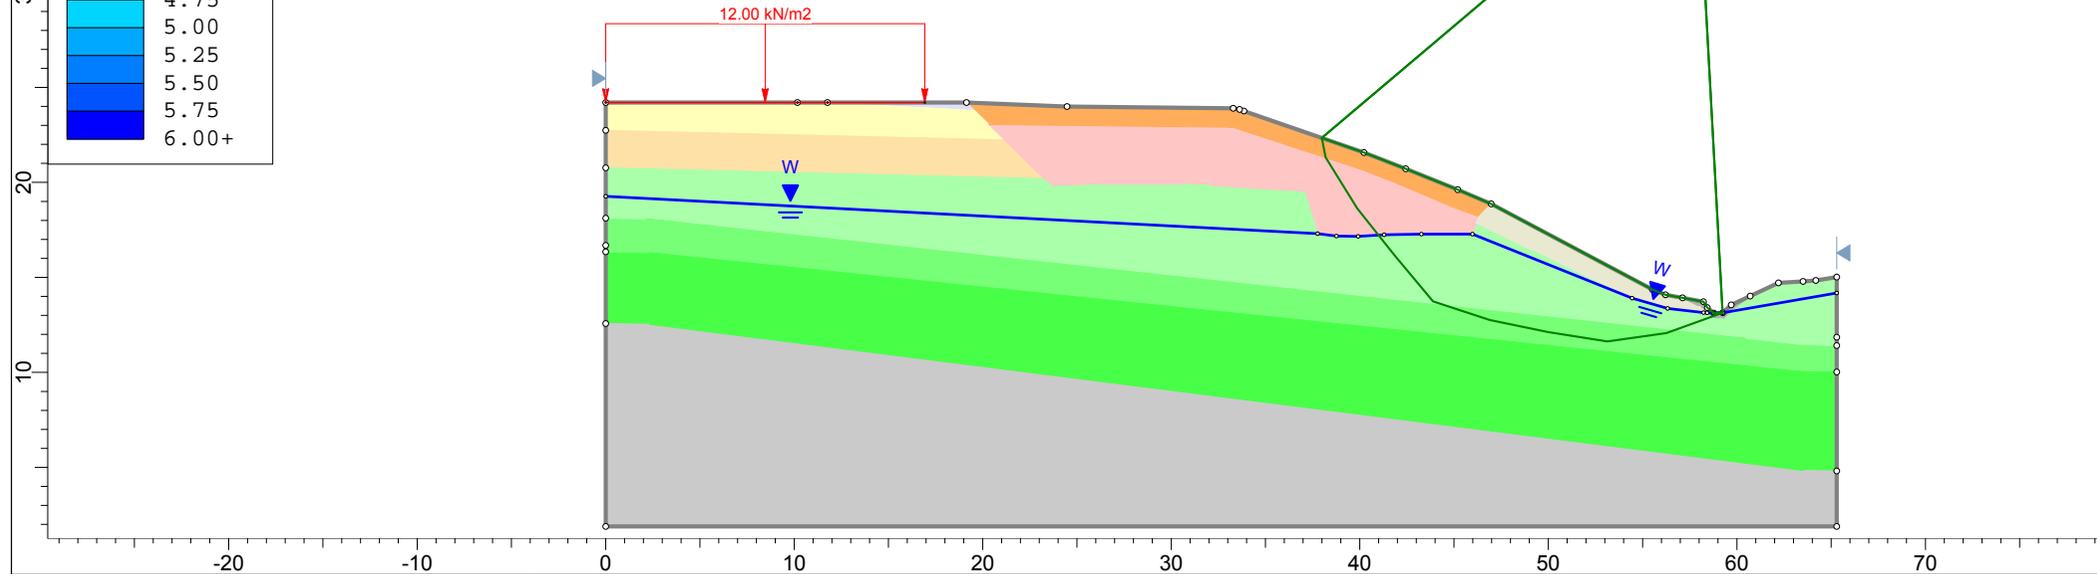
Project	Kaimai Views Subdivision - Fill Encapsulation	
	Analysis Description	Cross Section 4 - As-built GL - Elevated GW conditions	
	Drawn By	Company	Classic Developments Omokoroa Ltd
	Date	09/02/2018	File Name

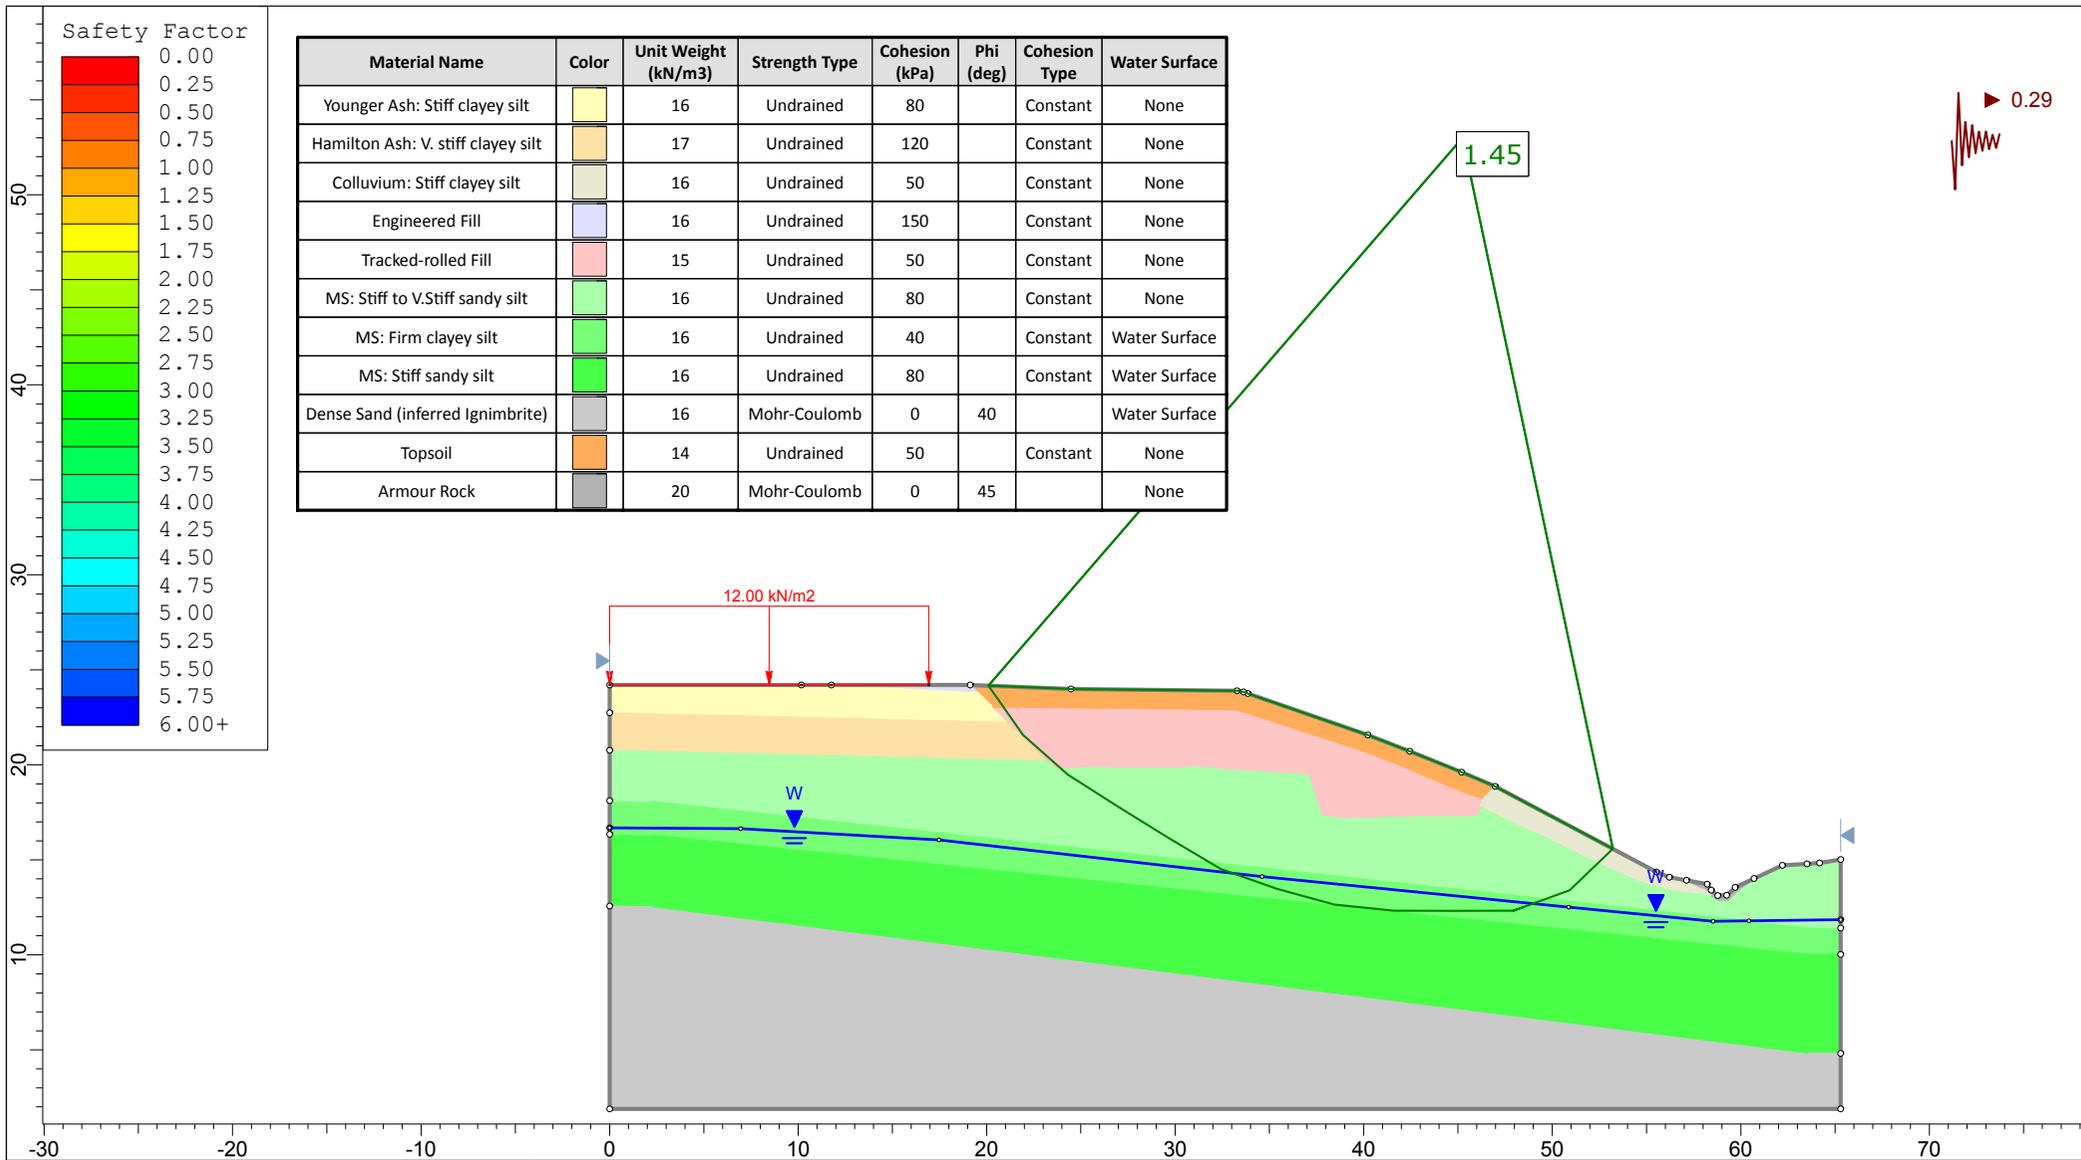
Project		Kaimai Views Subdivision - Fill Encapsulation	
	Analysis Description		Cross Section 4 - As-built GL - IL2 seismic case	
	Drawn By	Company	Classic Developments Omokoroa Ltd	
	Date	16/02/2018	File Name	ACM - As Built Section 4 - seismic case.slim
