**10 PIONEER CRESCENT, OMOKOROA**

# Land Information Memorandum

# **Kaimai Views Subdivision Development, Omokoroa**

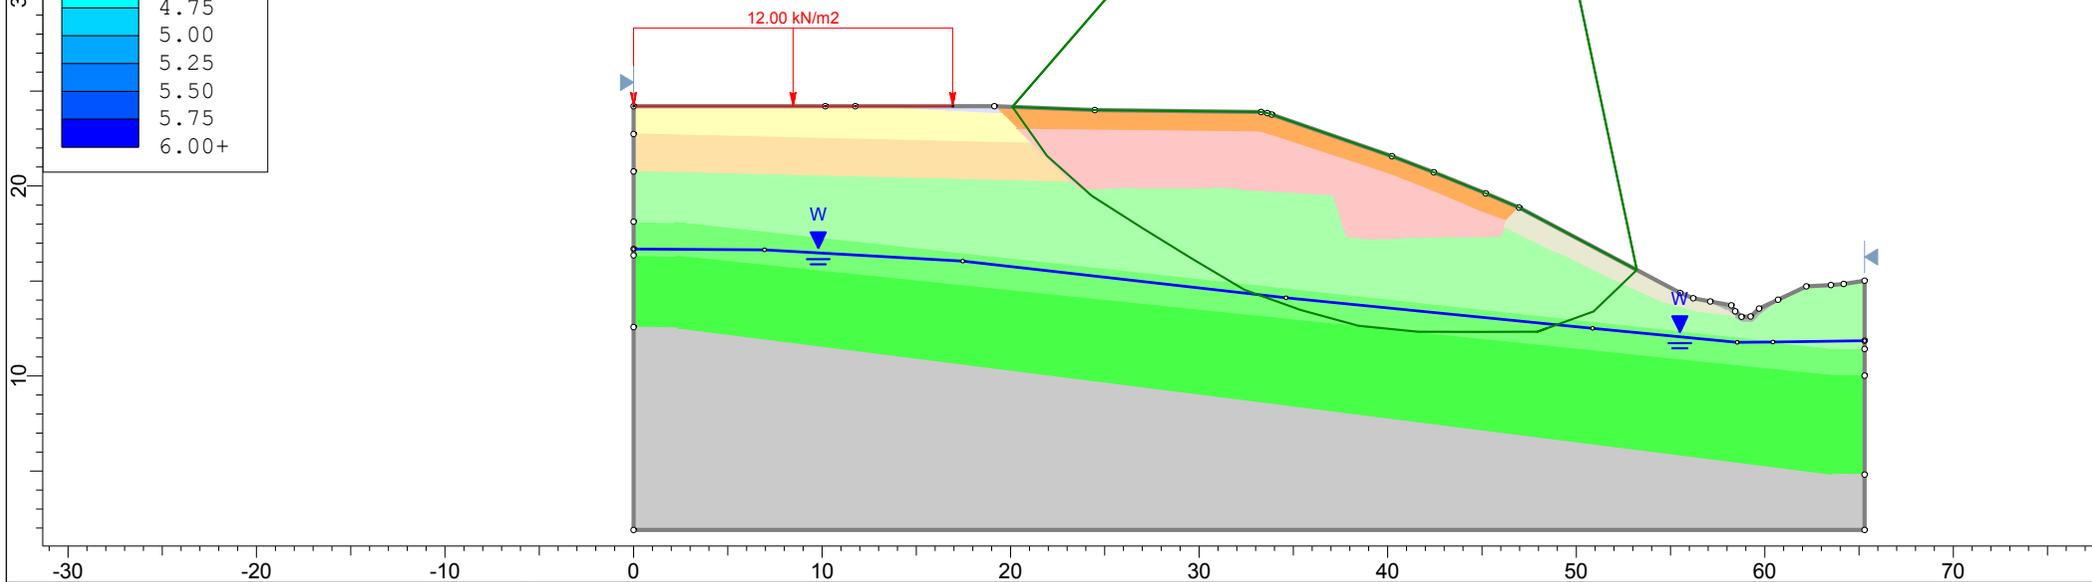
Material Name	Color	Unit Weight (kN/m <sup>3</sup> )	Strength Type	Cohesion (kPa)	Phi (deg)	Cohesion Type	Water Surface
Younger Ash: Stiff clayey silt	[Yellow]	16	Undrained	80		Constant	None
Hamilton Ash: V. stiff clayey silt	[Orange]	17	Undrained	120		Constant	None
Colluvium: Stiff clayey silt	[Light Green]	16	Undrained	50		Constant	None
Engineered Fill	[Light Blue]	16	Undrained	150		Constant	None
Tracked-rolled Fill	[Pink]	15	Undrained	50		Constant	None
MS: Stiff to V.Stiff sandy silt	[Light Green]	16	Undrained	80		Constant	None
MS: Firm clayey silt	[Light Green]	16	Undrained	40		Constant	Water Surface
MS: Stiff sandy silt	[Light Green]	16	Undrained	80		Constant	Water Surface
Dense Sand (inferred Ignimbrite)	[Grey]	16	Mohr-Coulomb	0	40		Water Surface
Topsoil	[Orange]	14	Undrained	50		Constant	None
Armour Rock	[Grey]	20	Mohr-Coulomb	0	45		None

Project	Kaimai Views Subdivision - Fill Encapsulation	
	Analysis Description	Cross Section 4 - As-built GL - IL3 seismic case	
	Drawn By	Company	Classic Developments Omokoroa Ltd
	Date	16/02/2018	File Name

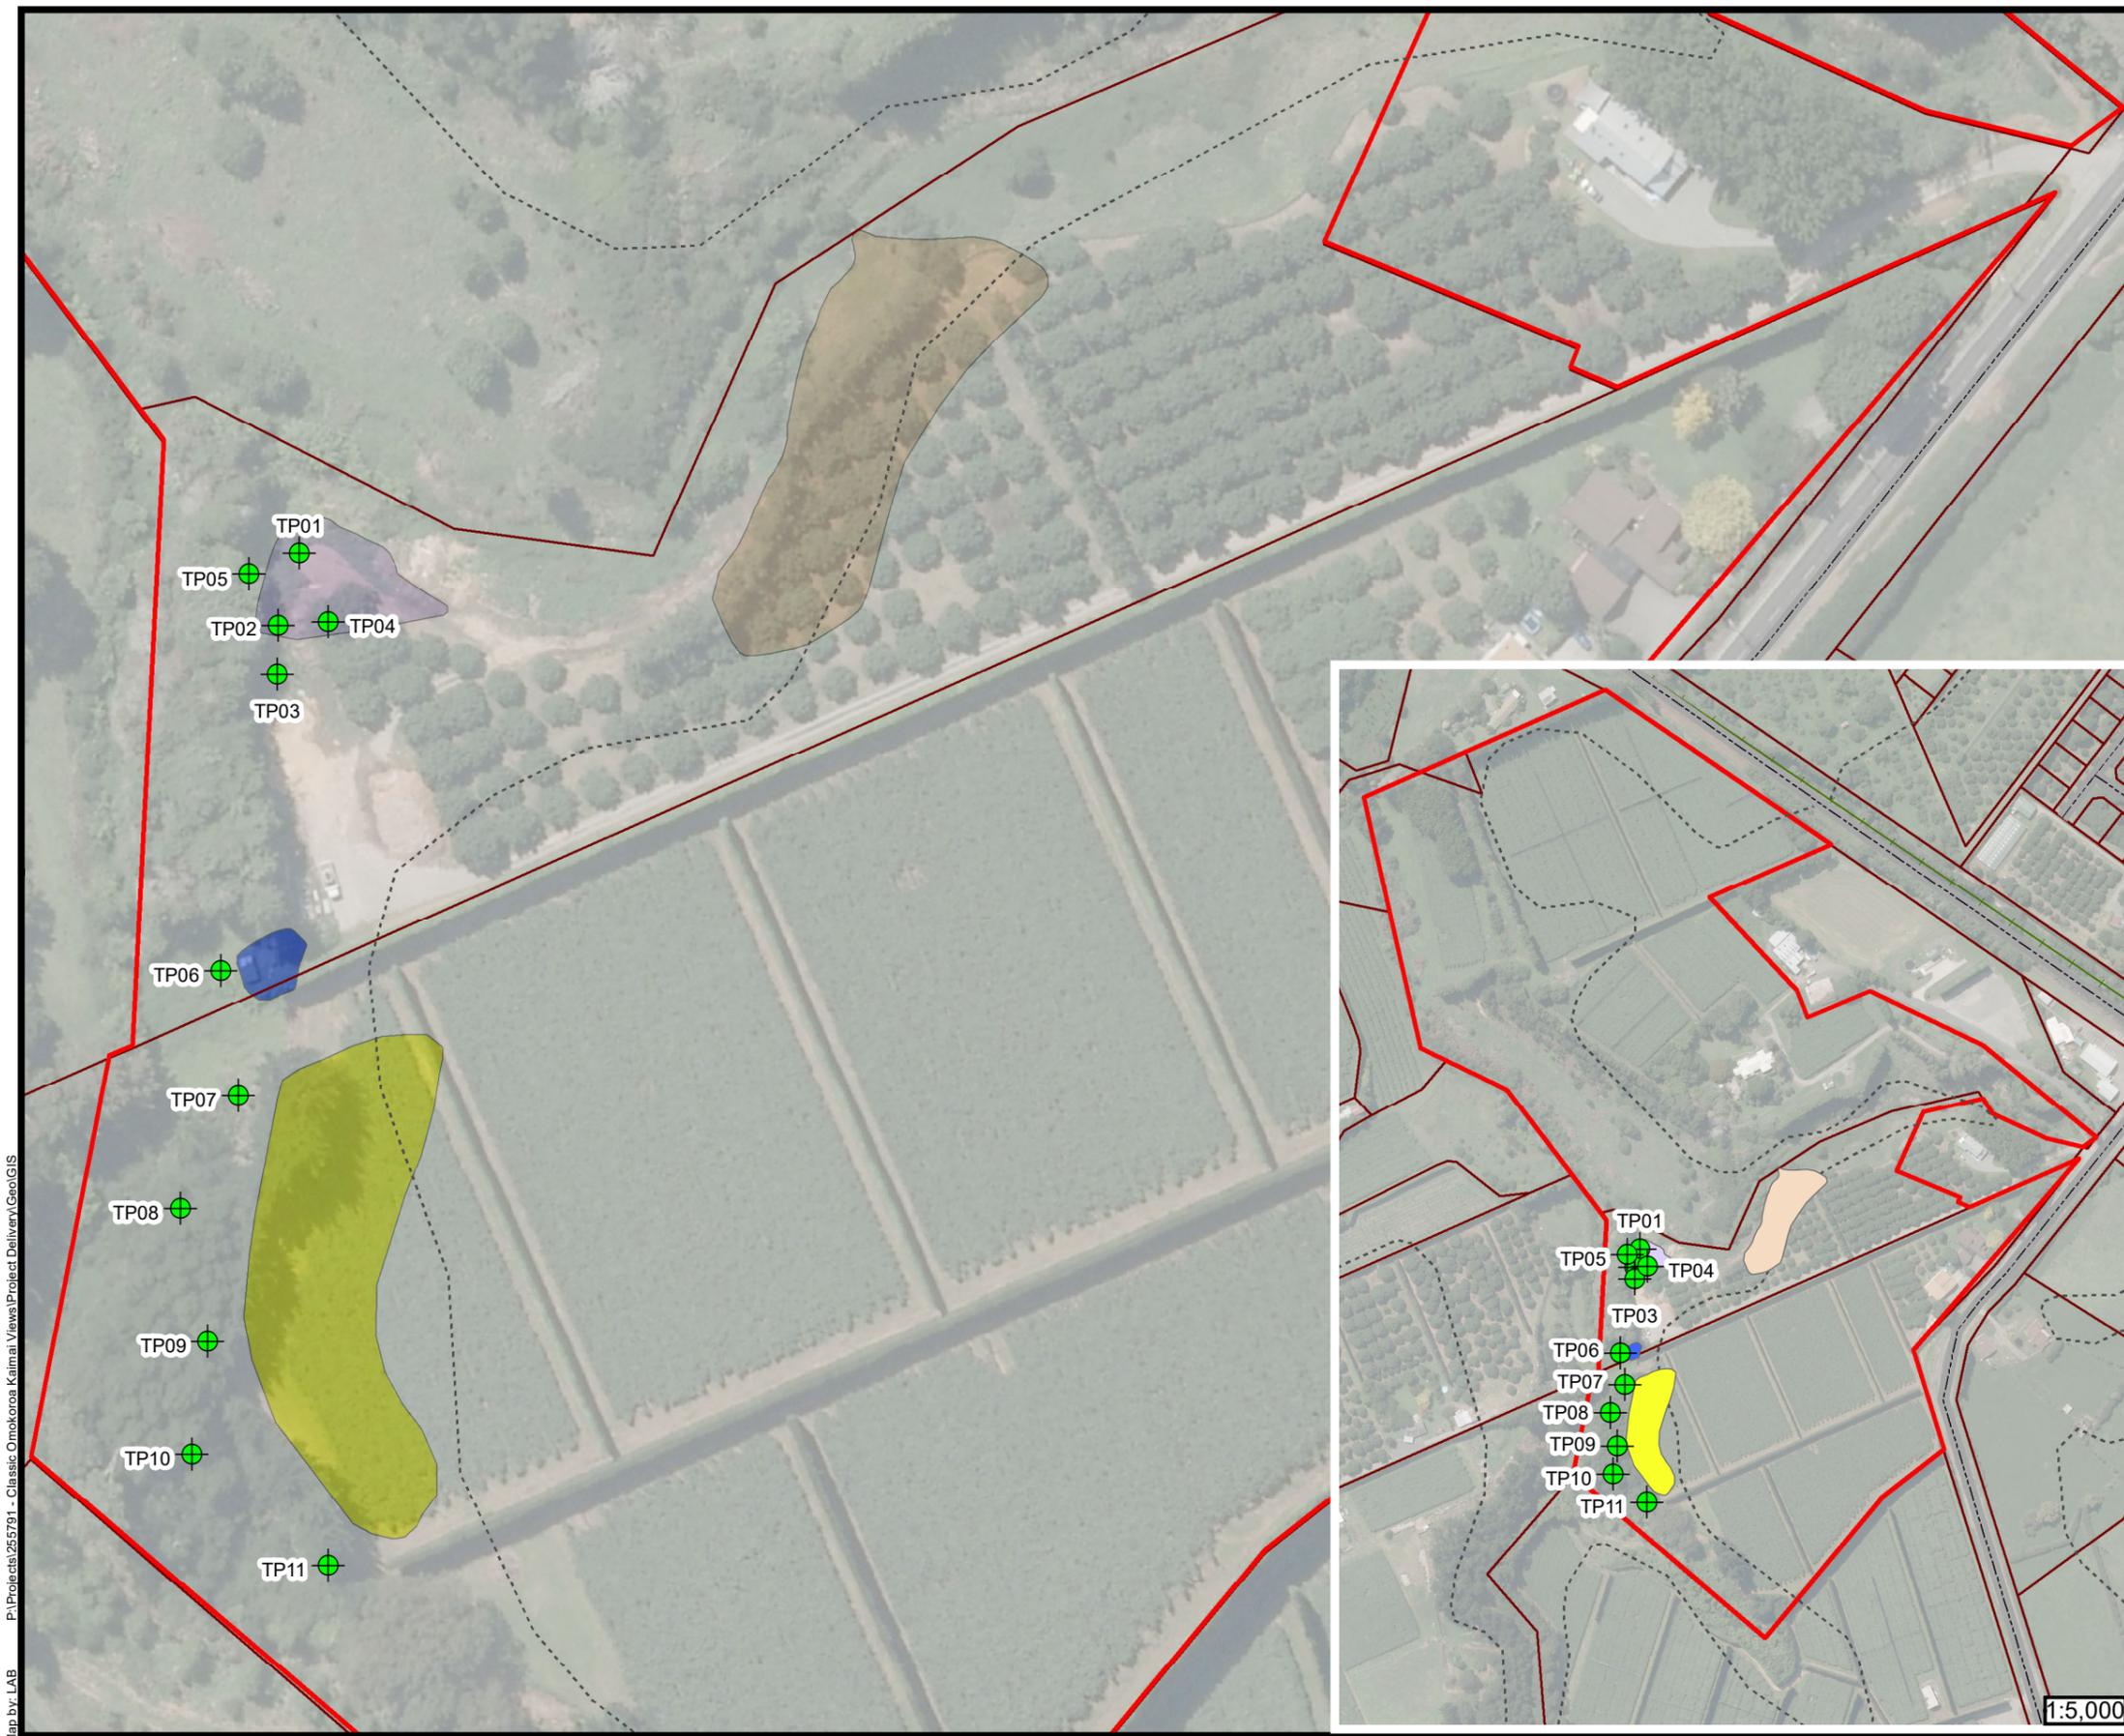
- SP1
- SP-A
- SP-B
- TP-6
- Test Pits
- Site boundary

**Notes:**  
 -Background image from Western Bay of Plenty Regional Council mapping  
 -Stockpile and test pit locations are approximate

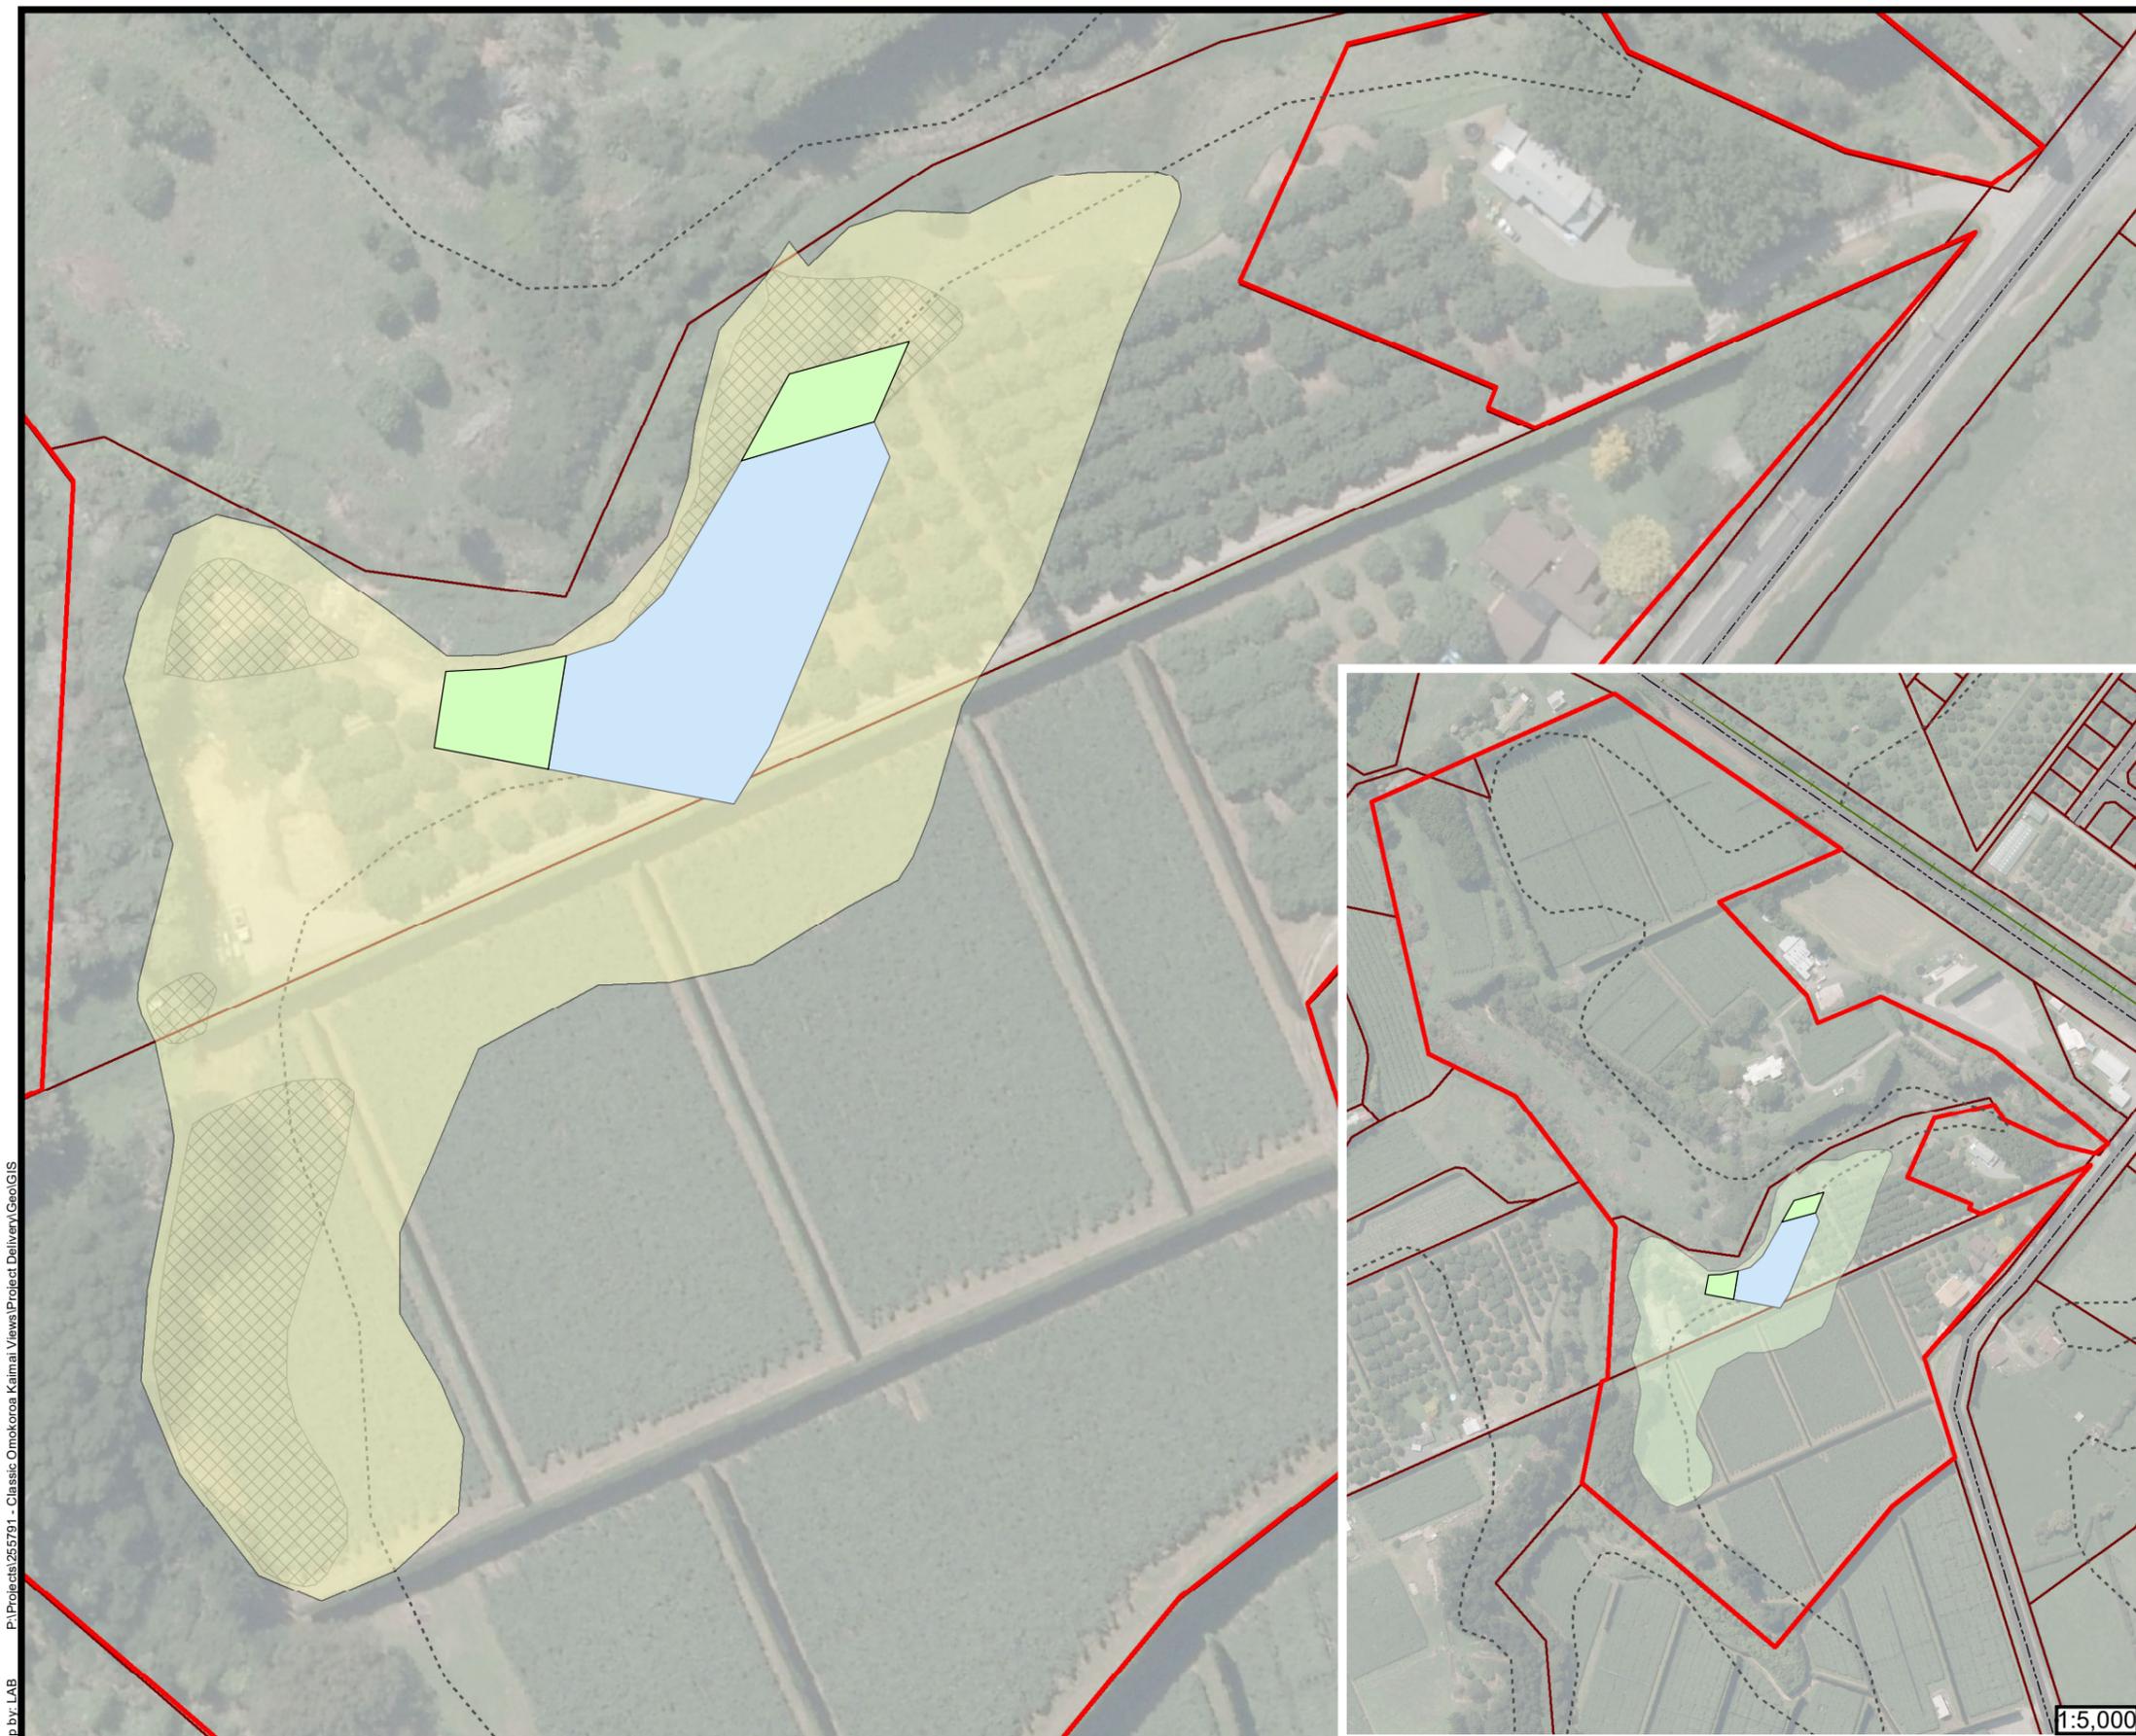
**Classic Developments Kaimai Views**  
**Figure 2: Containment cell and Validation Plan**

- Validation Area
- Containment cell
- Contingency Capacity
- Stockpile Locations

**Notes:**  
 -Background image from Western Bay of Plenty Regional Council mapping  
 -Remediation area is assumed, based on extent of contamination and observations made on site. This plan is for information only and the extent of the validation area is subject to change

The investigations to date have confirmed the presence of asbestos in four areas of the site. These areas require remedial action to make the site suitable for the proposed land use. A remediation location plan is presented in Figure 2 Appendix A.

To demonstrate to the WBODC and BOPRC the successful completion of remediation, soil validation by a SQEP is required to be undertaken, within the area considered by Aurecon to have been potentially impacted by earthworks activities. This area is shown on Figure 2, Appendix A. No works to validate surrounding site soils will be undertaken until all suspected ACM material has been transferred to the cell.

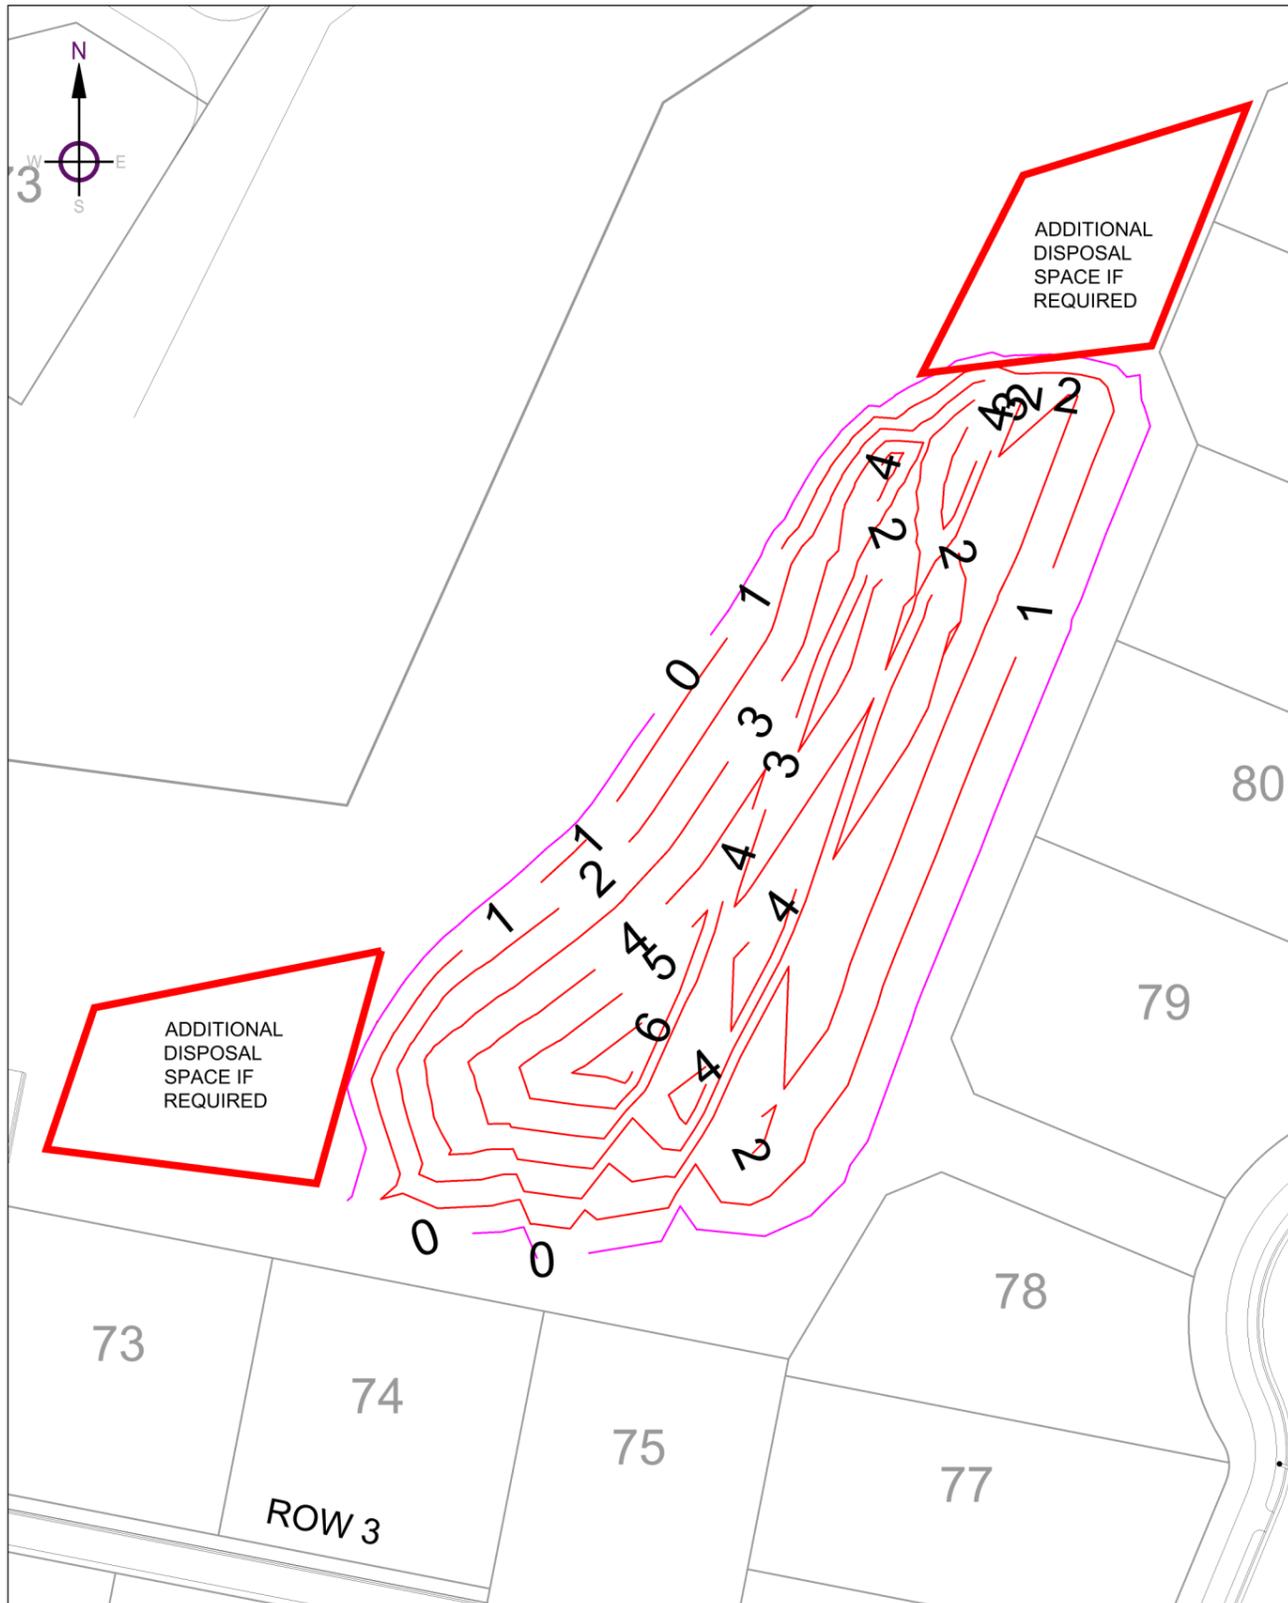
VOLUME CONTAMINATED MATERIAL TO BE DISPOSED OF:  
 MAIN STOCKPILE - 3600m<sup>3</sup>  
 SMALLER STOCKPILE - 550m<sup>3</sup>  
 IN-SITU 1 - 500m<sup>3</sup>  
 IN-SITU 2 - 100m<sup>3</sup>  
 TOTAL = 4750m<sup>3</sup>

ASSUMED COMPACTION FACTOR WITH TRACK ROLLED MACHINERY 1.2

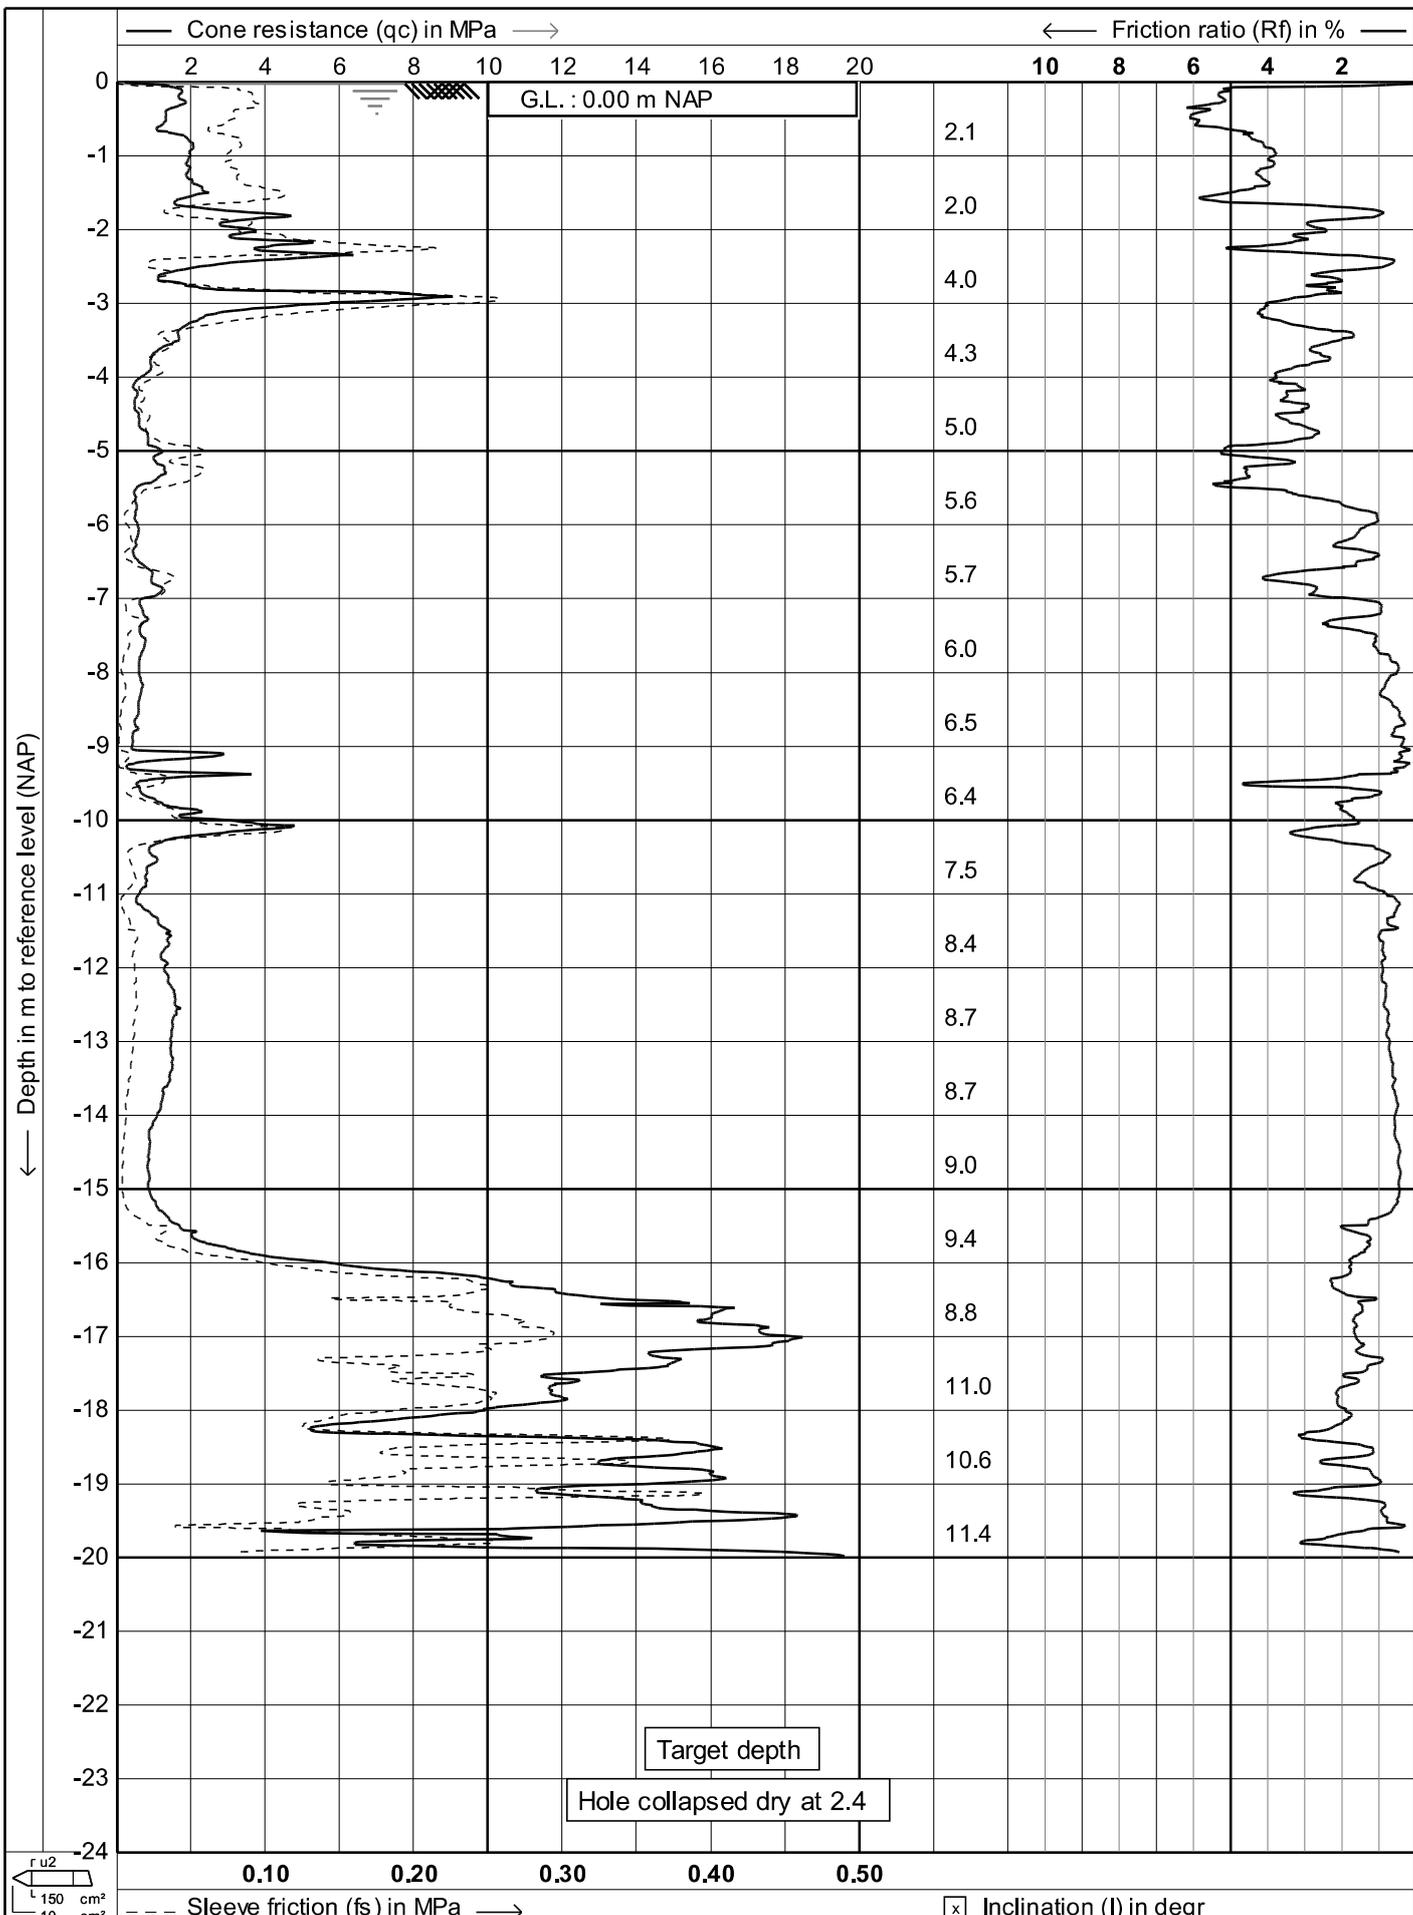
Test according A.S.T.M Standard D 5778-12		Date : 23-6-2016
Project : Site Investigations		Cone no. : C10CFIP.C13082
Location: 336		Project no. : 01CMW14
Position: 0, 0 RD		CPT no. : 10
		1/14

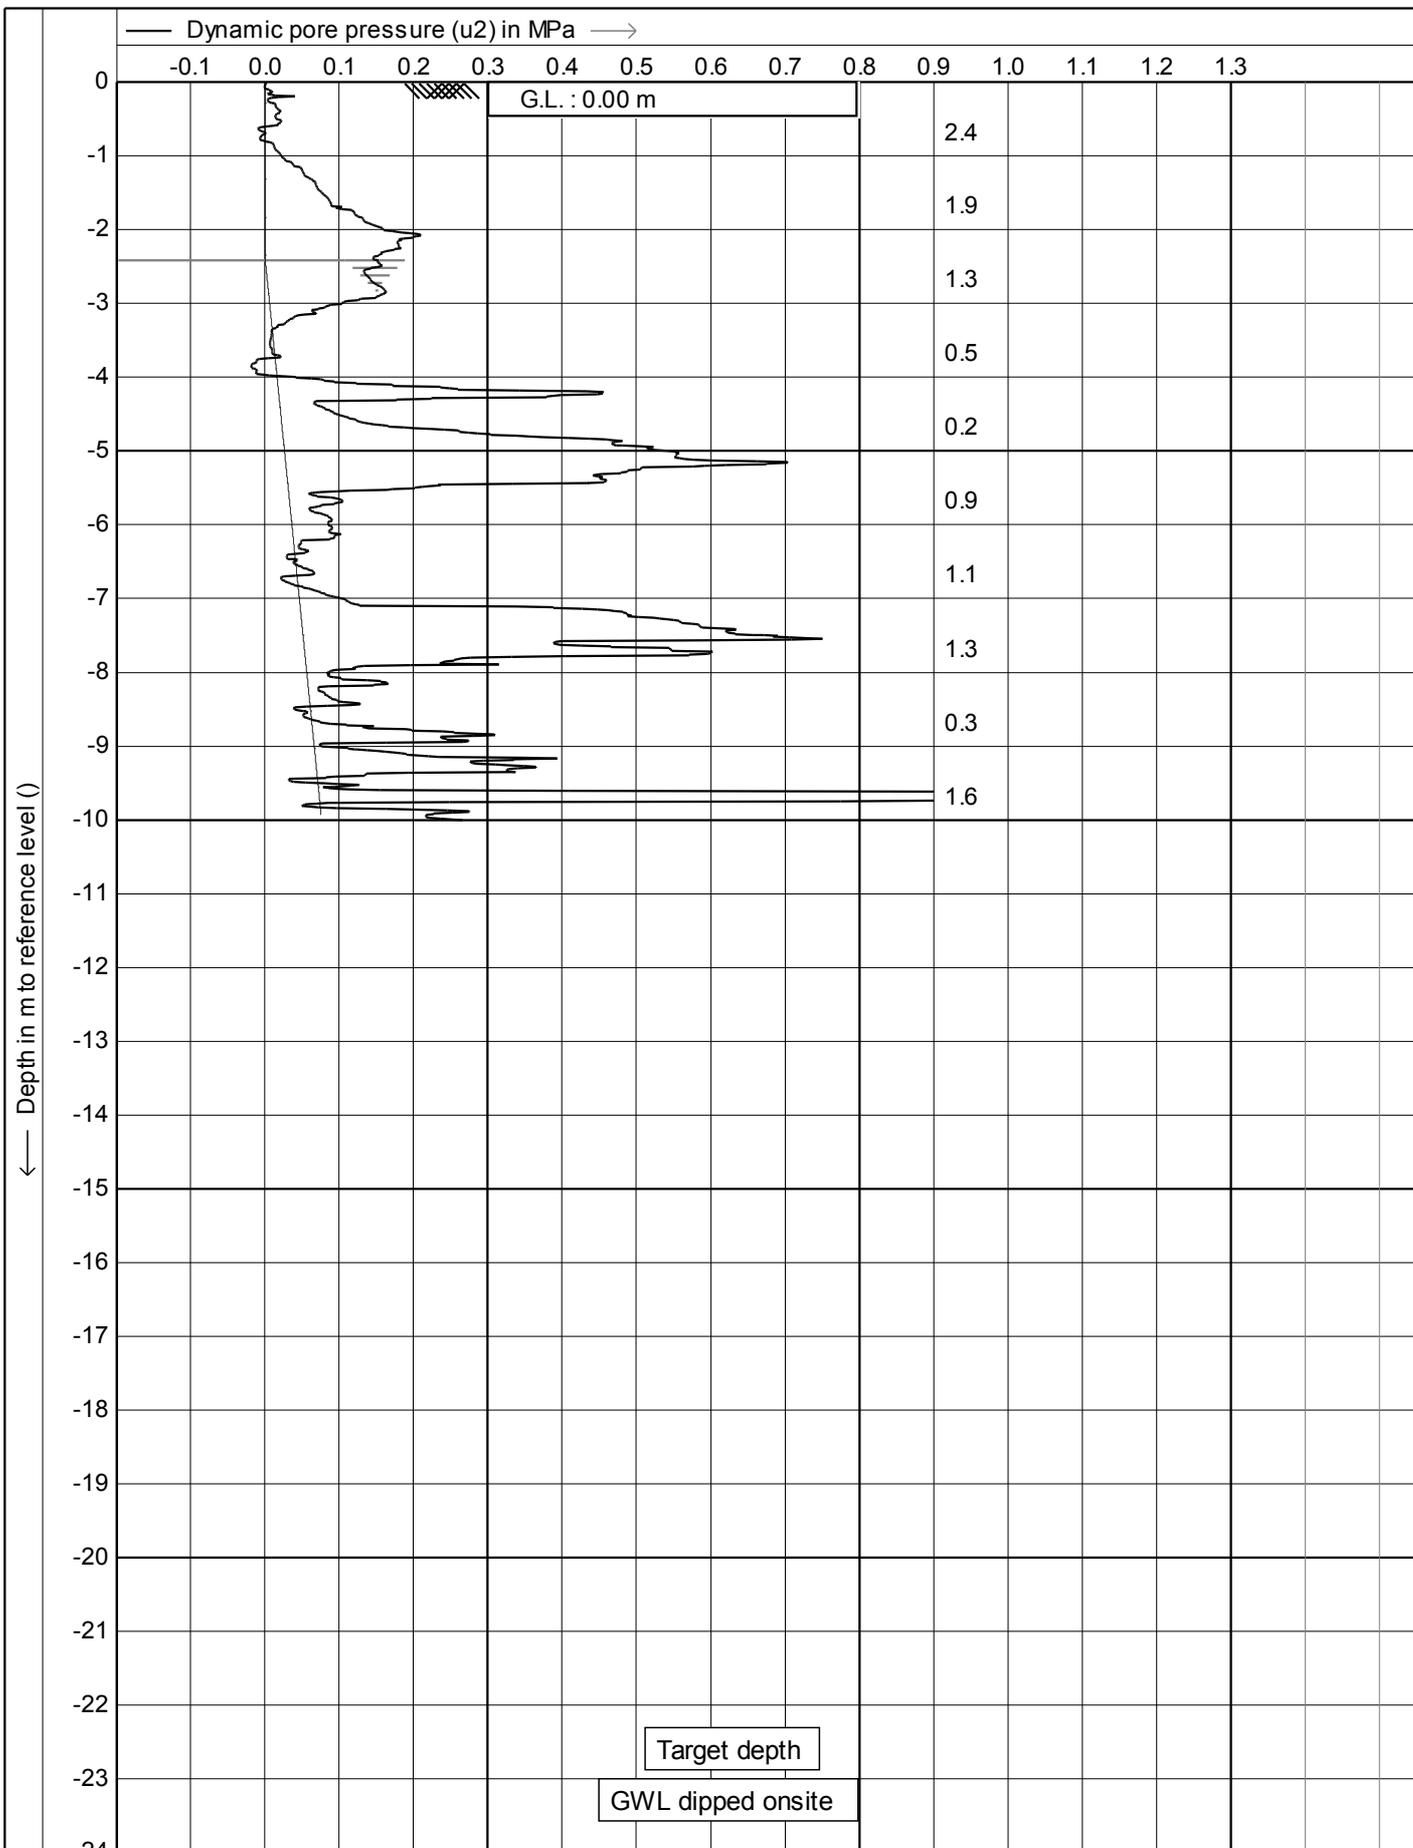
Test according A.S.T.M. Standard D 5778-12  
 Project : **Site Investigation**  
 Location: **Settlers hall - Omokoroa**

Date : **26-8-2016**  
 Cone no. : **C10CFIIP.C14123**  
 Project no. : **02CMW7**  
 CPT no. : **08**      1/14

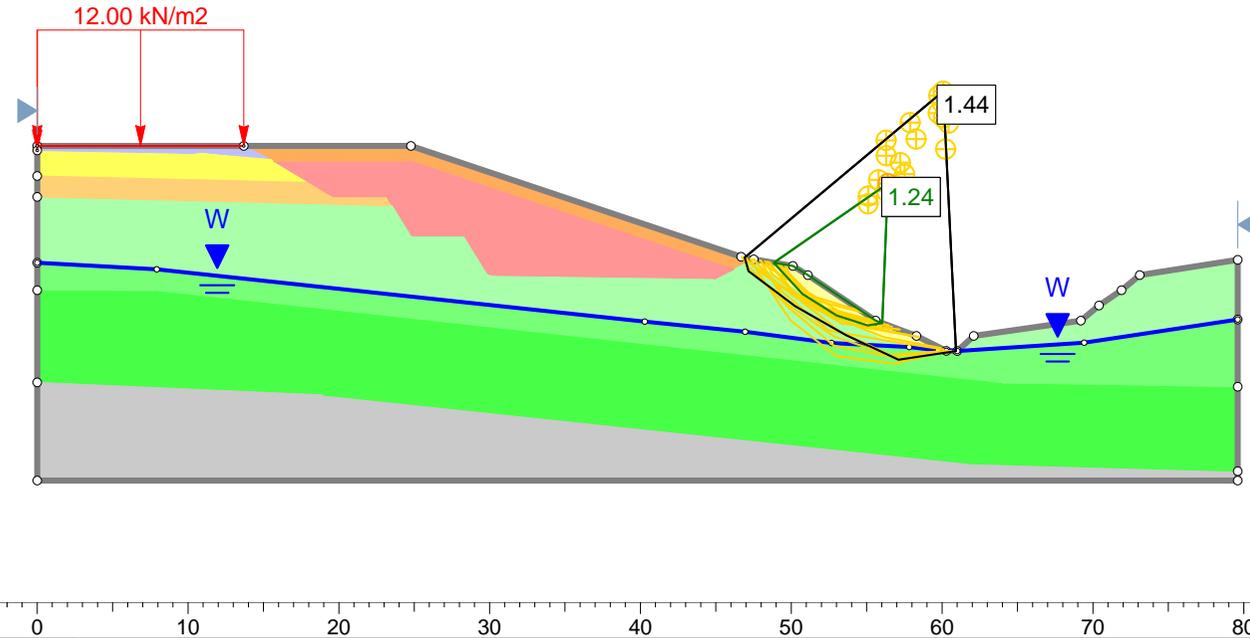
Project		
	Kaimai Views Subdivision - Fill Encapsulation		
	Analysis Description		
	Cross Section B-B - Proposed GL - Prevailing GW conditions		
Drawn By	Scale	Company	
	1:500	Classic Developments Omokoroa Ltd	
Date	File Name		
23/05/2017	Fill Encapsulation - Section B - Proposed profile prevailing GWL.slim

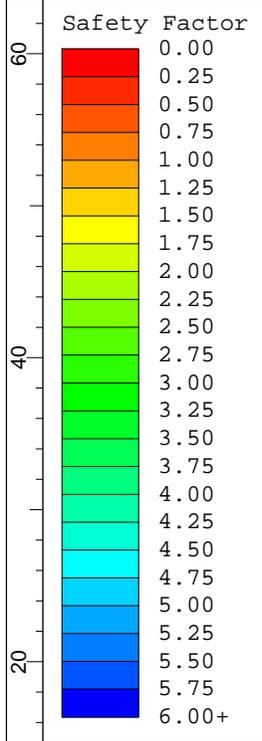
Material Name	Color	Unit Weight (kN/m <sup>3</sup> )	Strength Type	Cohesion (kPa)	Phi (deg)	Water Surface	Hu Type	Ru
Younger Ash: Stiff clayey silt	Yellow	16	Mohr-Coulomb	5	30	None		0.1
Hamilton Ash: V. stiff clayey silt	Orange	17	Mohr-Coulomb	10	25	None		0.1
Colluvium: Stiff clayey silt	Light Yellow	16	Mohr-Coulomb	3	25	None		0.1
Engineered Fill	Light Blue	16	Mohr-Coulomb	5	30	None		0.1
Tracked-rolled Fill	Red	15	Mohr-Coulomb	2	30	None		0.1
MS: Stiff to V.Stiff sandy silt	Light Green	16	Mohr-Coulomb	3	30	Water Surface	Automatically Calculated	
MS: Firm clayey silt	Green	16	Mohr-Coulomb	2	28	Water Surface	Automatically Calculated	
MS: Stiff sandy silt	Light Green	16	Mohr-Coulomb	3	30	Water Surface	Automatically Calculated	
Dense Sand (inferred Ignimbrite)	Grey	16	Mohr-Coulomb	0	40	Water Surface	Automatically Calculated	
Topsoil	Orange	14	Mohr-Coulomb	2	25	None		0.1

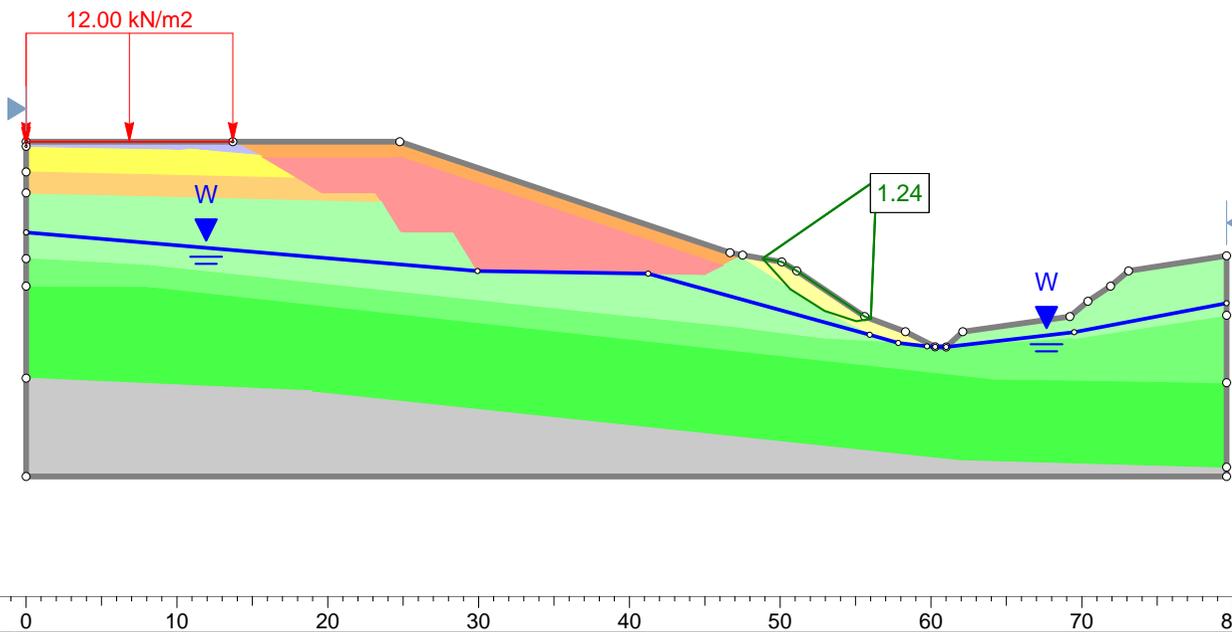
Project			Kaimai Views Subdivision - Fill Encapsulation		
	Analysis Description			Cross Section B-B - Proposed GL - Elevated GW conditions		
	Drawn By	Scale	Company	1:500	Classic Developments Omokoroa Ltd	
	Date	23/05/2017		File Name Fill Encapsulation - Section B - Proposed profile elevated GWL.slim

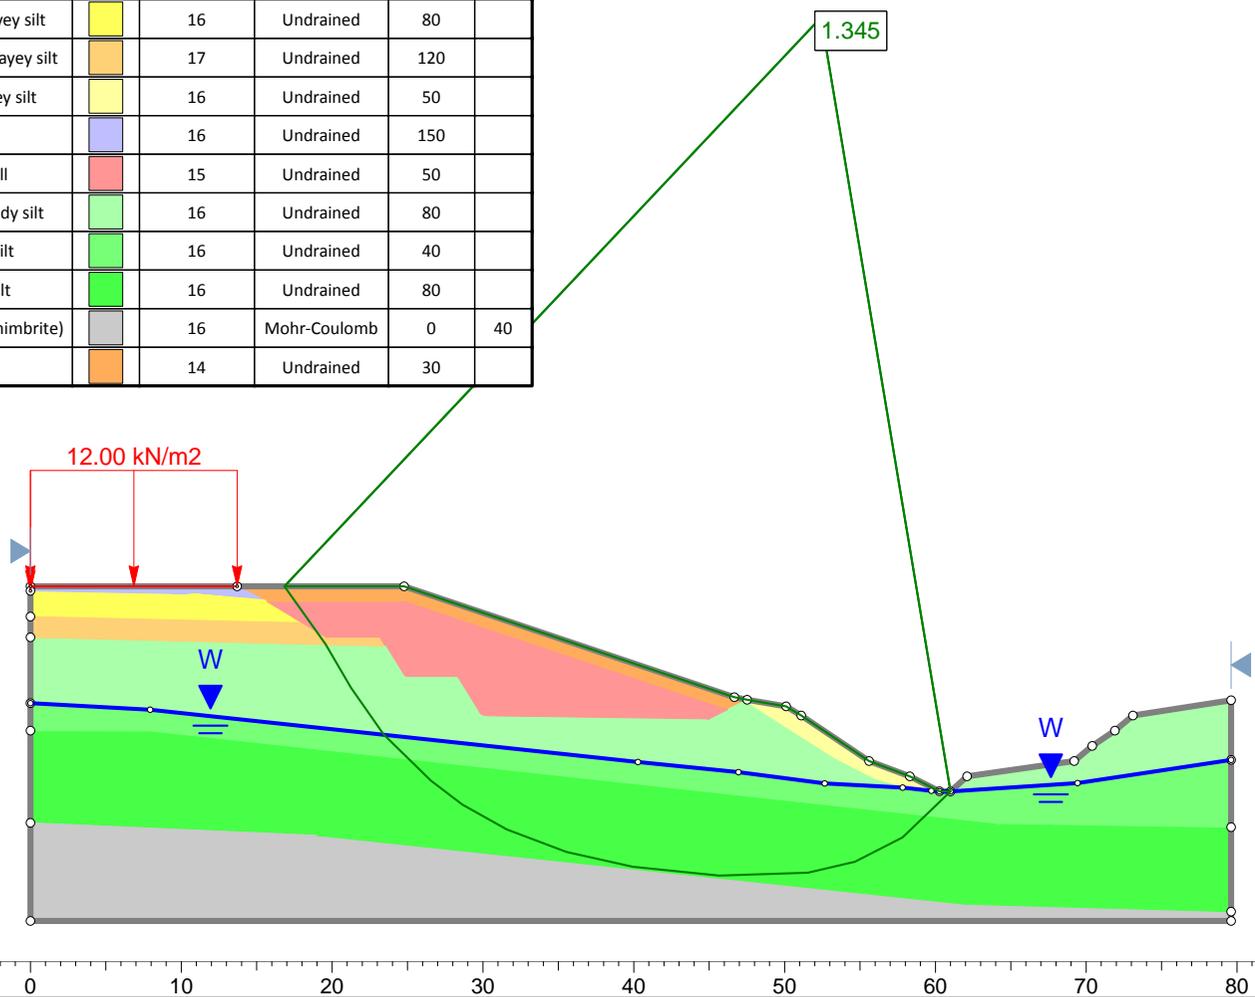
Material Name	Color	Unit Weight (kN/m <sup>3</sup> )	Strength Type	Cohesion (kPa)	Phi (deg)
Younger Ash: Stiff clayey silt	Yellow	16	Undrained	80	
Hamilton Ash: V. stiff clayey silt	Orange	17	Undrained	120	
Colluvium: Stiff clayey silt	Light Yellow	16	Undrained	50	
Engineered Fill	Light Blue	16	Undrained	150	
Tracked-rolled Fill	Red	15	Undrained	50	
MS: Stiff to V.Stiff sandy silt	Light Green	16	Undrained	80	
MS: Firm clayey silt	Green	16	Undrained	40	
MS: Stiff sandy silt	Light Green	16	Undrained	80	
Dense Sand (inferred Ignimbrite)	Grey	16	Mohr-Coulomb	0	40
Topsoil	Orange	14	Undrained	30

Project		
	Kaimai Views Subdivision - Fill Encapsulation		
	Analysis Description		
	Cross Section B-B - IL2 ULS Seismic Case		
Drawn By	Scale	Company	
	1:500	Classic Developments Omokoroa Ltd	
Date	File Name		
23/05/2017	Fill Encapsulation - Section B - IL2 ULS Seismic Case.slim
