**Waikato Building and Construction Limited**  
**106 Elmwood Road, Aongatete**

**773-TRGGE232725-AA**

Geotechnical Assessment Report

5 September 2019

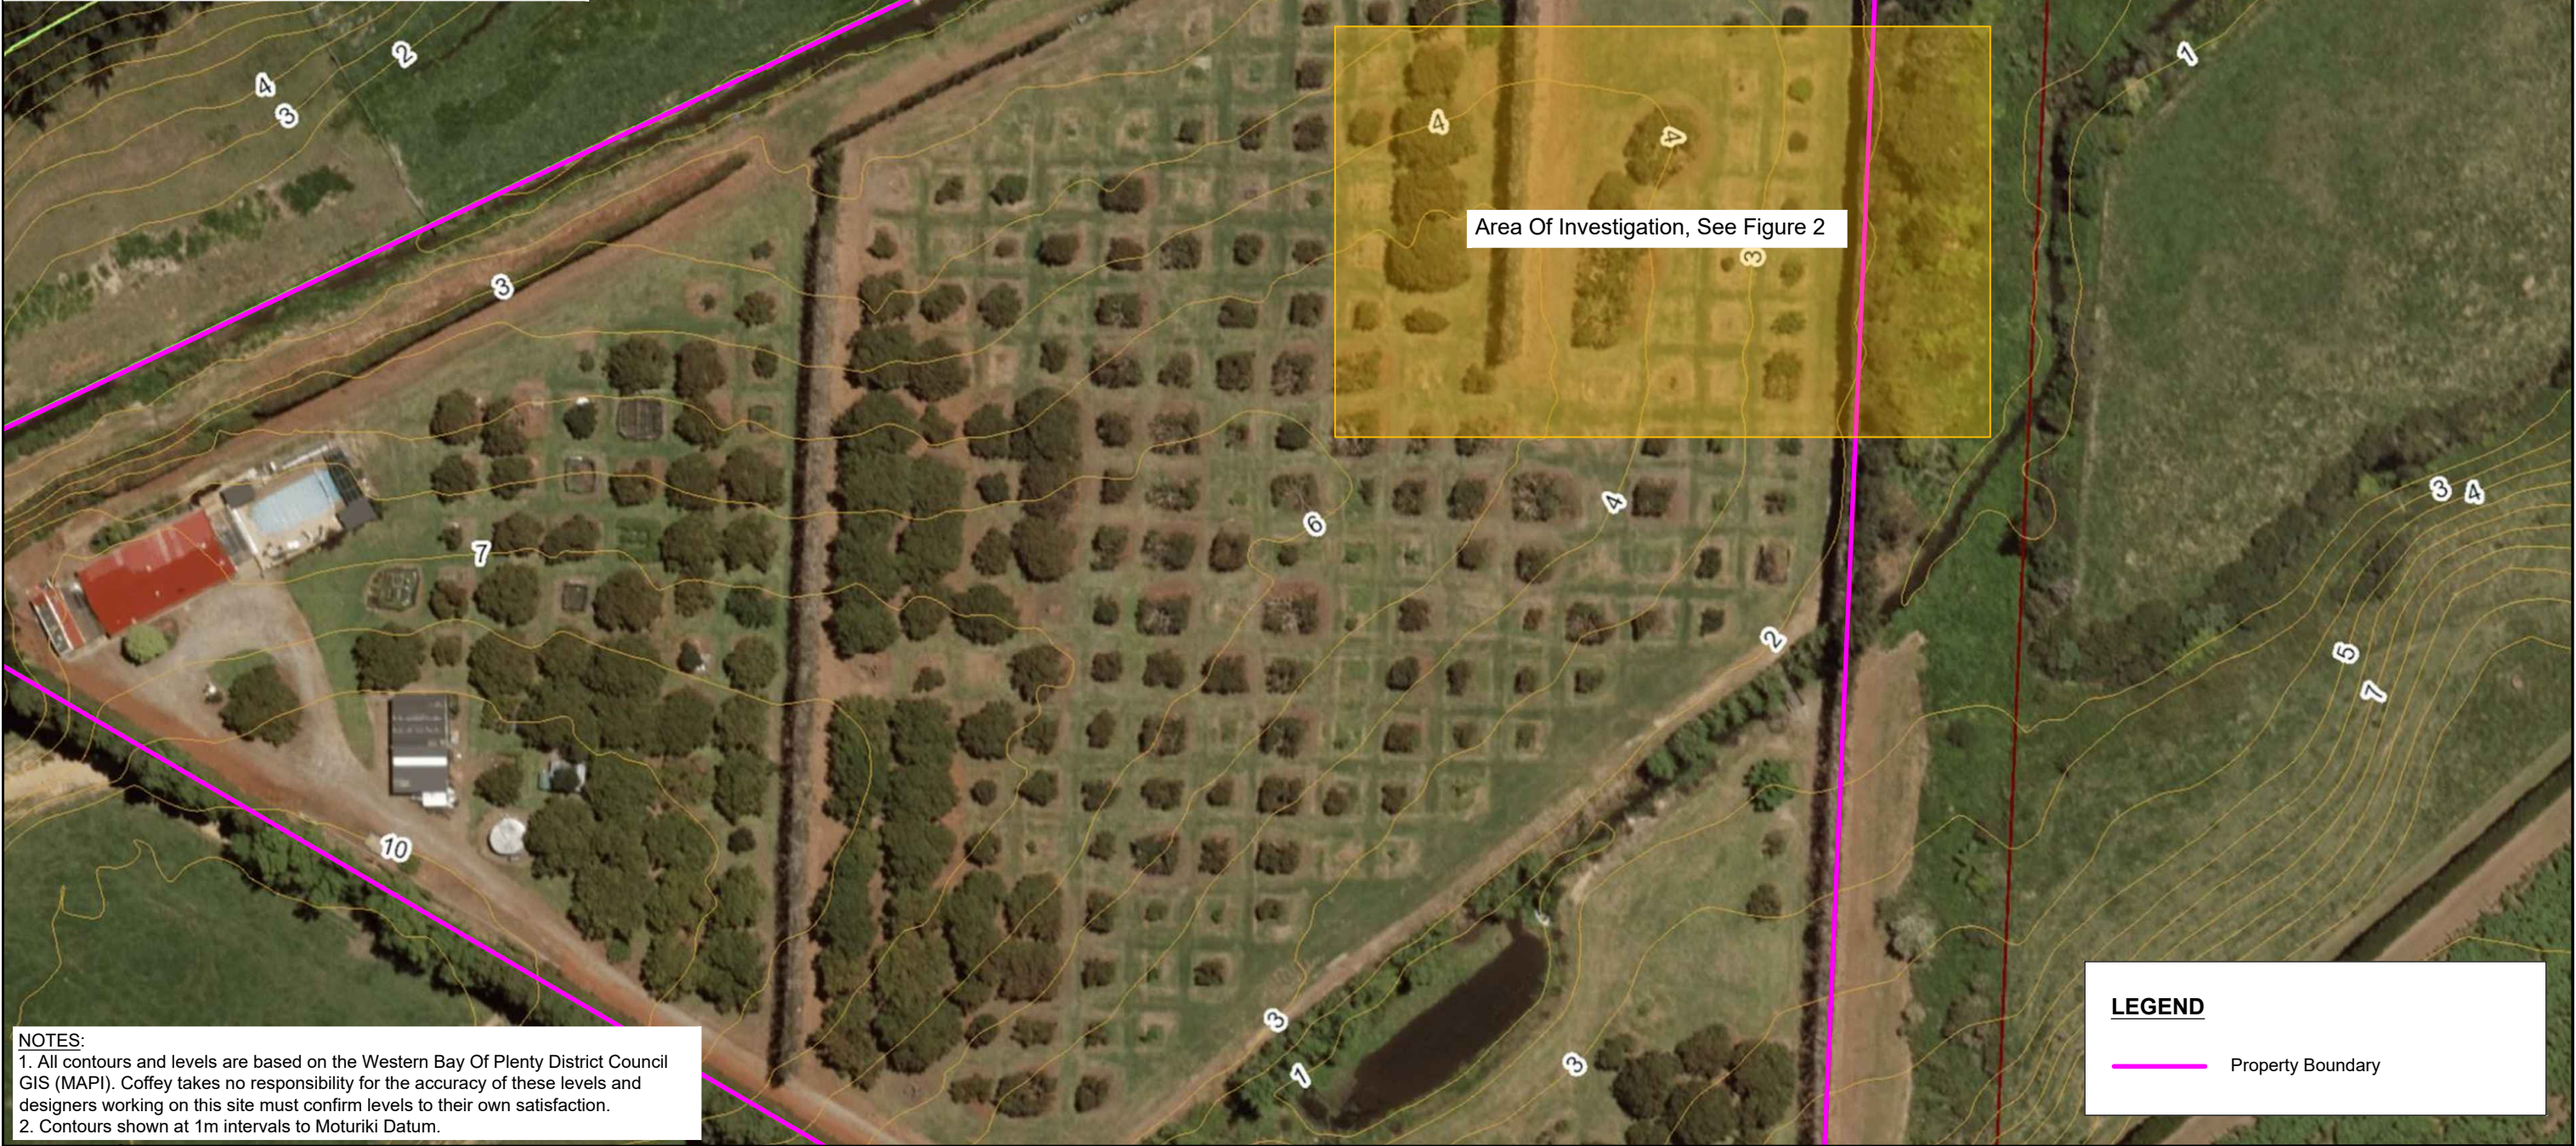
| project no: <b>773-TRGGE232725</b> | figure no: <b>1</b> | rev: <b>A</b> |

The site layout and contours are shown on Figure 1 and Figure 2 in Appendix A. The topography comprises gently sloping ground across much of the property, with a small narrow watercourse traversing the southern portion of the property and further watercourses bordering the property boundary in places. In the vicinity of the proposed dwelling and garage, the building platforms are positioned within a slightly elevated ridgeline orientated in a northeast-southwest direction.

The proposed designated dwelling and shed building platform locations, for which our investigation and analyses have focused on, was marked out onsite by the client and has been reproduced on Figures 1 and 2.

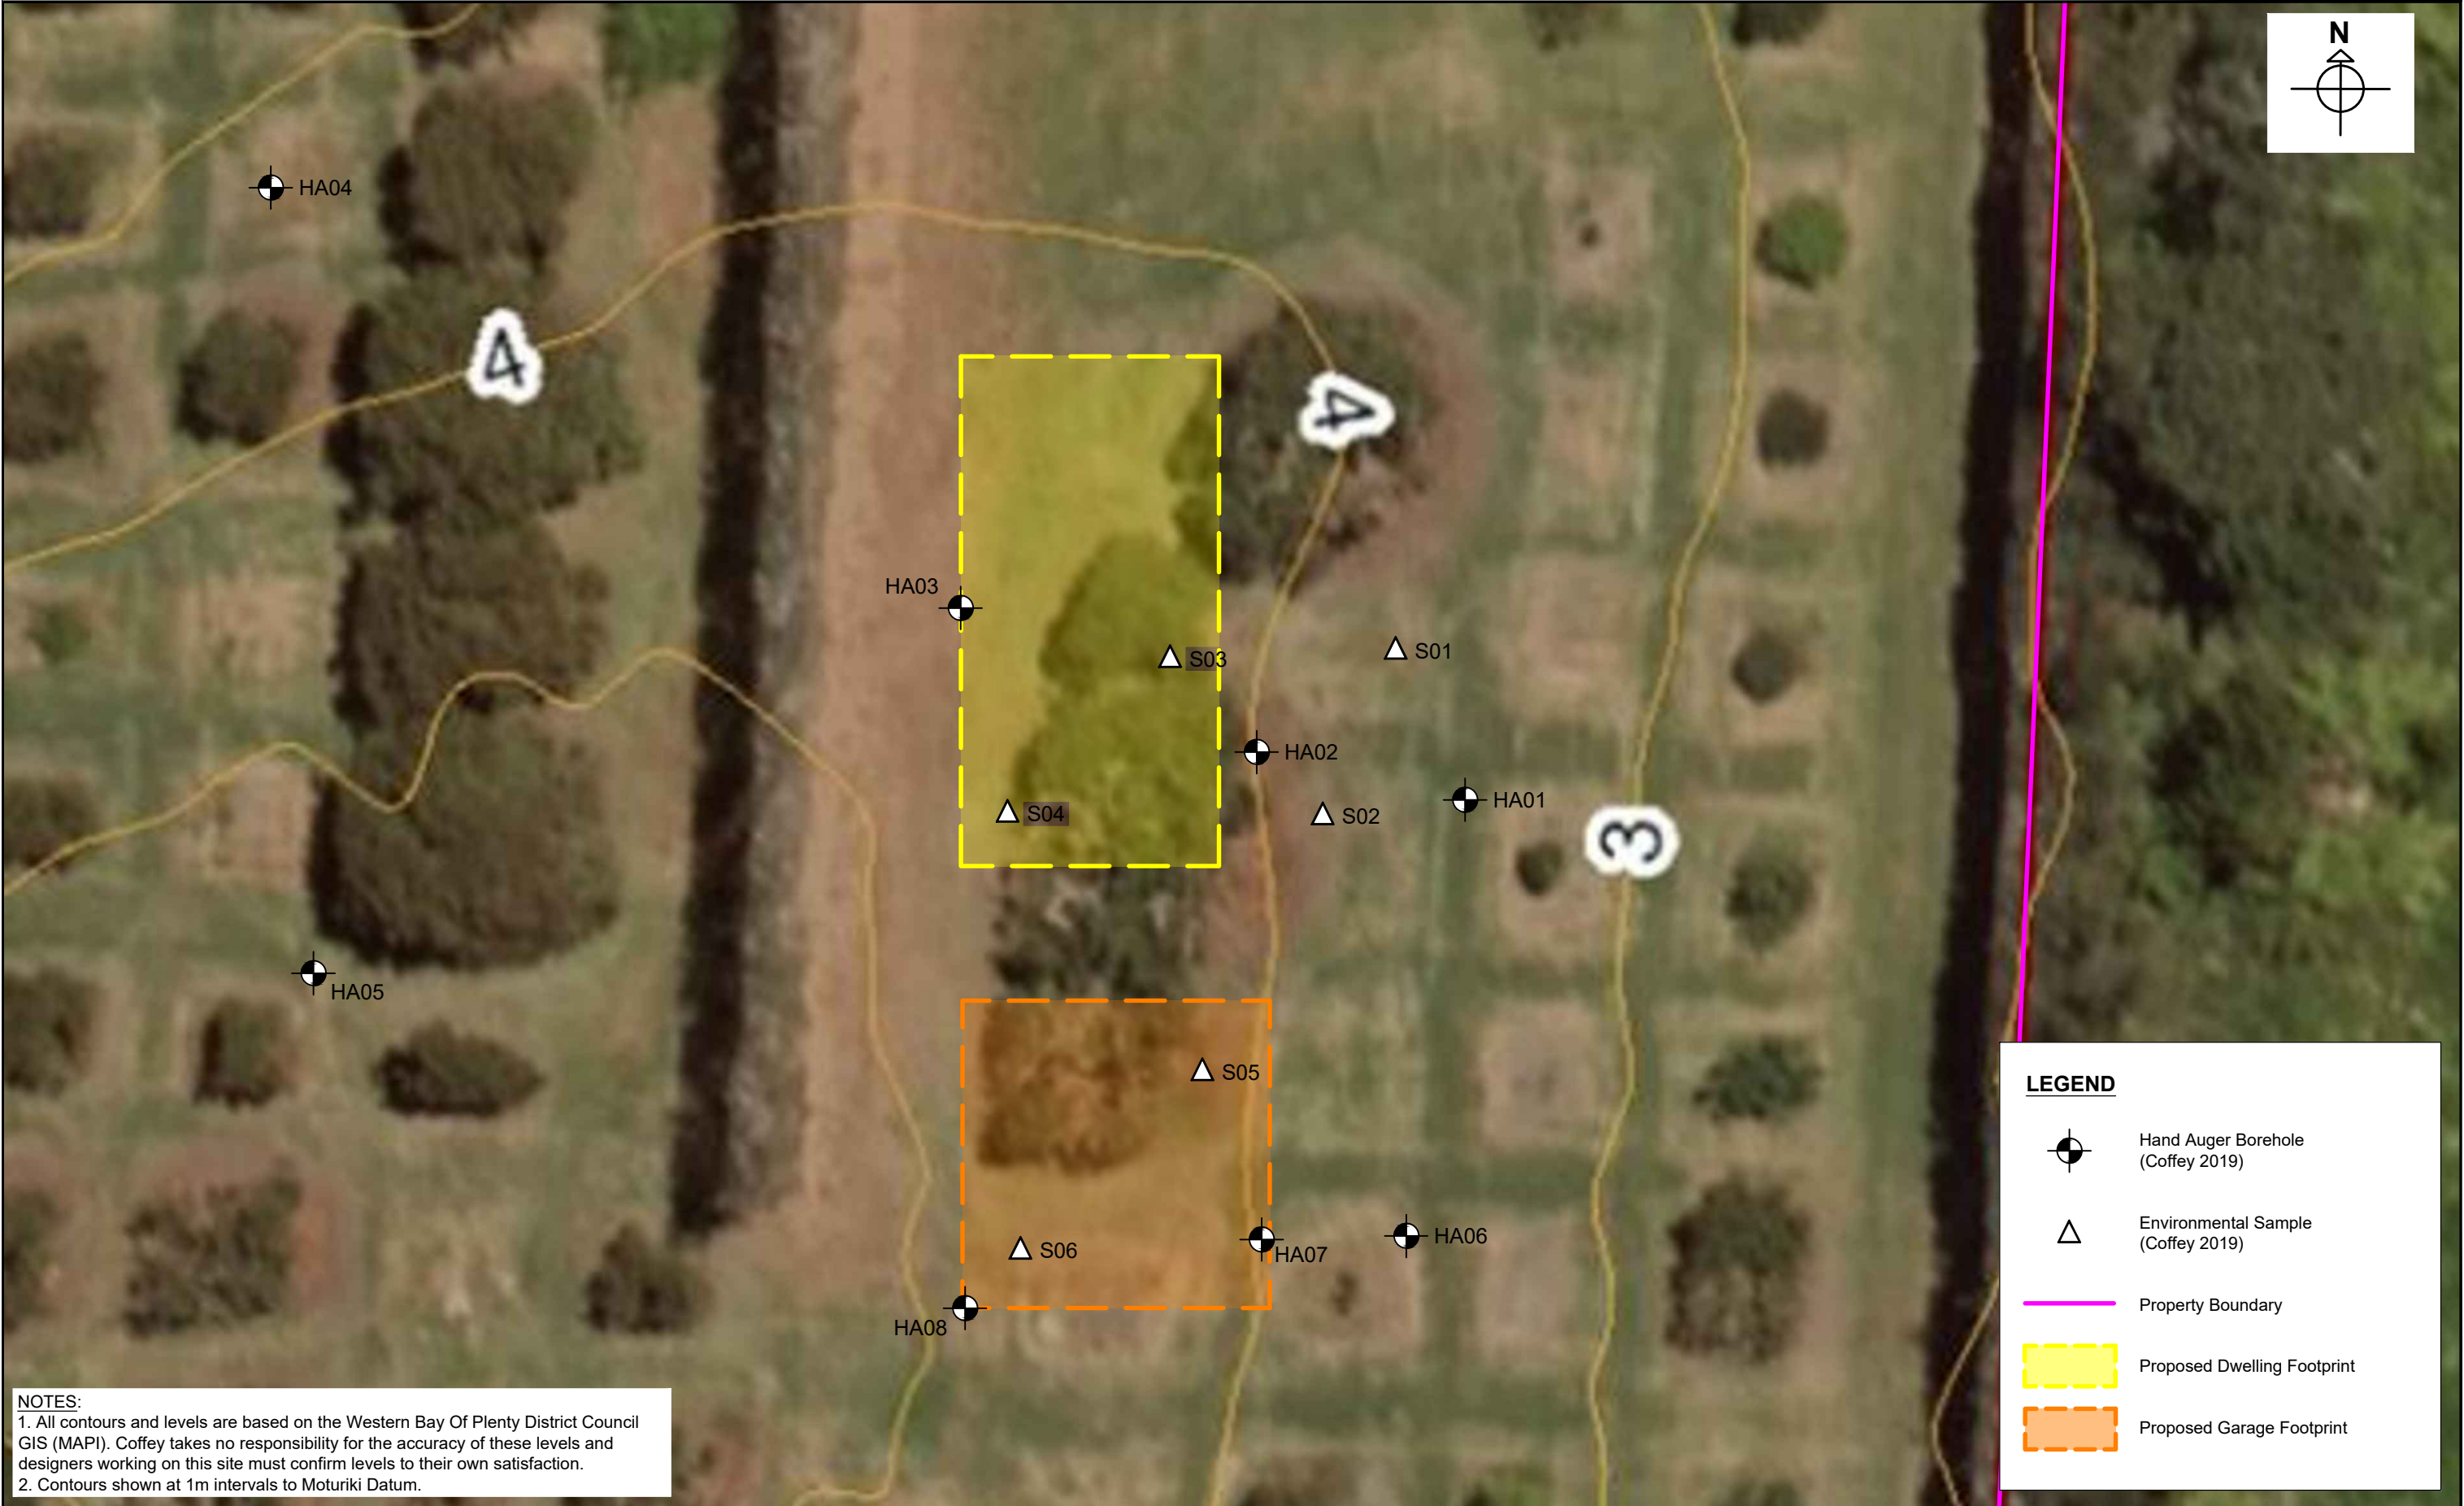
In-situ undrained shear strength measurements were taken within the boreholes using a 'Pilcon' shear vane. The locations of the investigations are shown on Figure 2. Borehole logs are provided in Appendix B.
