RED LBP PRE-PURCHASE REPORT

PRE-PURCHASE

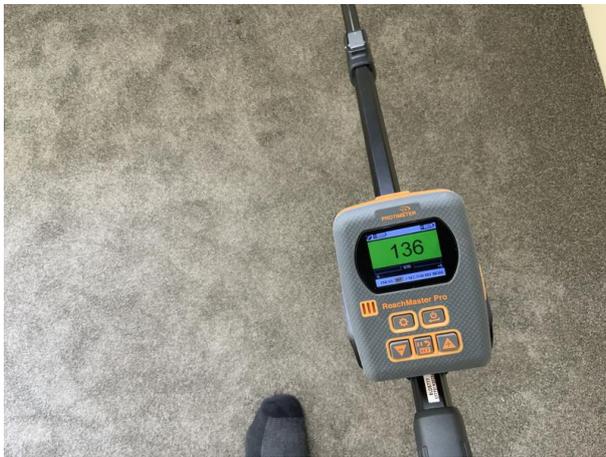
Photo 4

Dining room, east side. DRY
136.

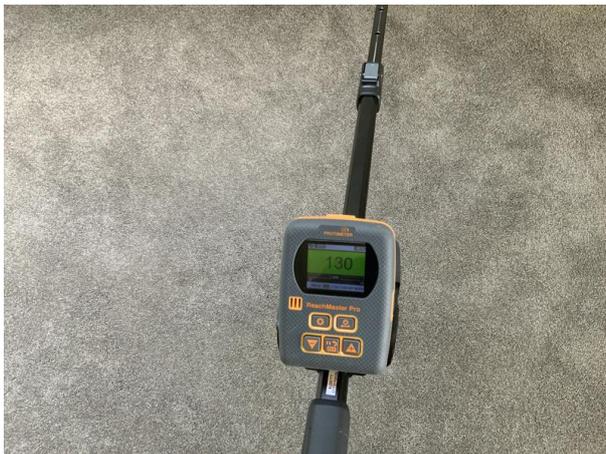
Photo 5

Dining room, north side. DRY
130.

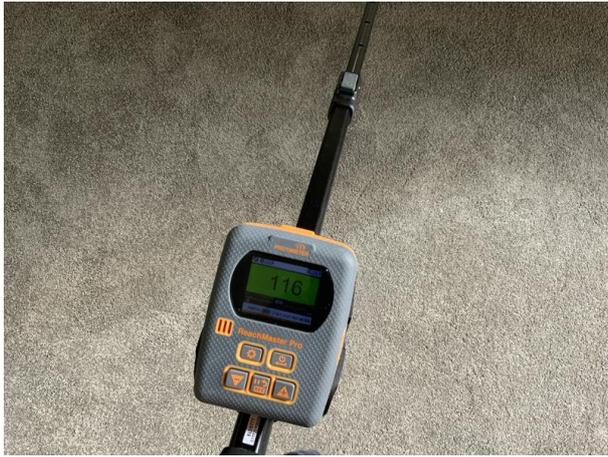
Photo 6

Lounge, north side. DRY 116.

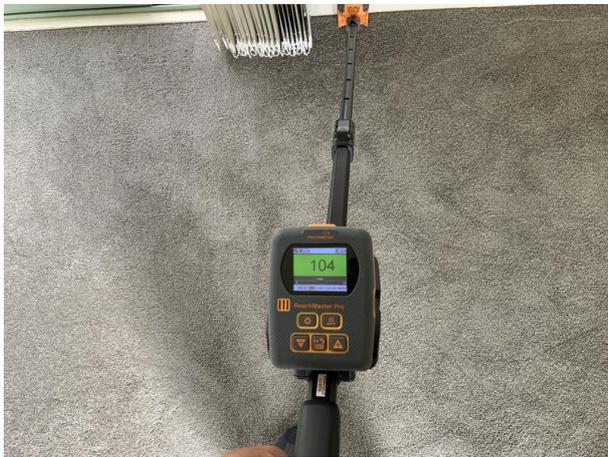
Photo 7

Lounge, west side. DRY 104.

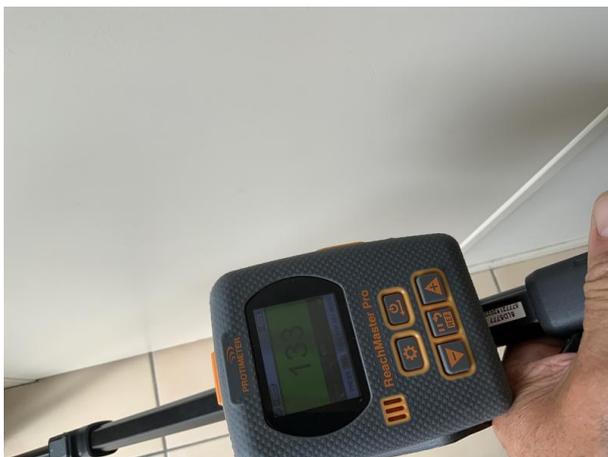
Photo 8

Entrance, east side. DRY 133.

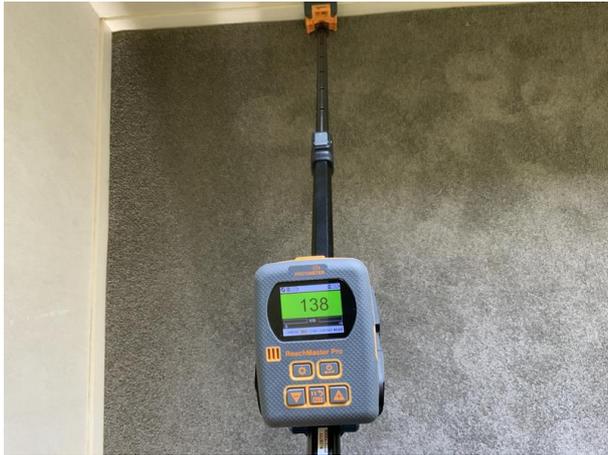
Photo 9

Bedroom 1, west side. DRY 138.

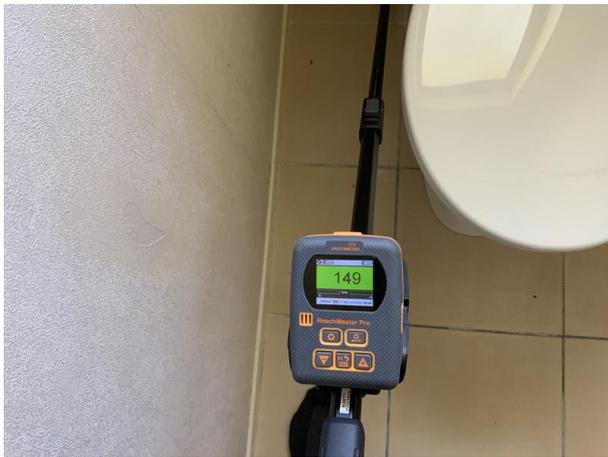
Photo 10

Water closet, west side. DRY 149.

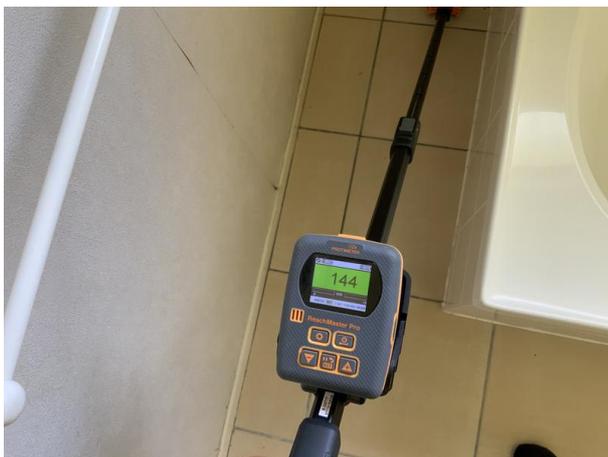
Photo 11

Bathroom west side. DRY 144.

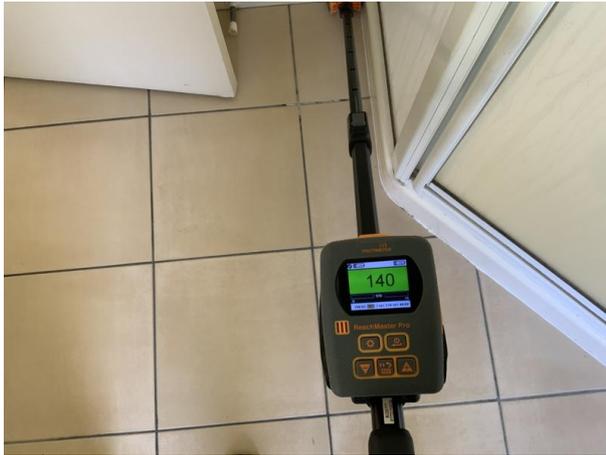
Photo 12

Internal wall by shower. DRY
140.

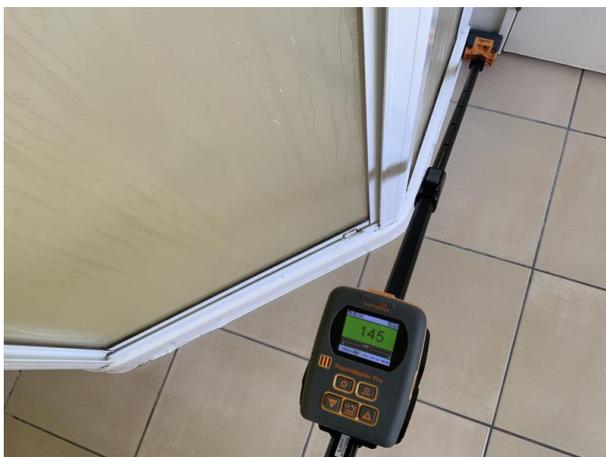
Photo 13

Internal wall by shower. DRY
145.

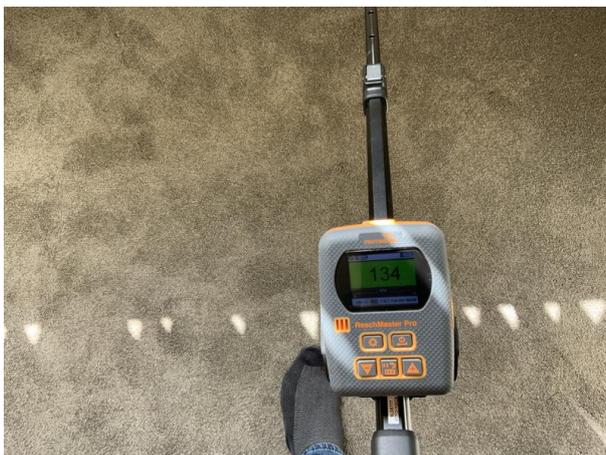
Photo 14

Bedroom 2, east side. DRY 134.

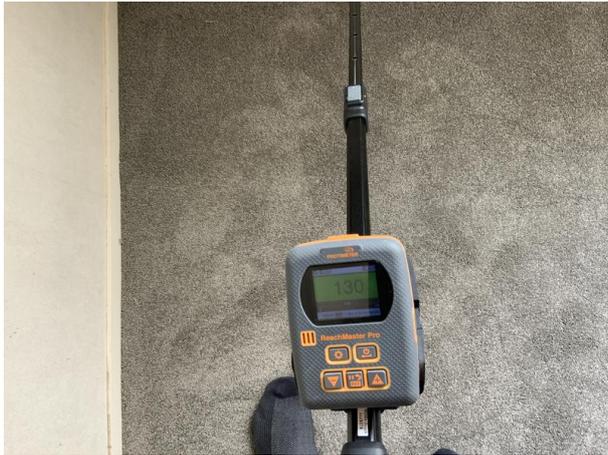
Photo 15

Bedroom 3, east side. DRY 130.

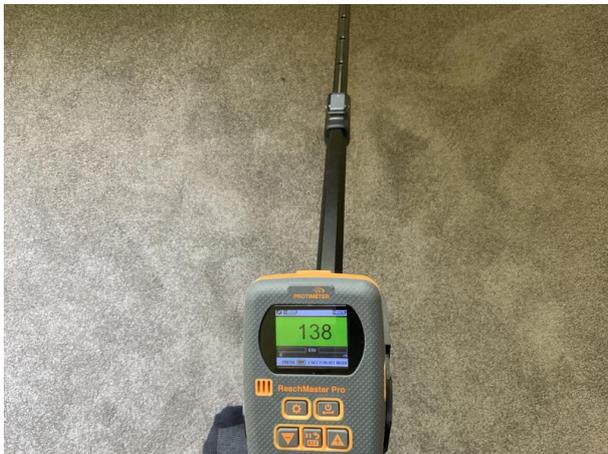
Photo 16

Bedroom 4, west side. DRY 138.

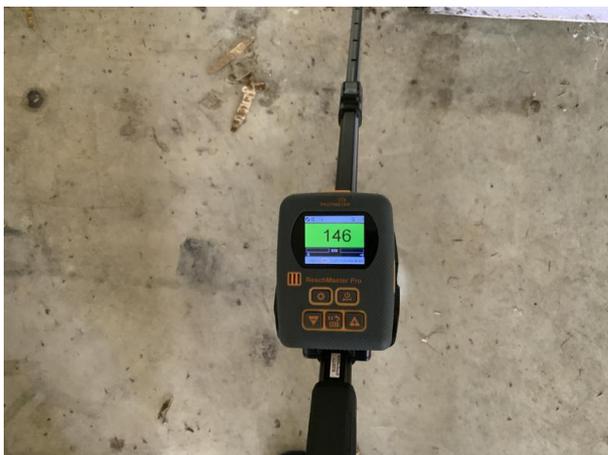
Photo 17

Garage, east side. DRY 146.

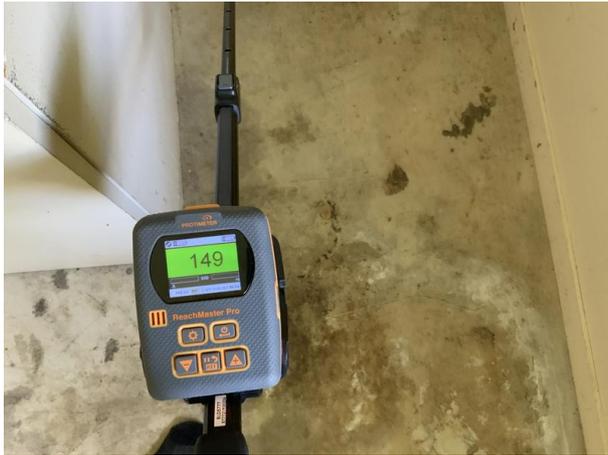
Photo 18

Garage, south side. DRY 149.

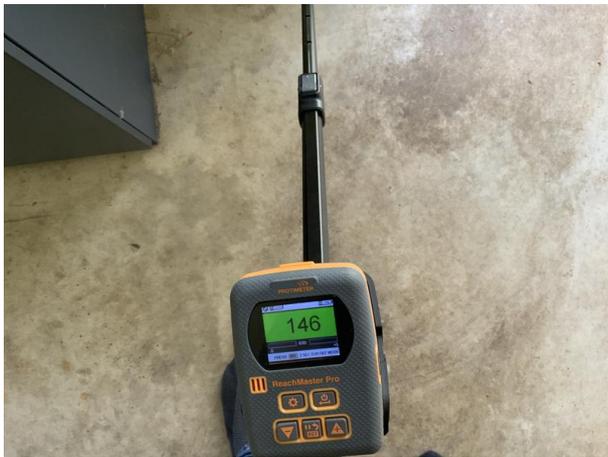
Photo 19

Garage, west side. DRY 146.

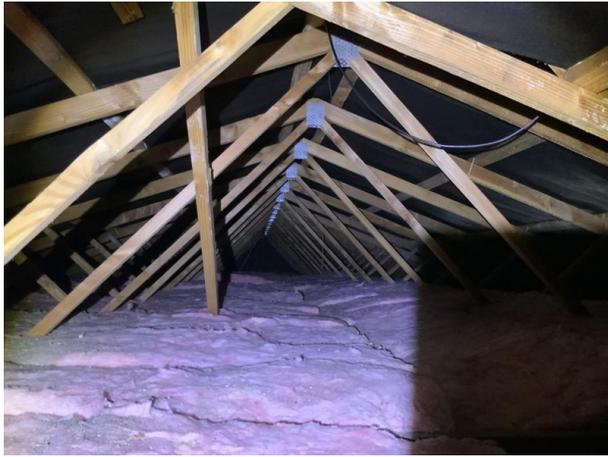
Photo 20

Manufactured timber truss roof construction, bituminous paper and glass wool insulation.

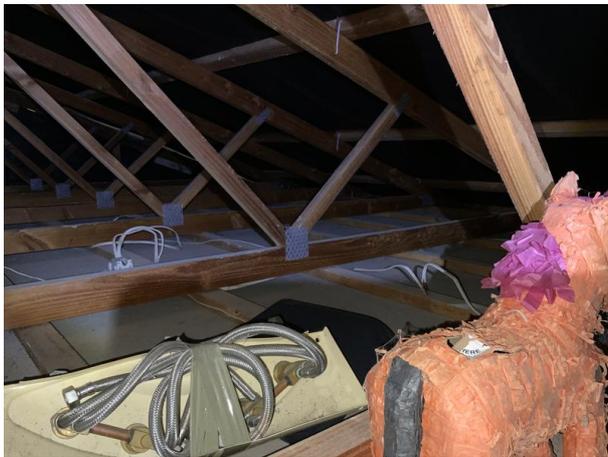
Photo 21

Manufactured timber truss roof construction over garage. Note: stored items visible.

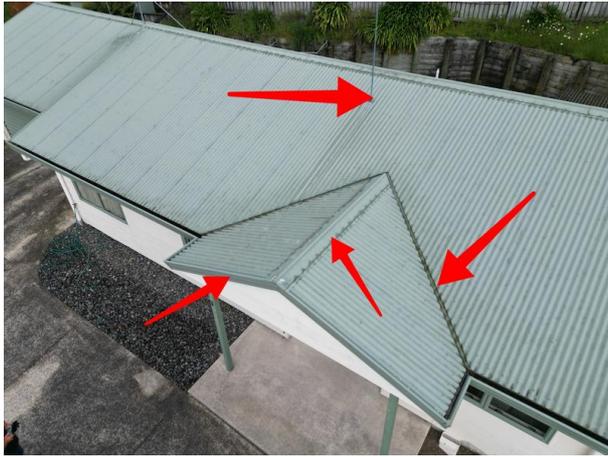
Photo 23

Profiled metal roof, ridge, valley, barge flashings and overflow penetration.

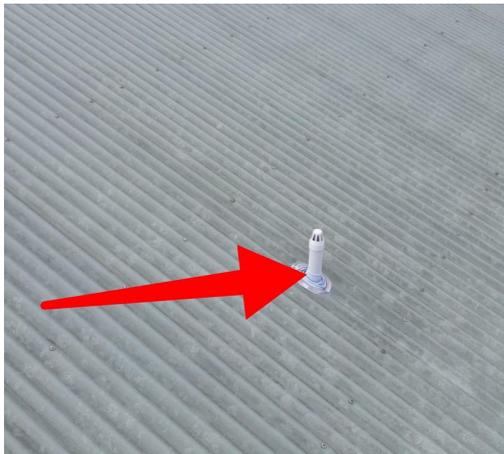
Photo 25

Vent pipe penetration.

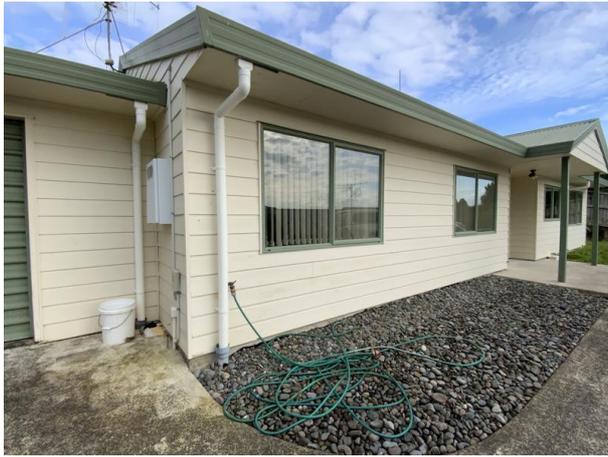
Photo 28

Weatherboard, east side.

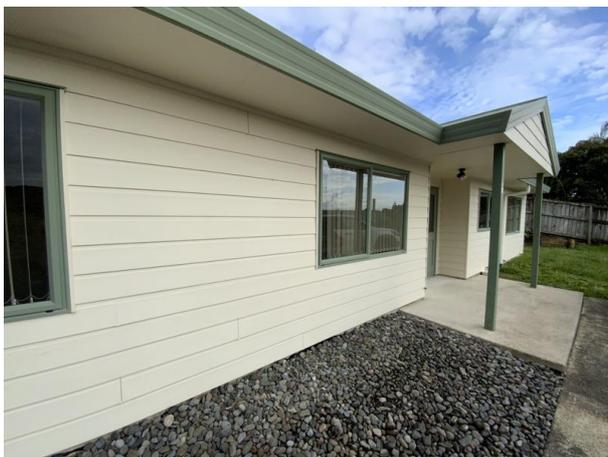
Photo 30

Weatherboard, east side.

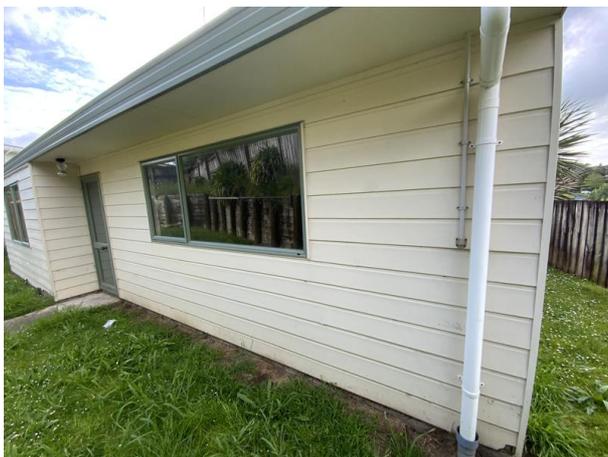
Photo 36

Weatherboard, west side.

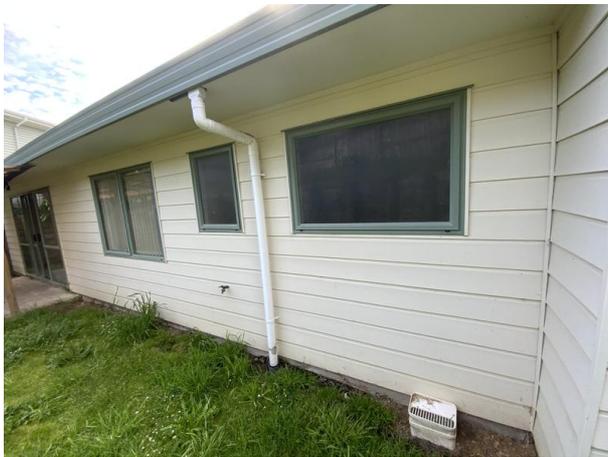
Photo 38

Weatherboard, west side.

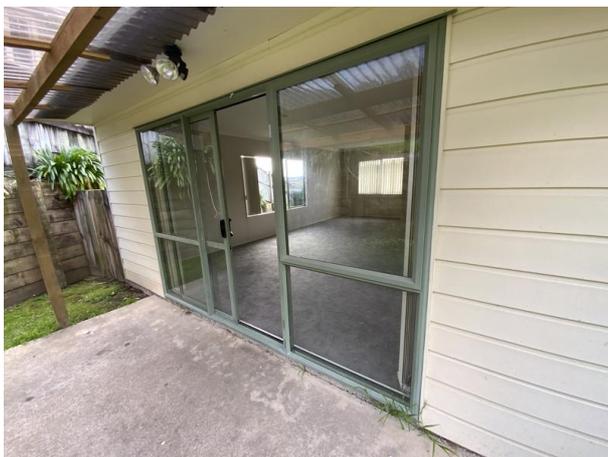
Photo 39

Weatherboard, west side.

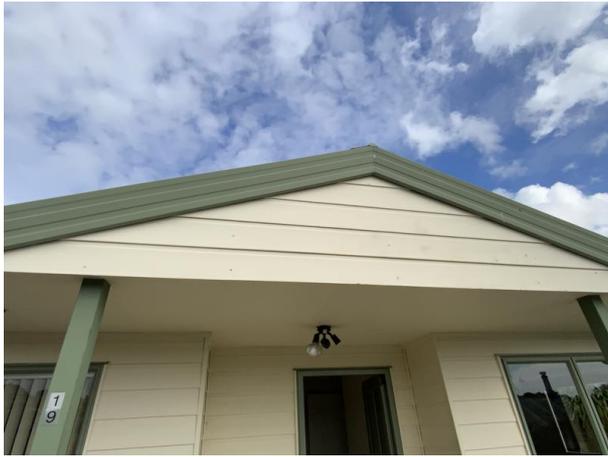
Photo 40

Fibrous cement weatherboard
gable end, east side.

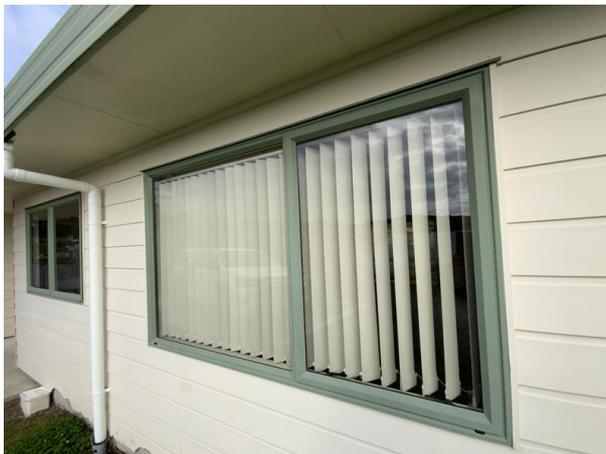
Photo 41

Single glazed aluminium joinery, east side.

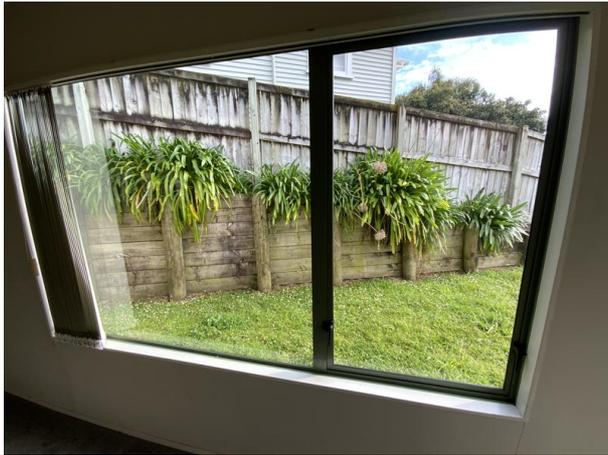
Photo 42

Single glazed aluminium joinery with painted timber reveals, located in lounge.

Keep tracks, drainage channels & weep-holes clear of debris. The paint is flaking on the sills, this may allow moisture to be absorbed into the timbers causing deterioration, correct preparation and decoration is required.

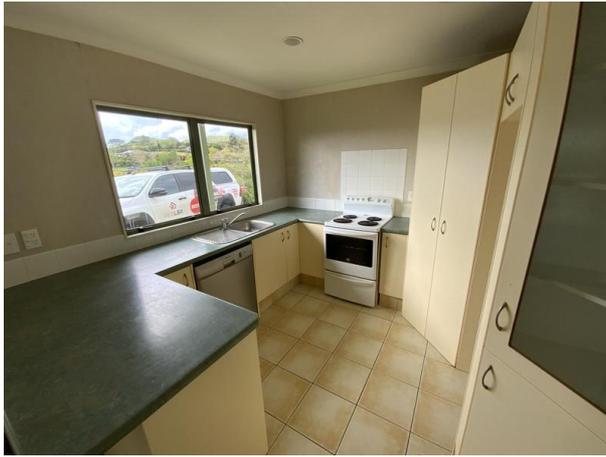
Photo 54

Kitchen.

There is no externally vented mechanical ventilation system installed in the kitchen. It is recommended to install a suitable system for the rooms requirements.

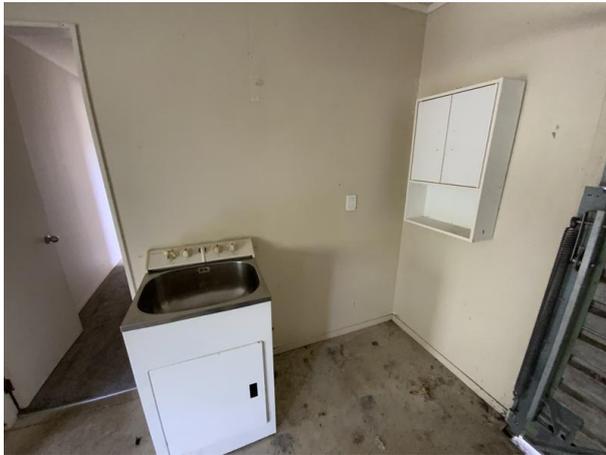
Photo 57

Laundry.

There is no externally vented mechanical ventilation system installed in the laundry. It is recommended to install a suitable system for the rooms requirements.

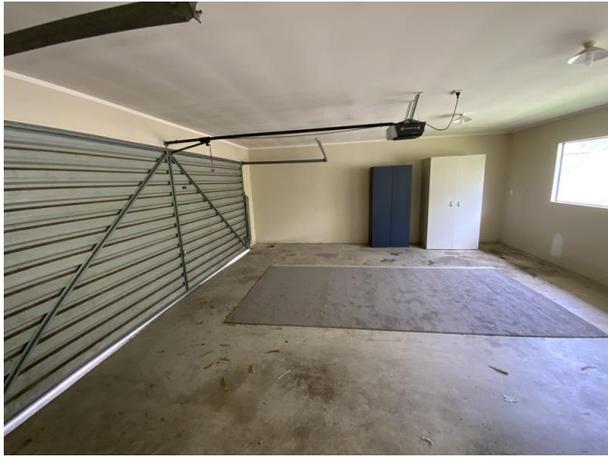
Photo 58

Garage.

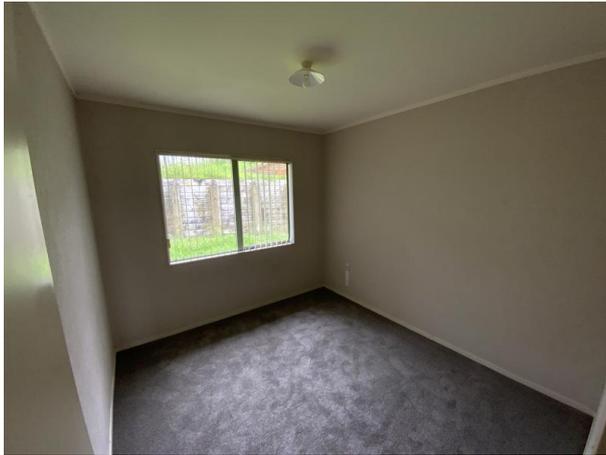
Photo 62

Bedroom 1.

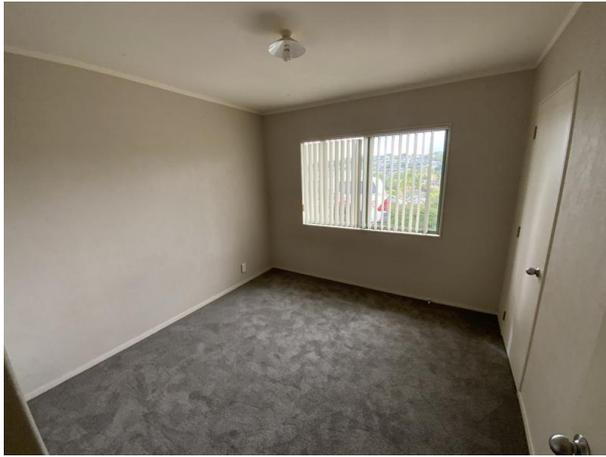
Photo 63

Bedroom 2.

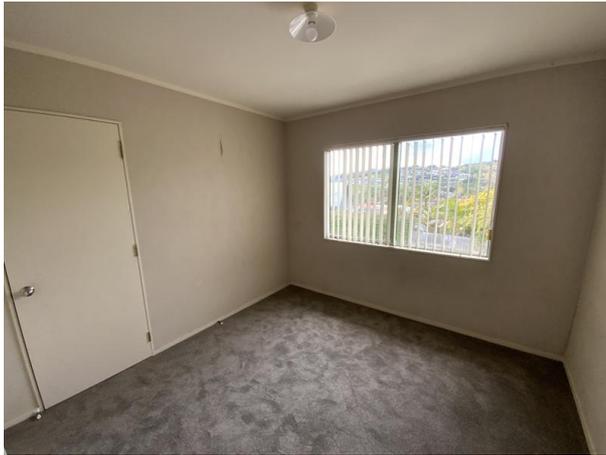
Photo 64

Bedroom 3.

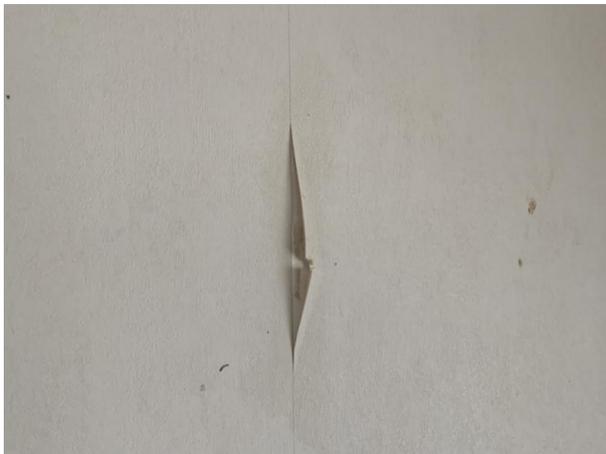
Photo 65

Peeling wallpaper visible.

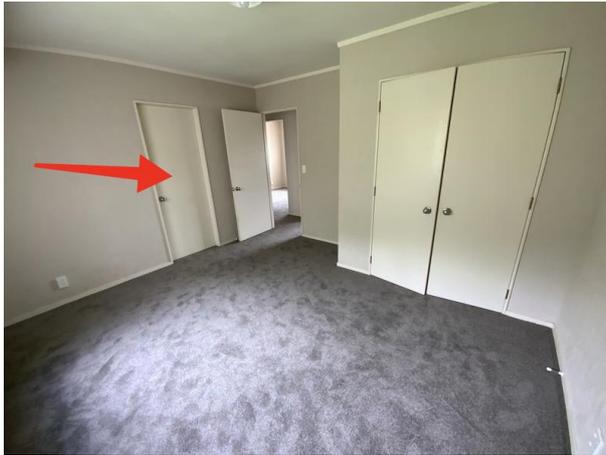
Photo 66

Bedroom 4. Note: this room has access to bathroom.

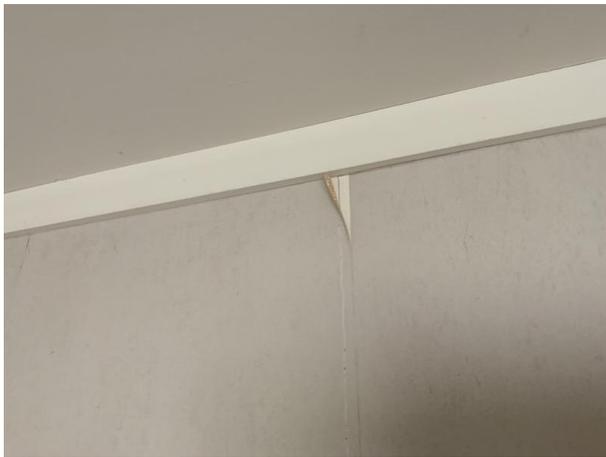
Photo 67

Peeling wallpaper visible.

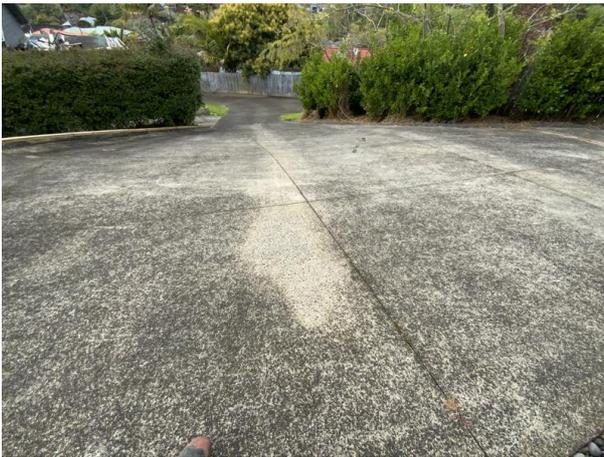
Photo 68

Cracking - Areas of cracking visible.

Concrete driveway to property.

General upkeep and maintenance of driveway by cleaning and keeping free of debris.

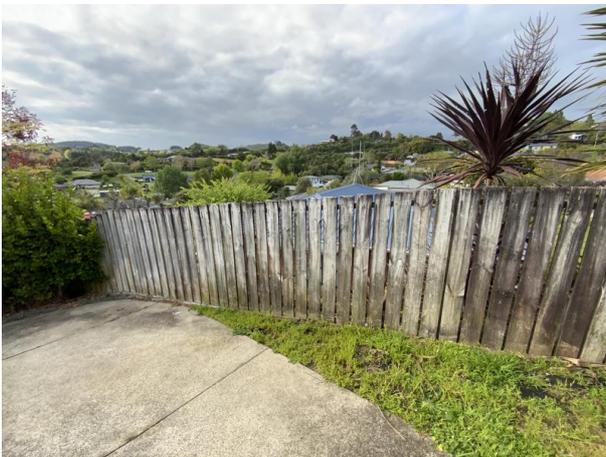
Photo 69

1.5 metre high timber fence,
south east side.

General upkeep and maintenance, keep vegetation and soils clear of timbers as these timbers are only exterior treated and will rot if vegetation or soils are up against them.

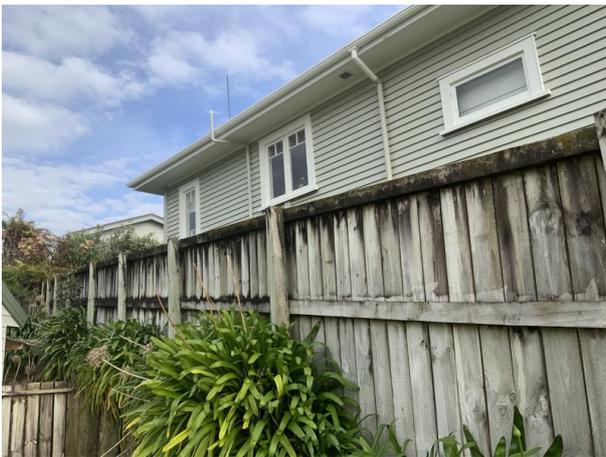
Photo 70

1.8 metre high timber fence,
north side above retaining wall.

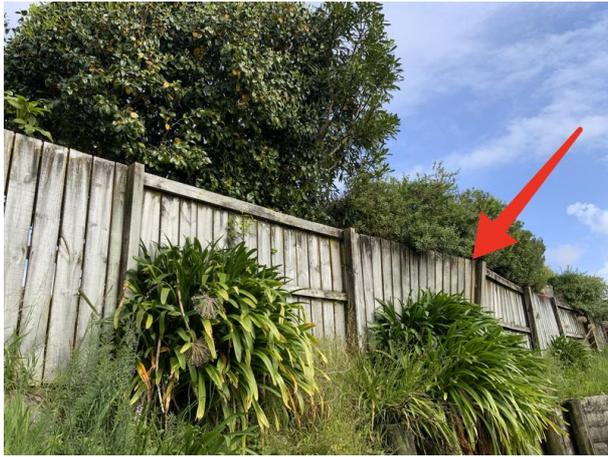
Photo 71

1.8 metre high timber fence west side. Note: alignment issue visible.

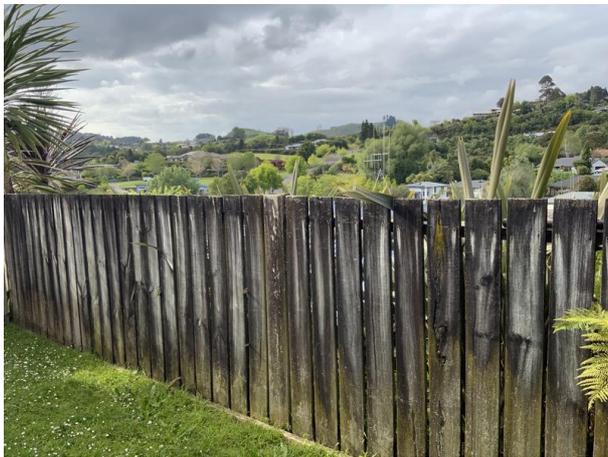
Photo 72

1.5 metre high timber fence, south side.

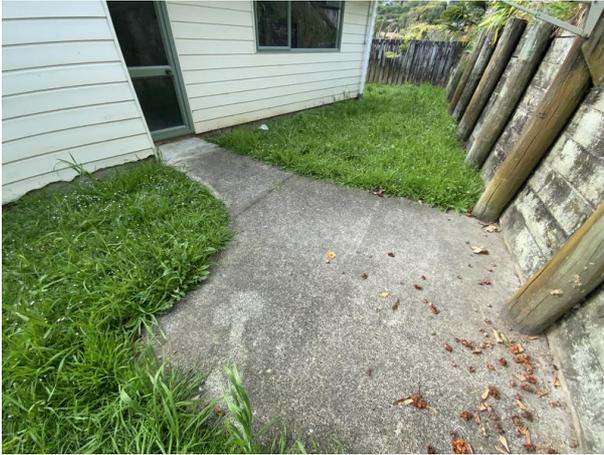
Photo 73

Concrete path, west side.

General upkeep and maintenance.

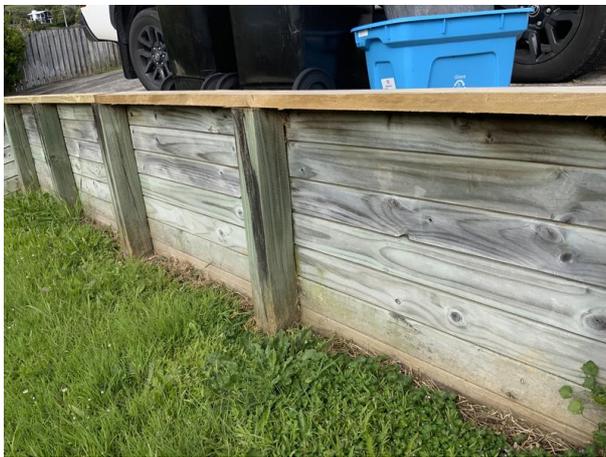
Photo 74

800mm high timber retaining wall, east side.

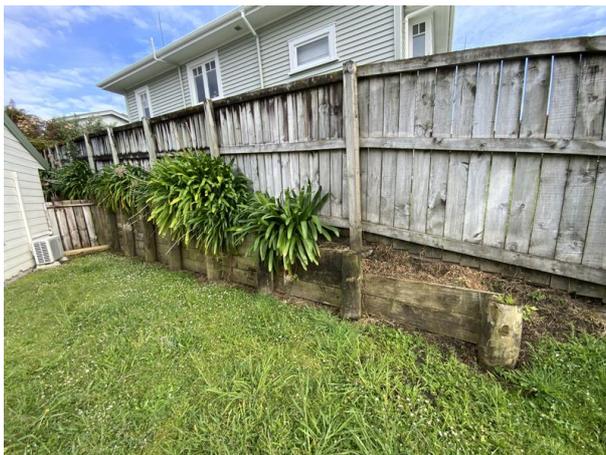
Photo 75

400 to 1.6 metre high timber retaining wall, north side.

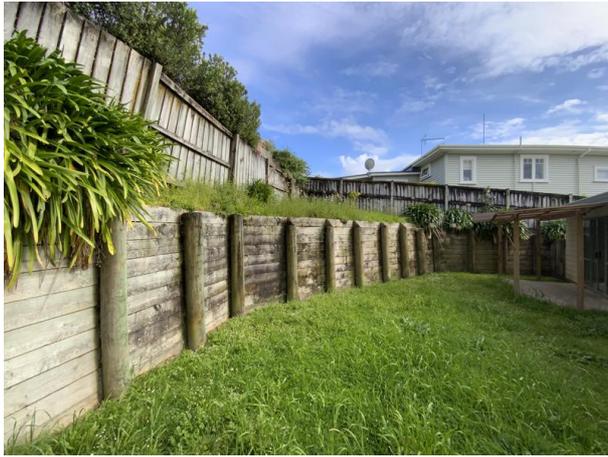
Photo 76

2.0 metre high timber retaining wall, west side.

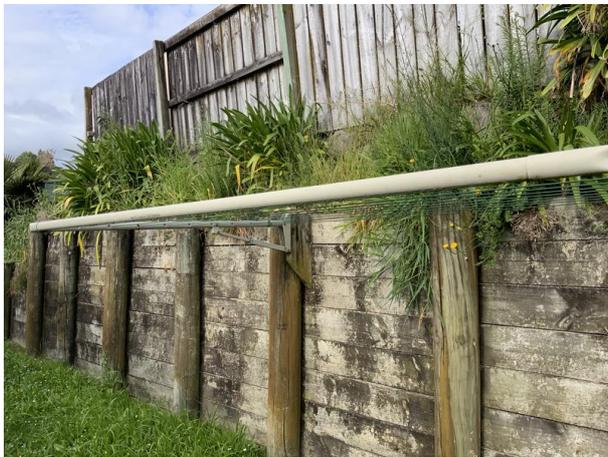
Photo 77

1.8 metre high timber retaining wall, west side.

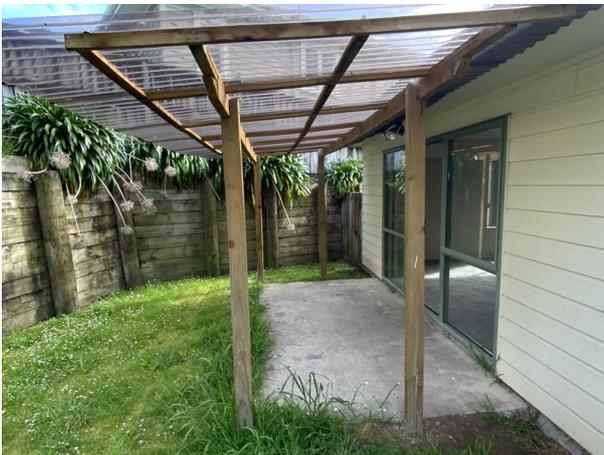
Photo 79

Concrete patio with roof cover, west side.

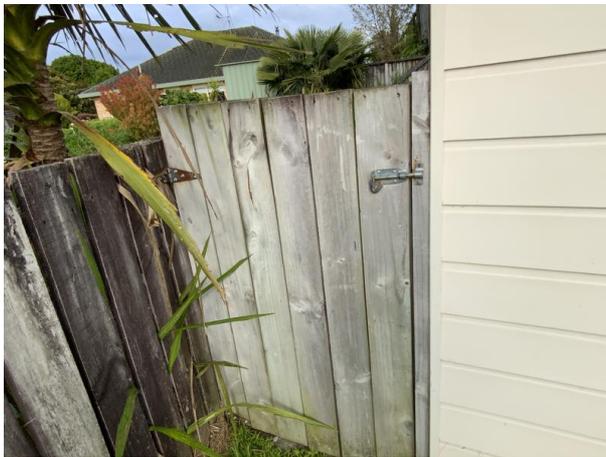
Photo 80

1.5 metre high timber gate,
south east side.

Recommend regular lubrication of the hinges and latch to maintain full function.

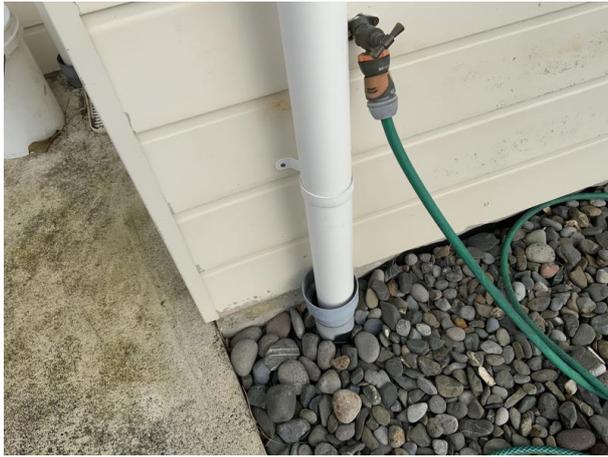
Photo 82

Downpipe and riser connection, east side.

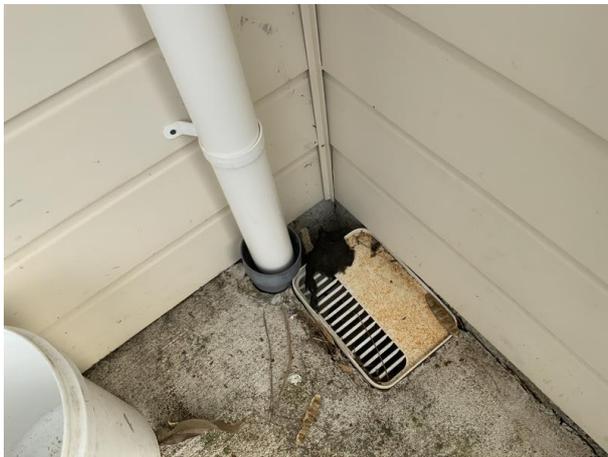
Photo 83

Gully trap drain and downpipe and riser connection, east side.

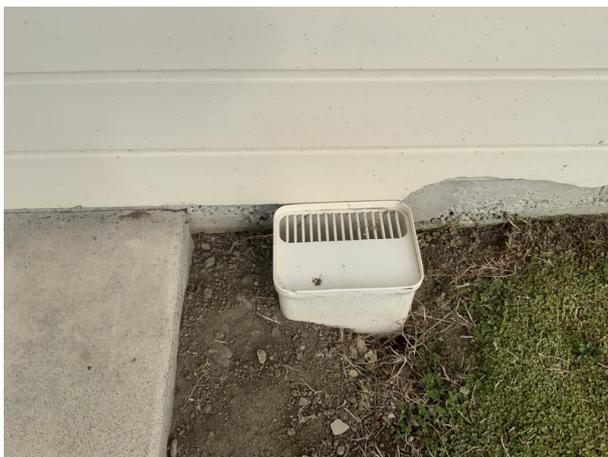
Photo 84

Gully trap drain, east side.

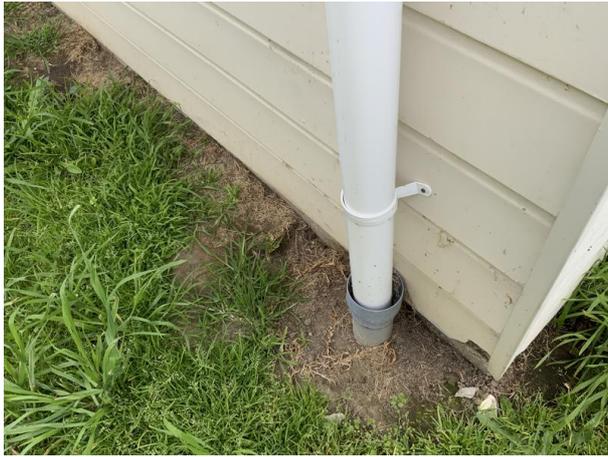
Photo 85

Downpipe and riser connection, west side.

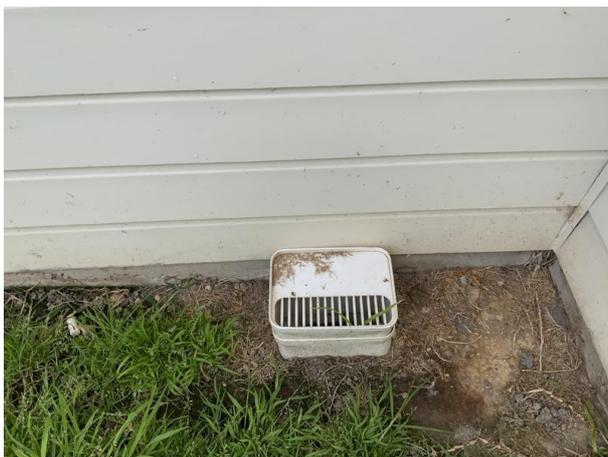
Photo 87

Gully trap drain, west side.

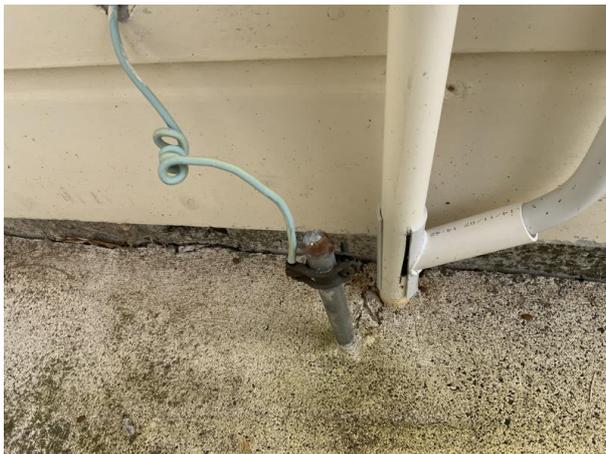
Photo 88

Earth stake, east side.

Engage a registered electrician for all repairs and maintenance.

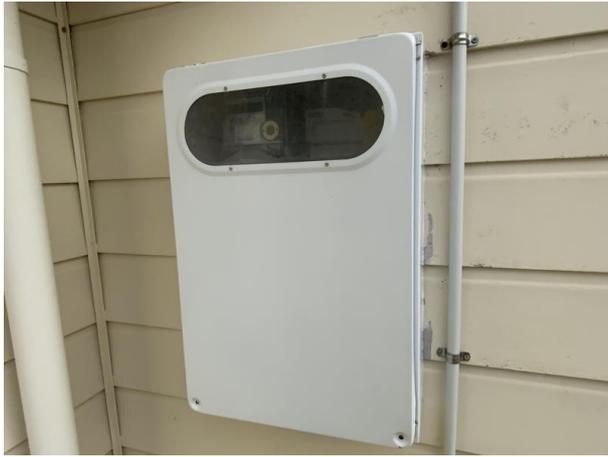
Photo 89

Meter box, east side.

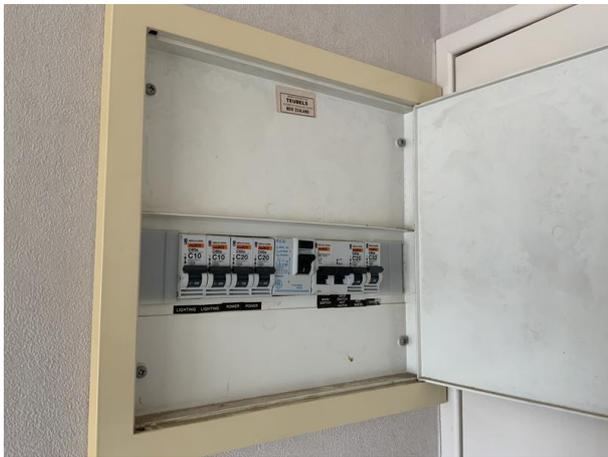
Photo 90

Distribution board, located in bedroom 2.

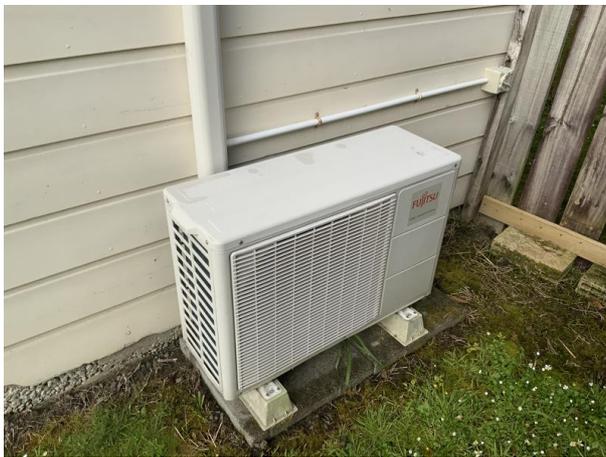
Photo 91

External heat pump unit,
located north side.

Service as per manufacturer's recommendations.

Clean heat pump filters every 4 - 12 weeks depending on the placement of the unit.

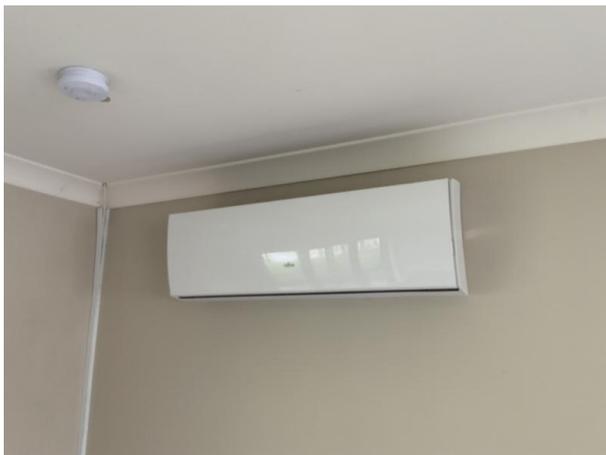
Photo 92

Internal heat pump unit,
located in lounge.

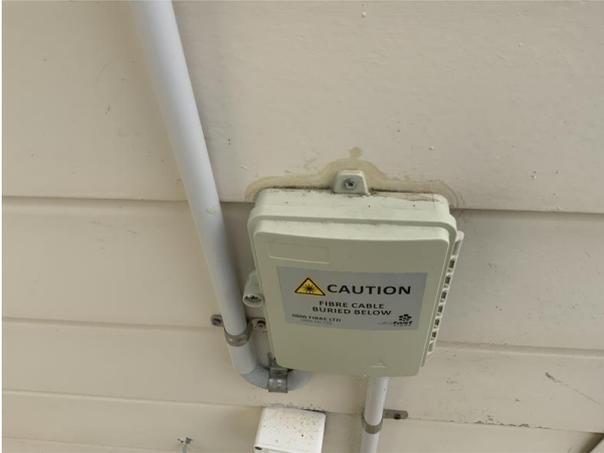
Photo 93

Fibre connection, east side.

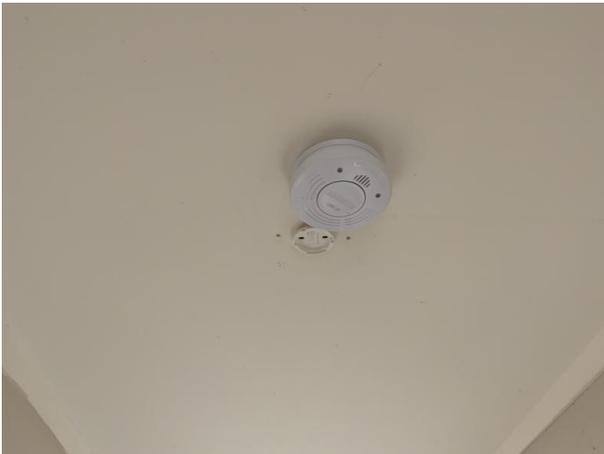
Photo 94

Smoke alarm, located in hallway.

Regular checks to ensure smoke detectors are functional.

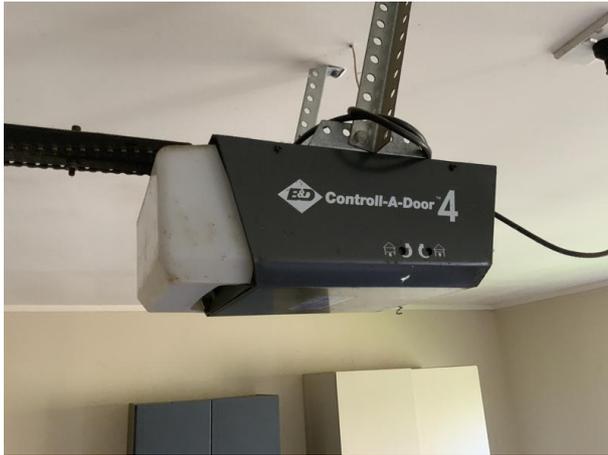
Photo 95

Garage door opener.
