## RED LBP PRE-PURCHASE REPORT

# PRE-PURCHASE BUILDING REPORT

<b>Property Address</b>	14A Hastings Street, Te Puke 3119
<b>Client</b>	Jonny Menzies
<b>Date of Inspection</b>	20th August 2025
<b>Time</b>	8:30 am
<b>Inspector</b>	Brennan Rapira National Certificate in Carpentry, Licensed Building Practitioner
<b>LBP Number</b>	138160
<b>People Present</b>	Inspector
<b>House Occupied</b>	Staged

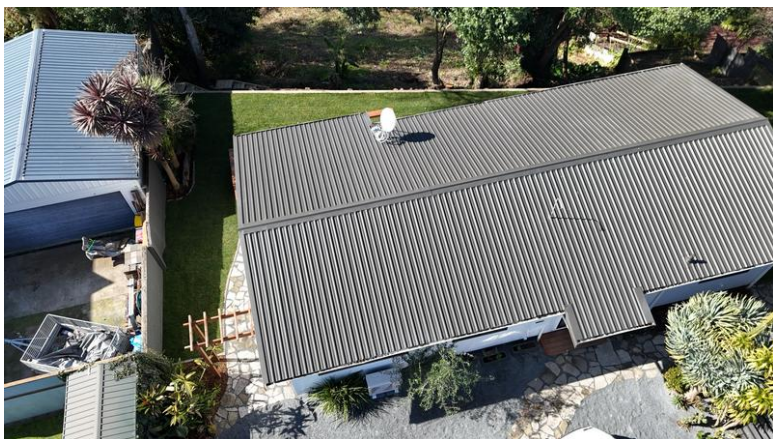
**Photo 3**  
Profiled metal gable roof construction  
with nail fixings.

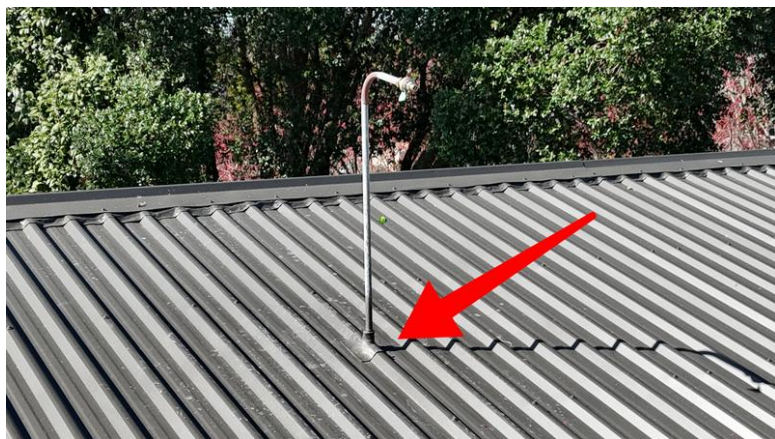
**Photo 5**

Overflow penetration.

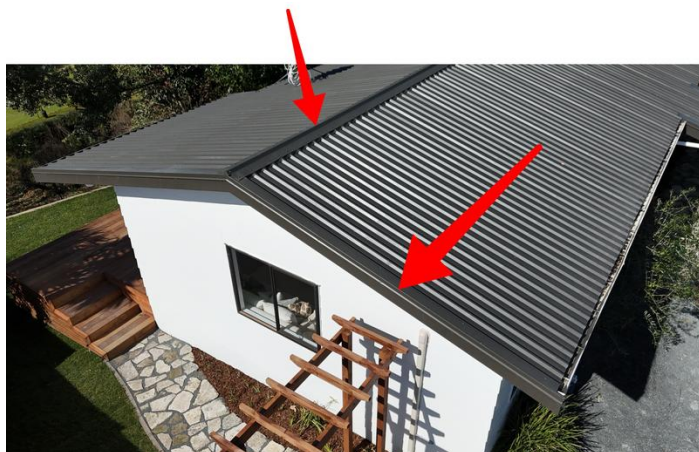
**Photo 6**

Ridge and barge flashings.

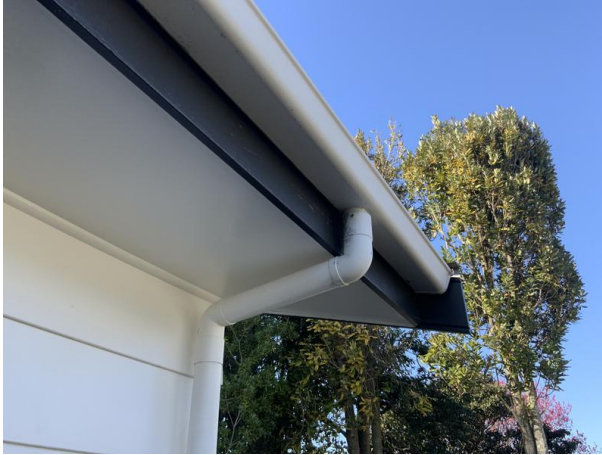
**Photo 7**

PVC gutter system, timber fascia board, fibrous cement sheet soffit and PVC downpipe.

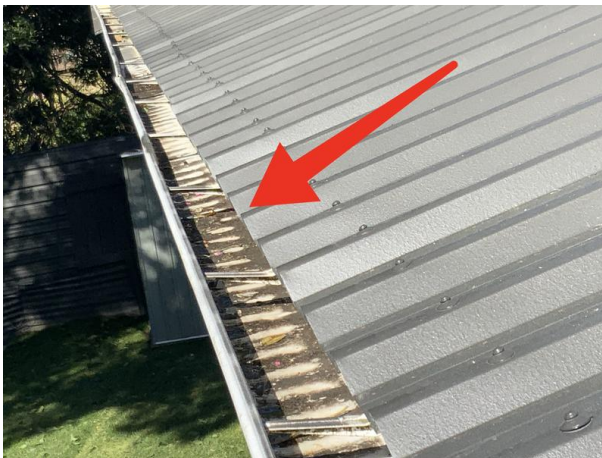
**Photo 8**

Gutter system east side clear of debris.

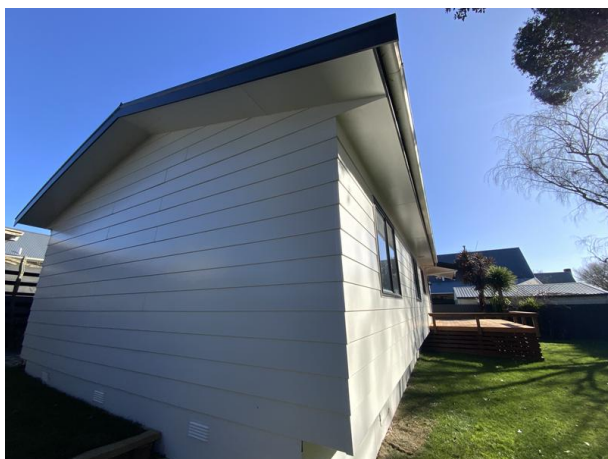
**Photo 10**

Fibrous cement weatherboard cladding system with paint coating.

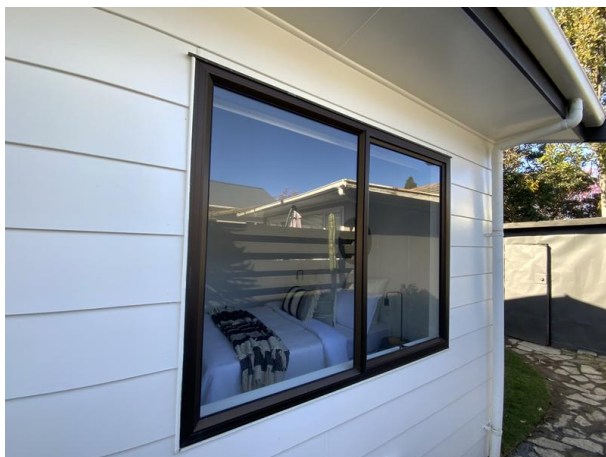
**Photo 14**

Single glazed anodised aluminium joinery, west side.

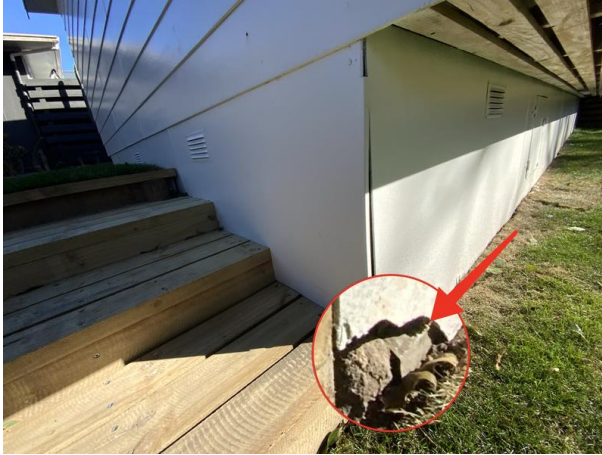
**Photo 19**

Fibrous cement sheet base cladding with vents, south and east side.

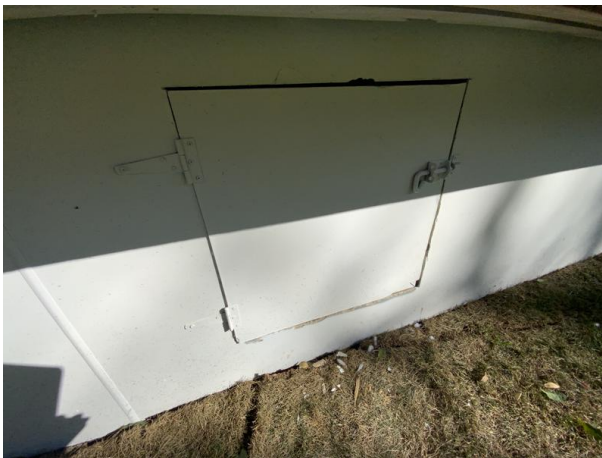
**Photo 20**

600 x 500mm access hatch to subfloor space, east side.

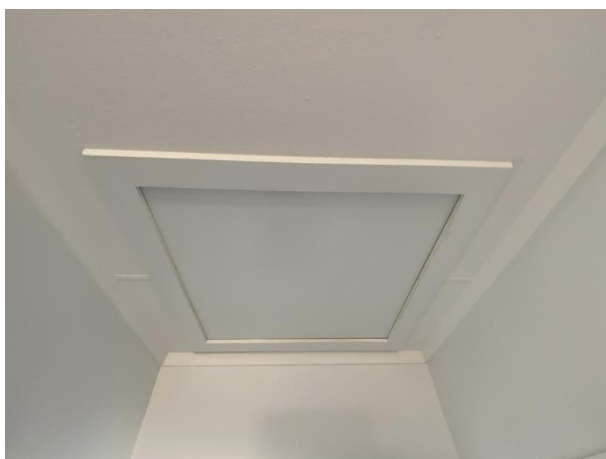
**Photo 23**

600 x 600mm access hatch to roof space, located in hallway.

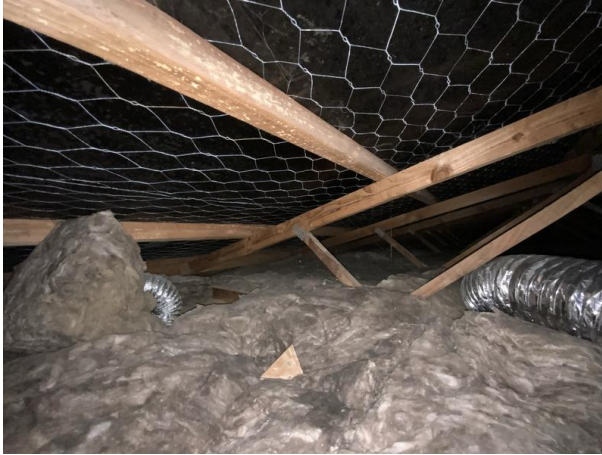
**Photo 24**

Manufactured timber truss roof construction, bituminous paper with wire mesh and natural wool insulation.

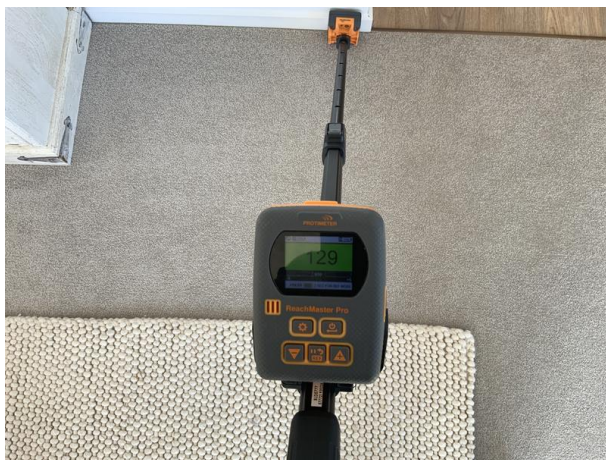
**Photo 26**

Base reading taken from lounge internal wall.

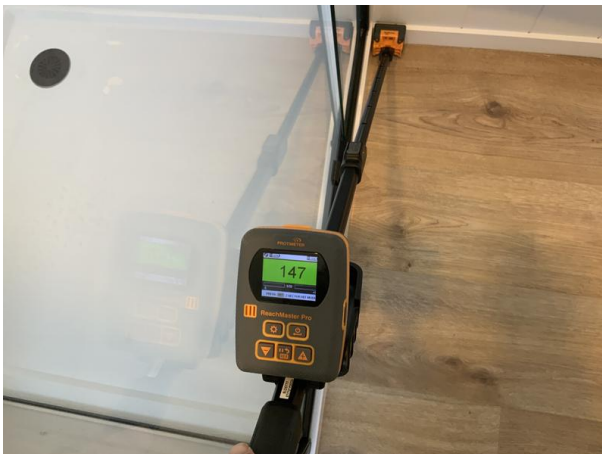
**Photo 29**

Bathroom, east side.

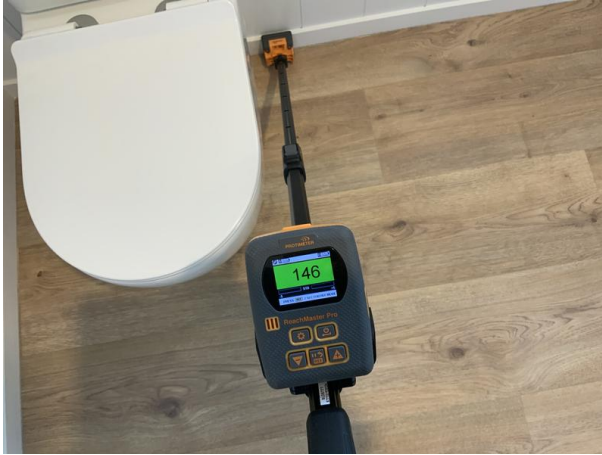
**Photo 30**  
Bathroom, west side.

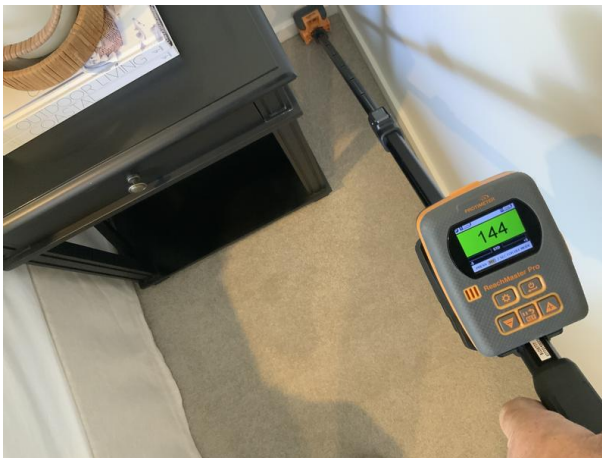
**Photo 31**  
Bedroom 2, south side.

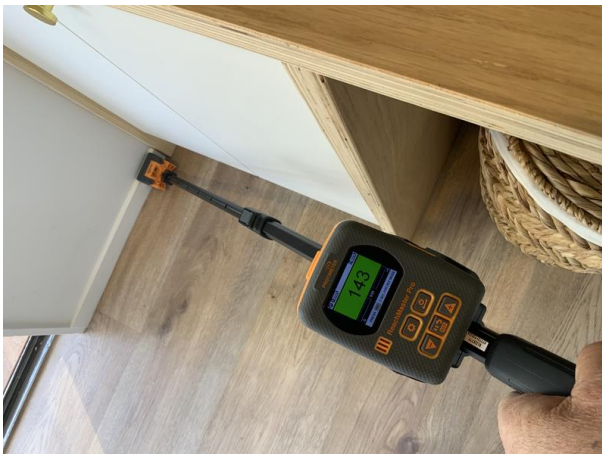
**Photo 32**  
Laundry, west side.

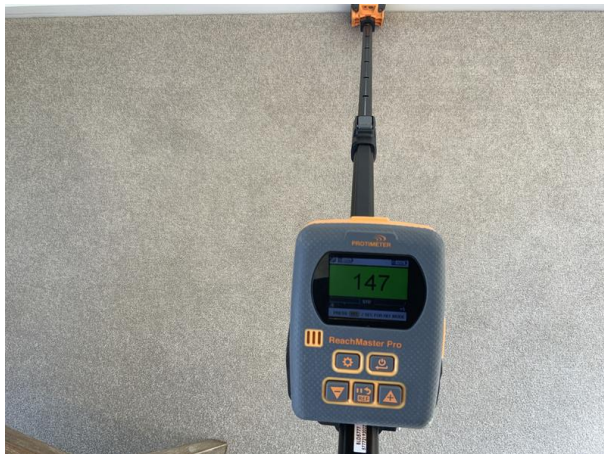
**Photo 33**  
Lounge, north side.

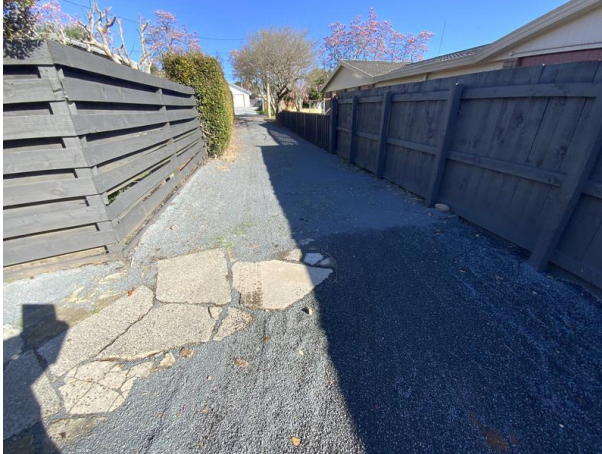
**Photo 43**

Shingle driveway to property.

General upkeep and maintenance of driveway by cleaning and keeping free of debris. Add more shingle as required.

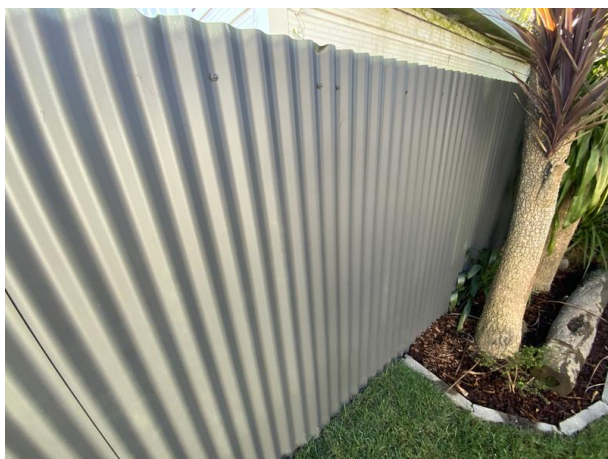
**Photo 44**

1.5 metre high profiled metal fence, north side.

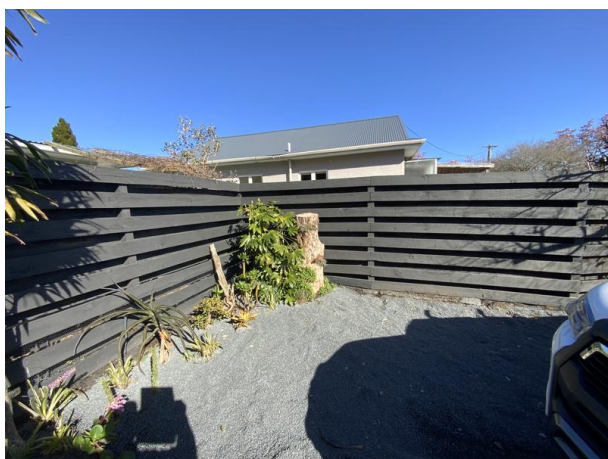
**Photo 45**

1.8 metre high timber fence, west side.

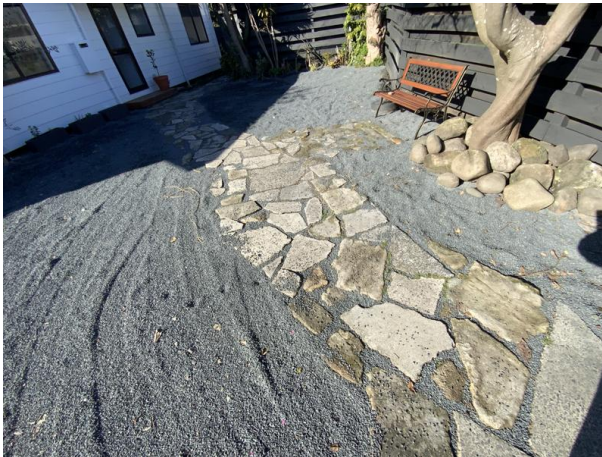
**Photo 46**  
Concrete pavers, west side.

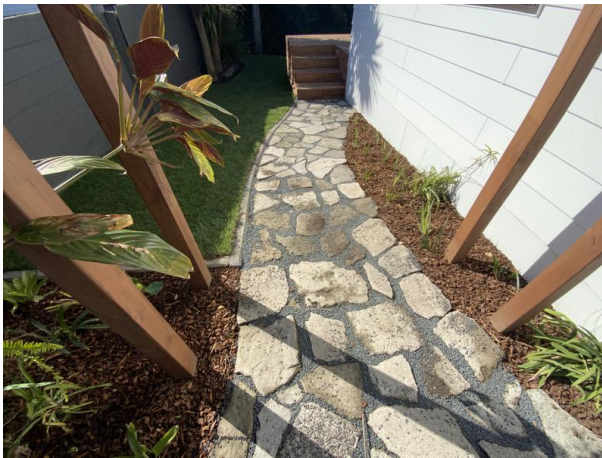
**Photo 47**  
Concrete pavers, north side.

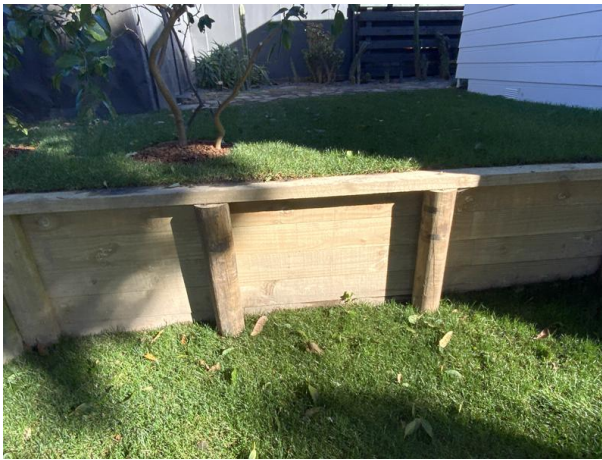
**Photo 48**

700mm high timber retaining wall, south side.

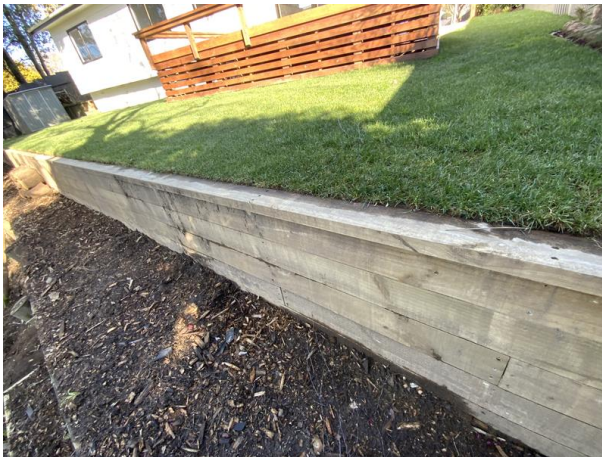
**Photo 49**

800mm high timber retaining wall, east side.

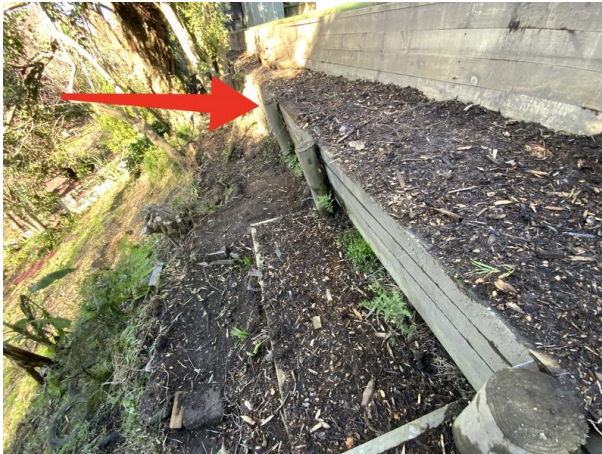
**Photo 50**

1.0 metre high timber retaining wall, east side. Note: rotation visible.

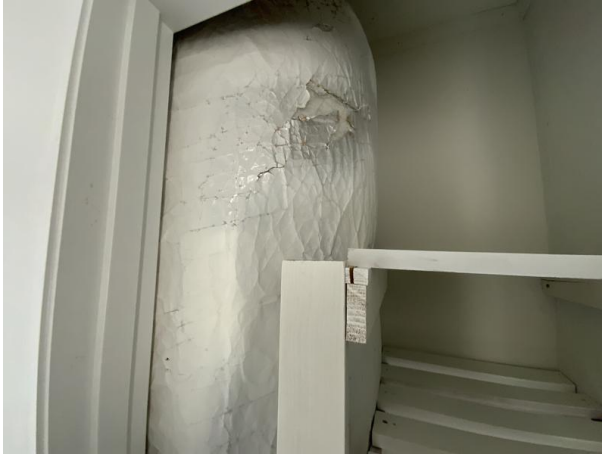
**Photo 58**

Leak detected with the hot water cistern, further investigation and maintenance is required.

Hot water cistern, located in hallway cupboard.

It is recommended to engage a Plumber to further investigate the ho water cylinder, that seems to be leaking.

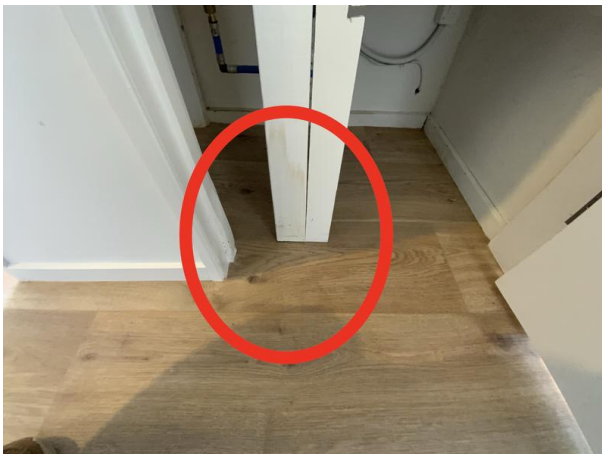
**Photo 60**

Water visible on floor of hallway cupboard
