Building Inspection

Home Inspection Report

14 Nairn Street, Spreydon, Christchurch, 8024

Inspection prepared for: Aaron and Tammy Lorenzen Hart
Date of Inspection: 3/5/2021 Time: 10:30 AM
Age of Home: 1930s Size: 110m²
Weather: Fine

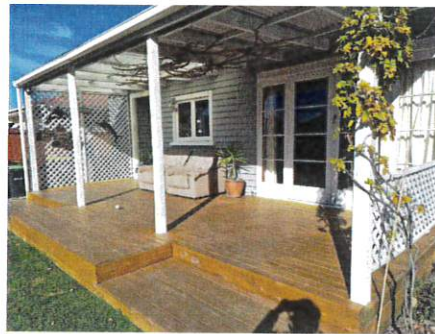
1. Location

- North east side of home

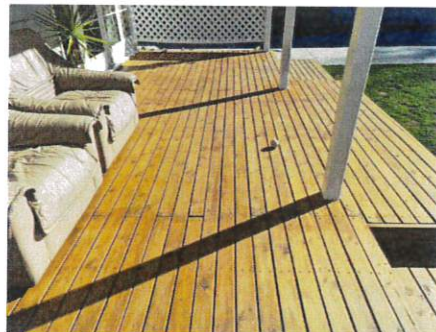
2. Material type and condition

- Timber in good condition

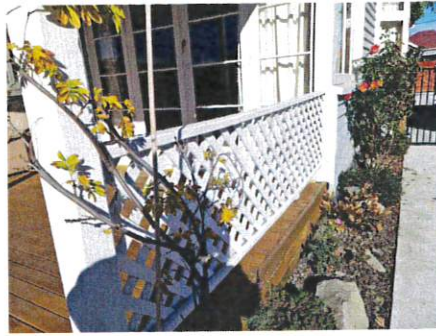
3. Balustrades

- Adequately rigid

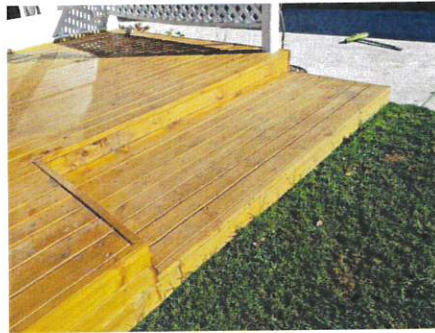
4. Thresholds (step downs)

- Satisfactory

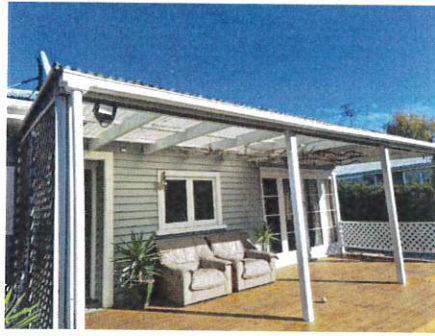
1. Location

- Above deck

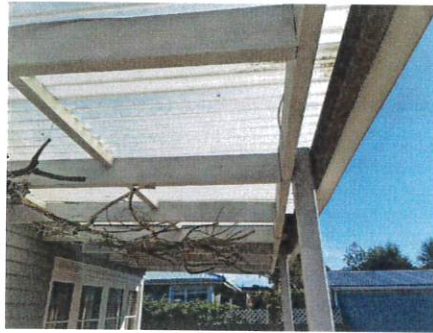
2. Material type and condition

- Timber in good condition

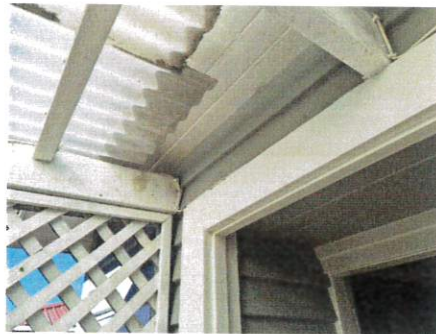
4. Connection to structure

- Satisfactory

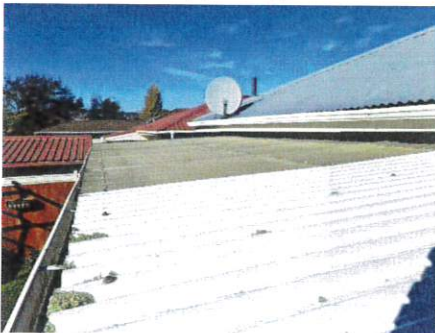
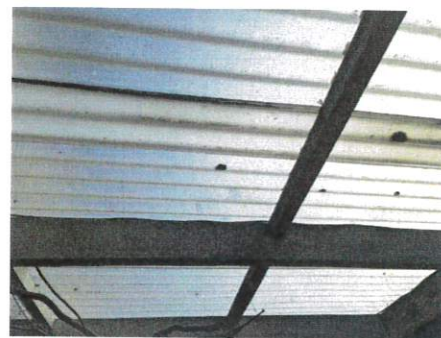
5. Roof

- Polycarbonate type in good condition

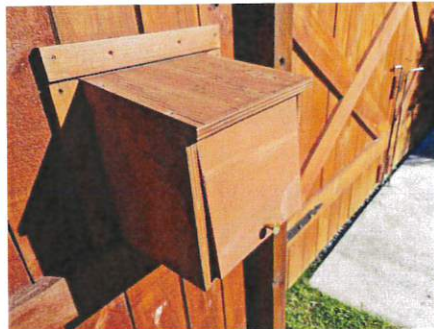
1. Material type and condition

- Timber in good condition

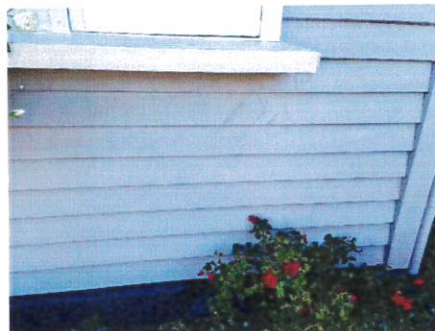
1. Type

- Weatherboard

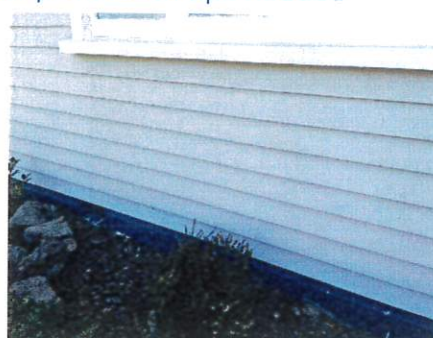
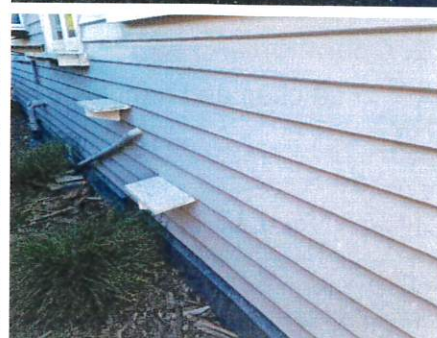
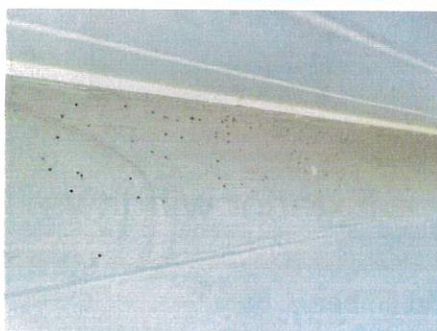
2. Surface finish

- Signs of borer that should be regularly treated and some minor paint touch ups needed

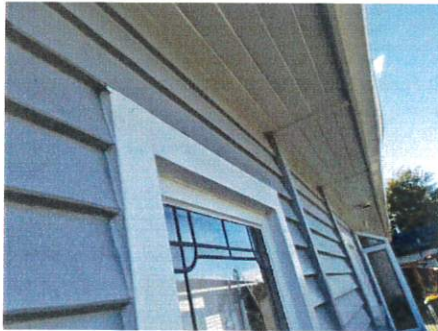
3. Flashings

- All flashings in place

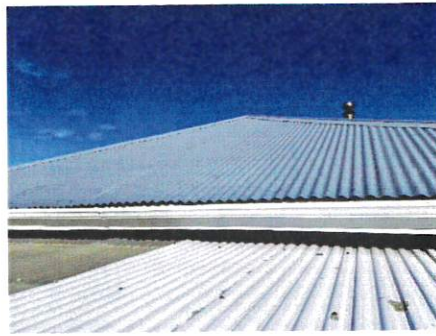
2. Pitch appropriate to material type

- Appropriate for this material type

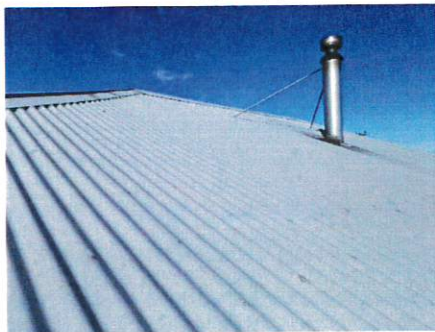
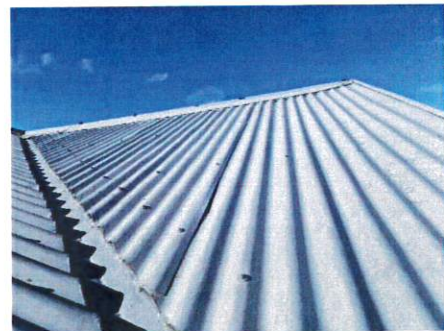
3. Surface damage and deterioration

- No surface damage apparent

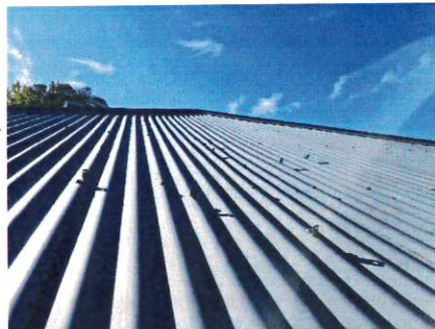
4. Lichen/moss

- No lichen or moss present that can cause damage to roof surface

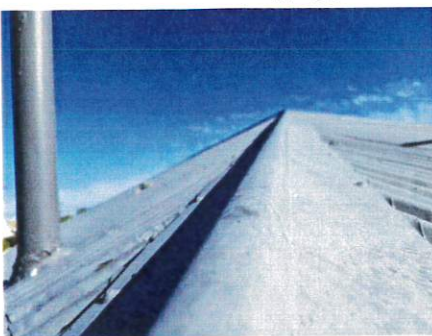
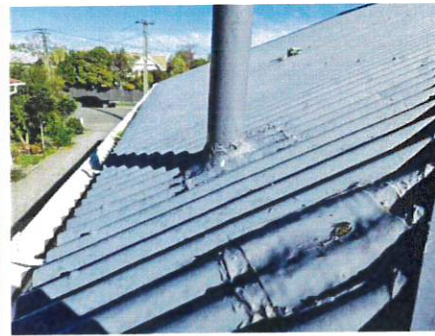
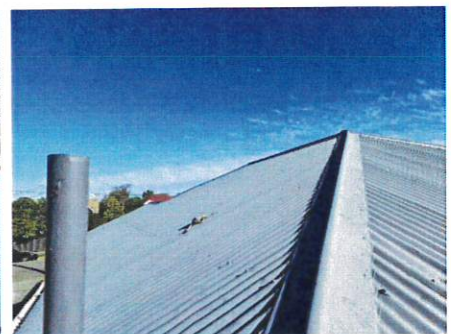
5. Flashings

- All roof flashing appears to be in place and correctly installed

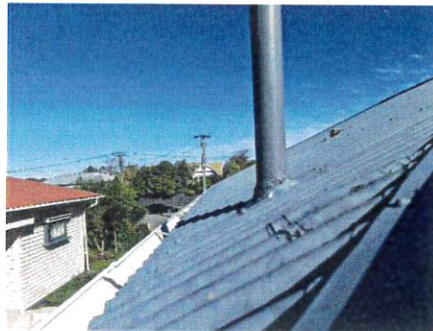
7. Sagging

- No apparent sagging can be seen at the time of inspection

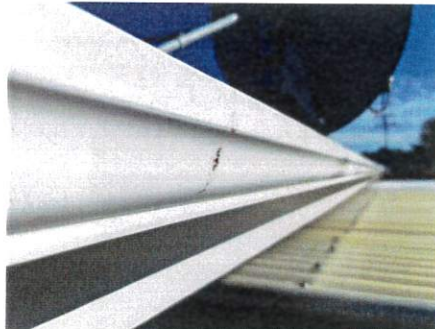
1. Gutter type

- External **PVC**

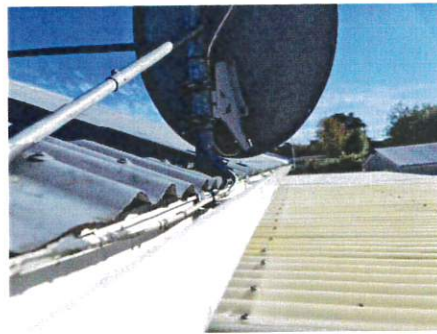
2. Fall

- Satisfactory

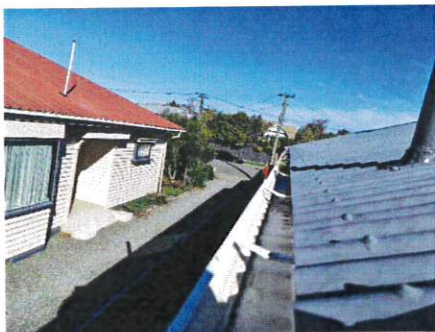
3. Obstruction

- No obstruction present

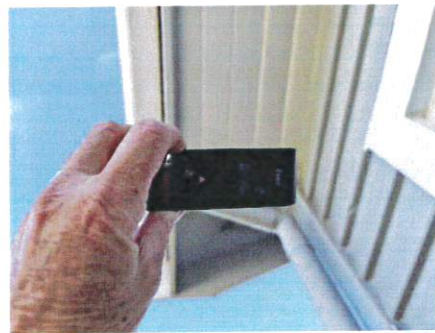
2. Approximate width

- 450mm

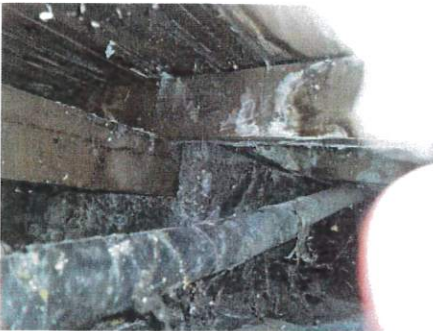
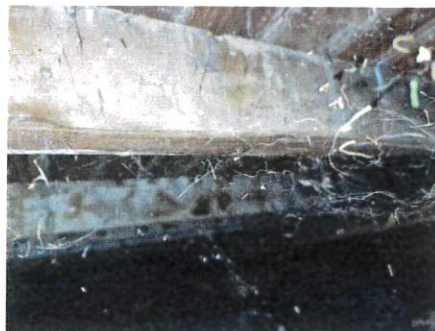
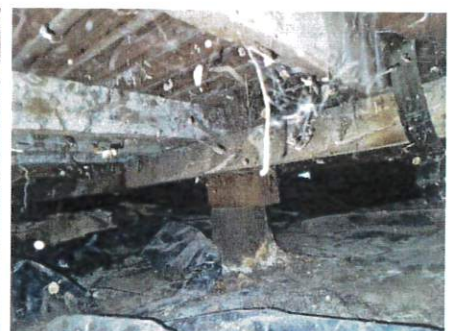
3. Pile type and condition

- Concrete piles

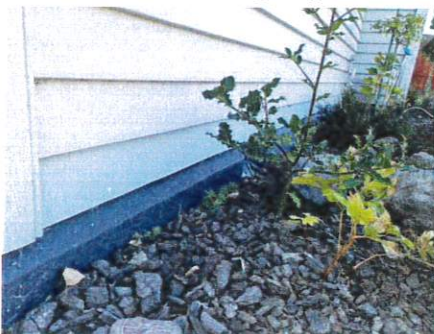
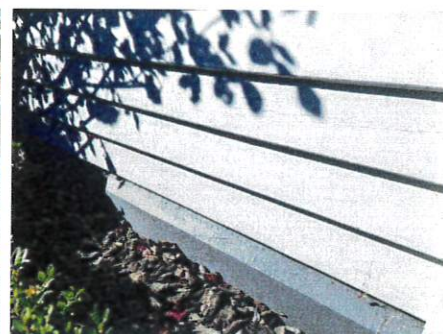
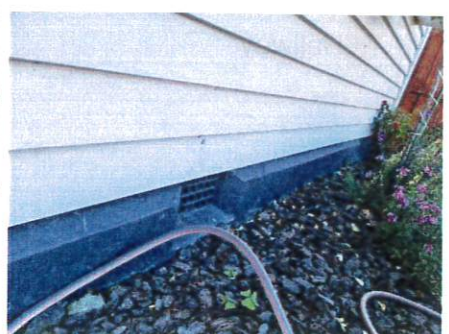
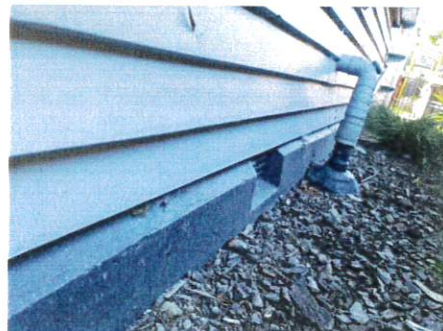
4. Foundation walls

- Concrete ring in good condition

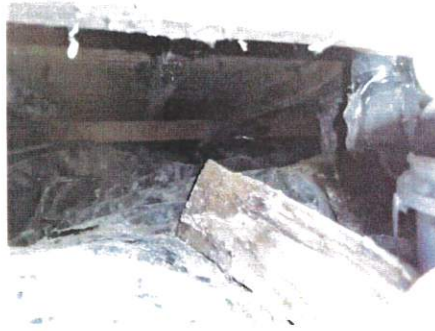
5. Ground clearance of timber framing

- Appears satisfactory

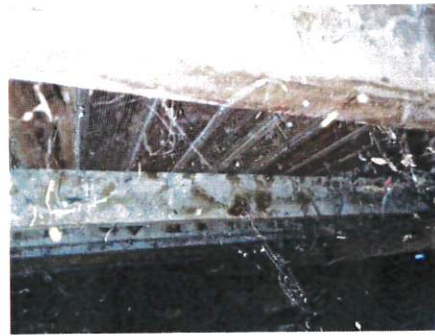
6. Timber framing and bracing

- Appears satisfactory

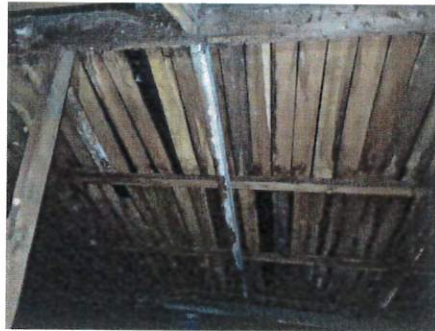
3. Roof frame construction & connections

- Satisfactory for the year of construction

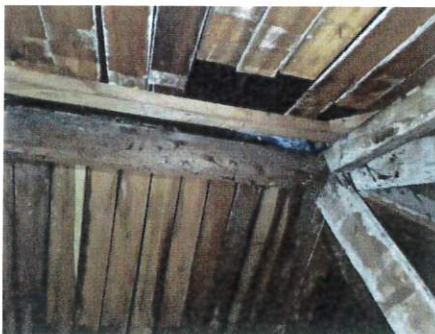
5. Rotting timber

- None evident at the time of inspection

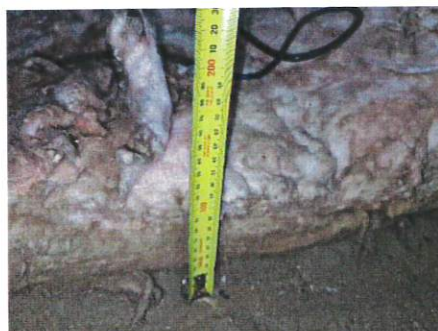
2. Thickness

- 130mm

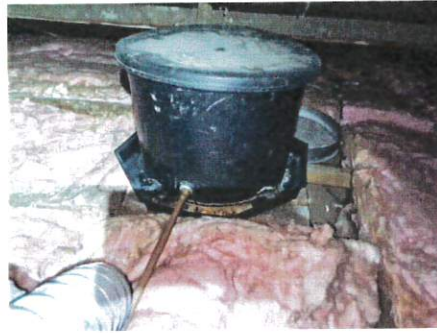
2. Header tank

- No evidence of leaks at time of inspection

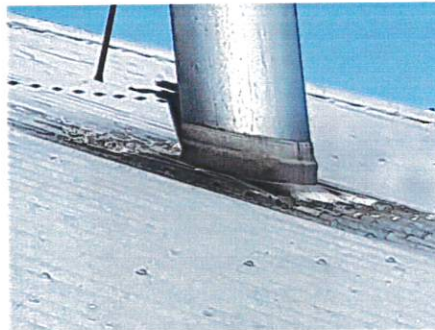
2. Flashings

- Chimney flashing appears to be in place, installed well and in good condition

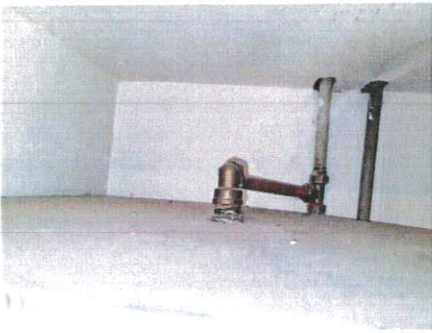
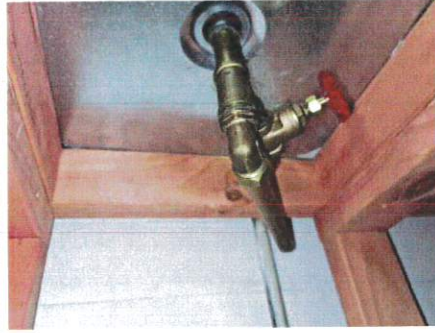
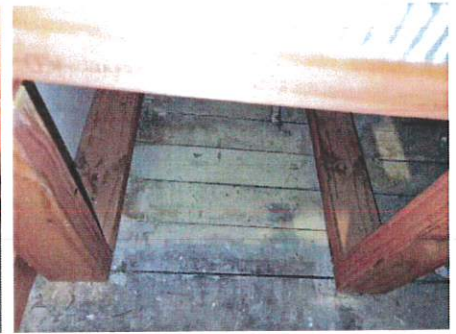
5. Leakage

- No water leaks visible at time of inspection

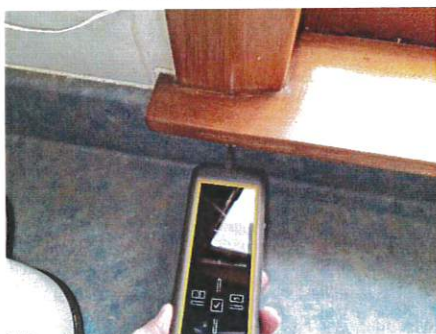
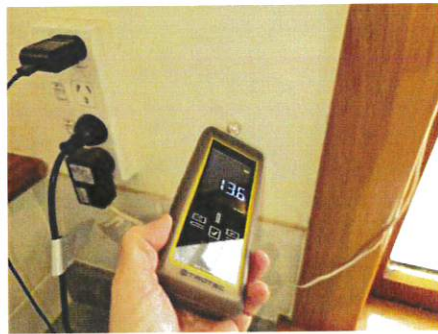
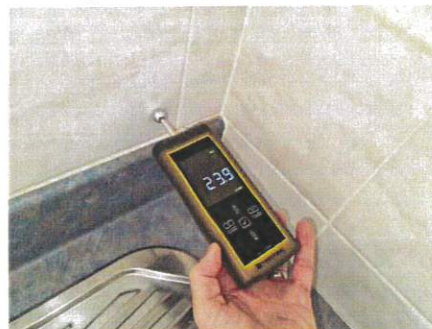
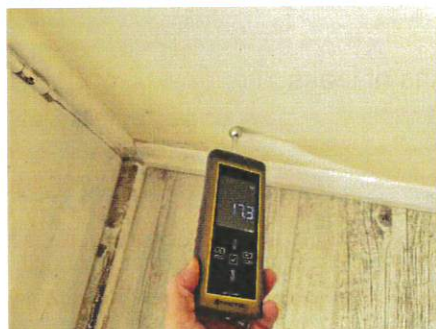
16. Moisture Readings

- Several readings were taken and all were within the acceptable range

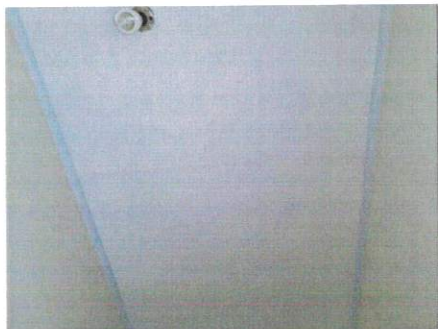
2. Ceiling material and covering

- Painted plaster board requiring repairs

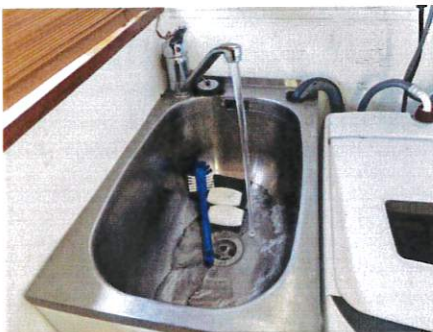
11. Taps and Waste Traps

- Good water flow and no signs of leaks at time of inspection.

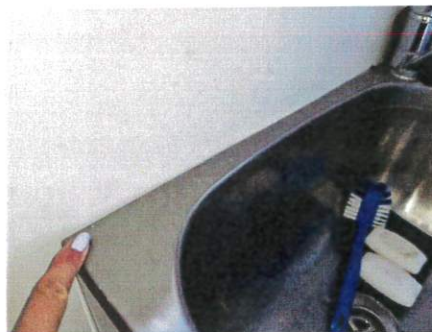
12. Correct wall junction detail

- No, suggest repairing/adding to prevent water damage

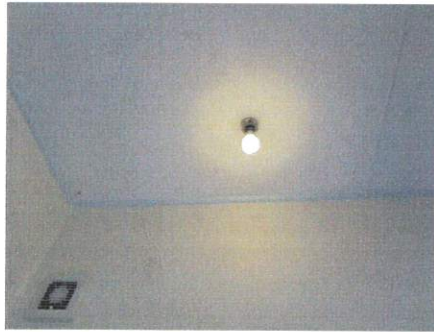
13. Lights and switches

- Tested and functional

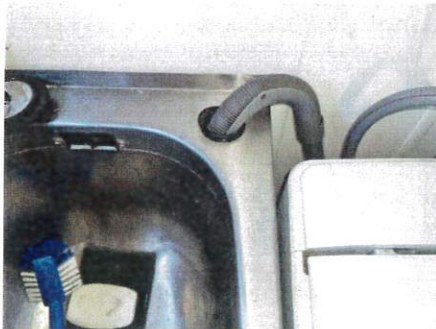
15. Washer drain

- Drains directly to waste trap

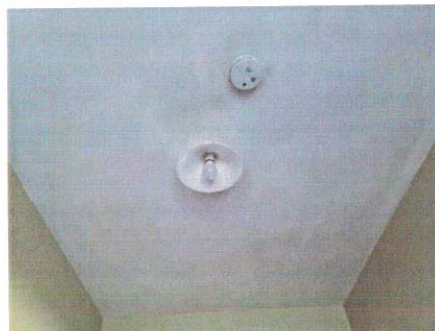
2. Ceiling

- Painted plaster board, would benefit from a repaint

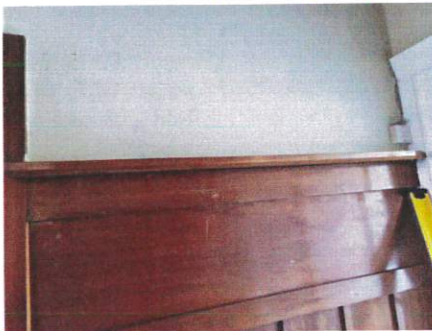
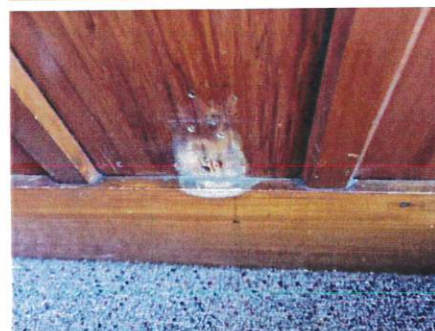
3. Walls

- Painted plaster board requiring minor repairs
- Wooden paneling requiring minor repairs

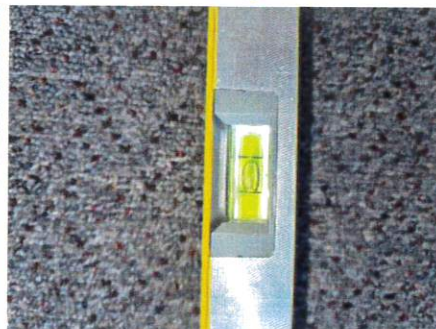
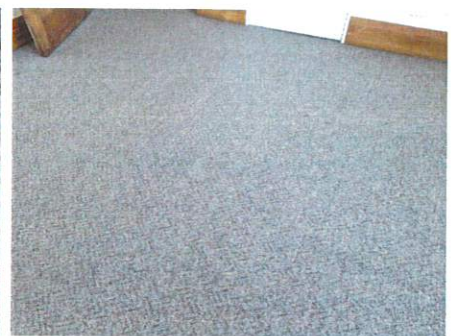
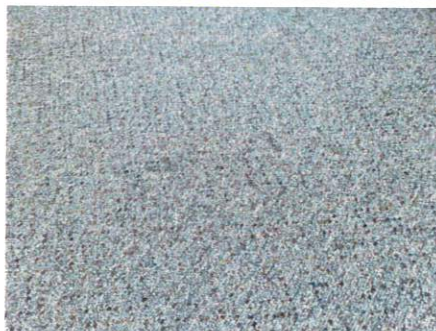
4. Floor

- Carpet in good condition, some marks/staining noted

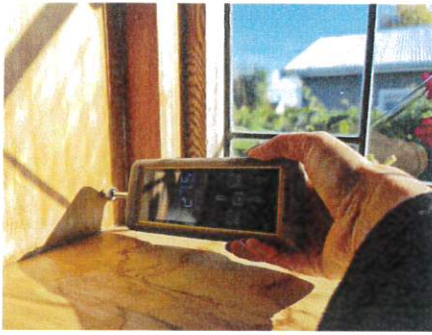
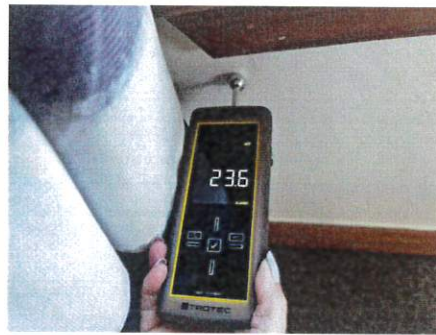
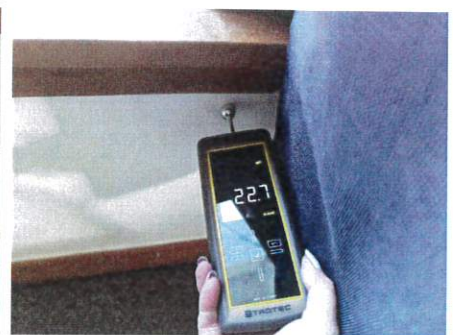
- Several readings were taken and all were within the acceptable range

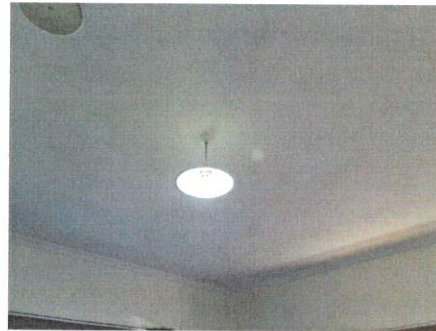
- Tested and functional

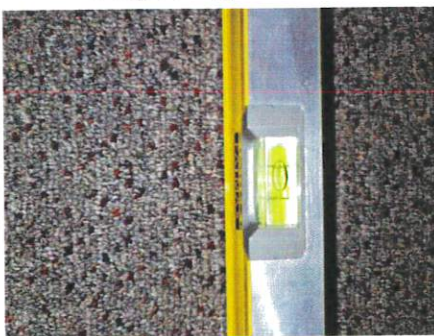
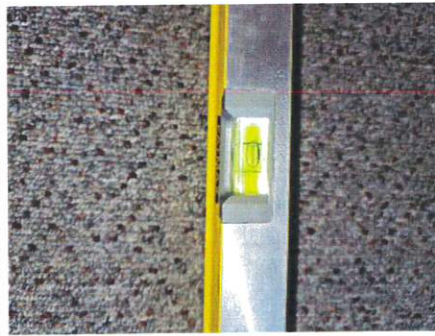
- Carpet in good condition

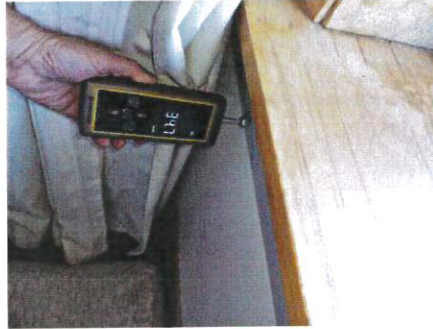
- Several readings were taken and all were within the acceptable range

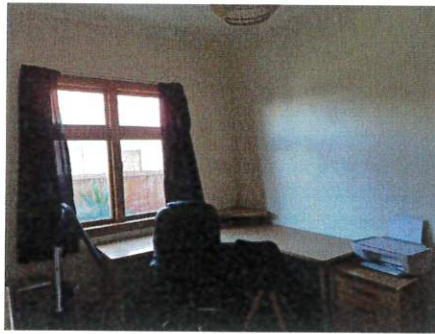
- Painted plaster board requiring minor repairs

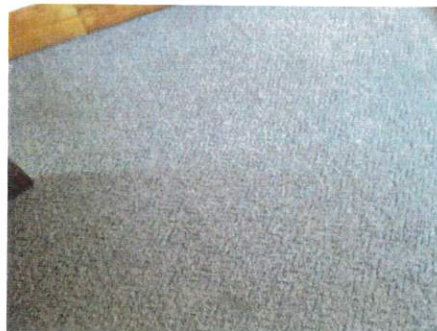
- Carpet in good condition

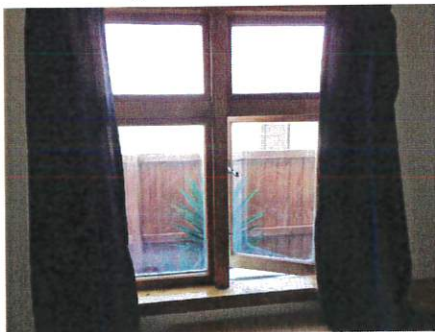
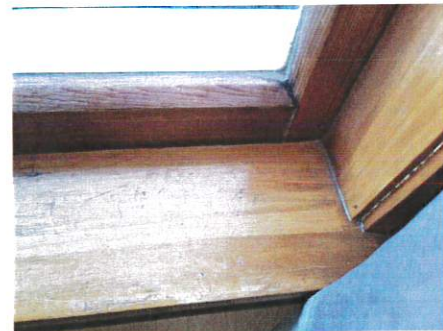
- Wooden in good condition

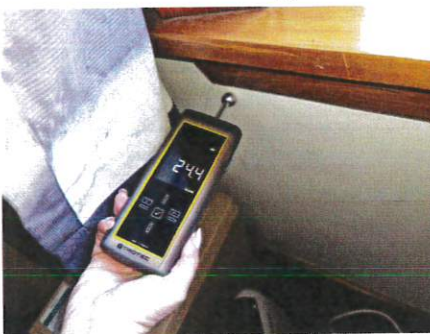
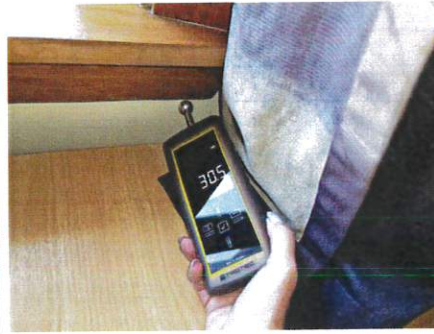
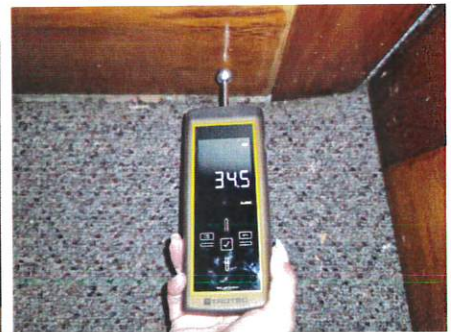
- Several readings were taken and all were within the acceptable range

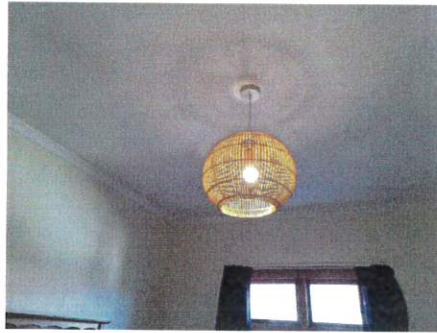
- Tested and functional

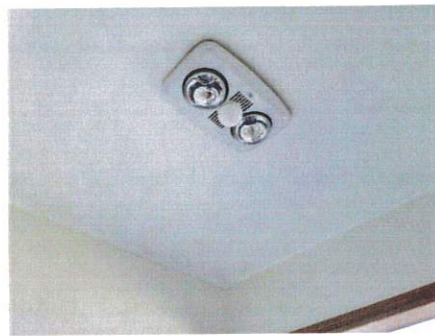
- Painted plaster board requiring minor repairs

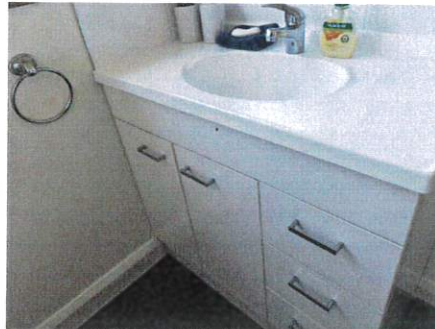
- Plastic composite in good condition

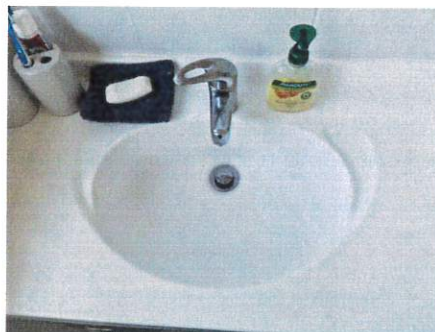
- Good water flow, waste trap operative and no signs of leaks

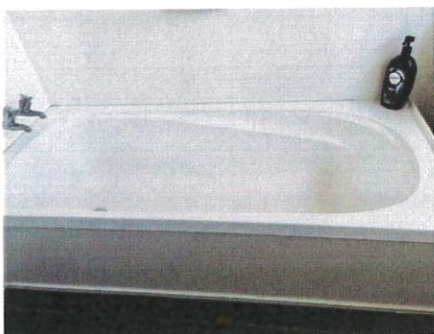
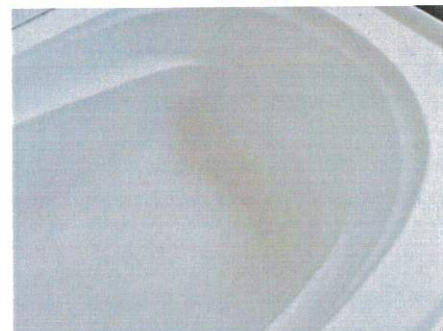
19. Bath/surround

- Plastic bath and plasterboard surround in good condition. Some staining noted on bath

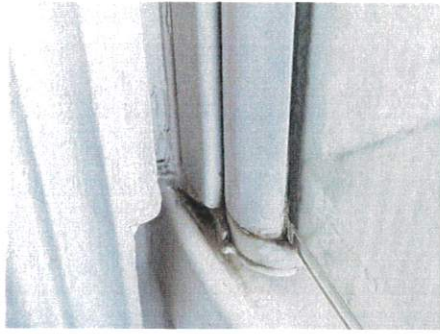
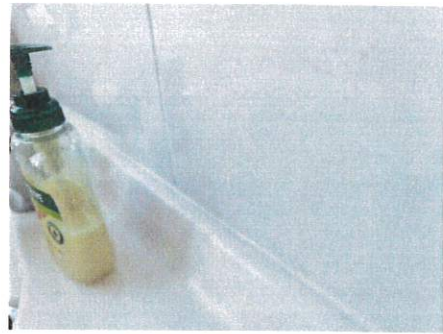
20. Adequately sealed at wall junctions

- Basin and shower wall junctions are all adequately sealed

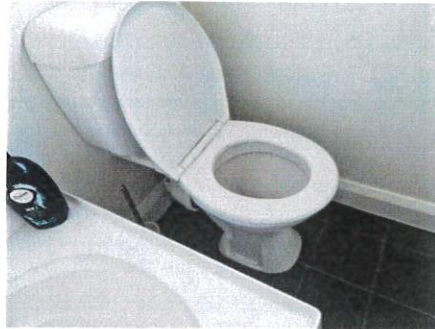
21. Toilet type and seat

- Floor mounted S trap in good condition

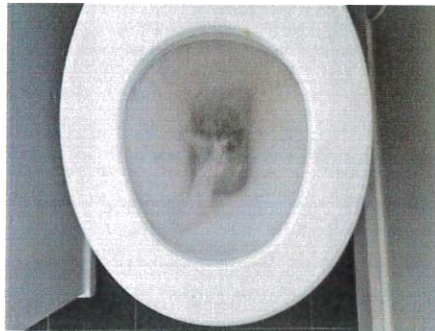
22. Toilet flush

- Good toilet flush

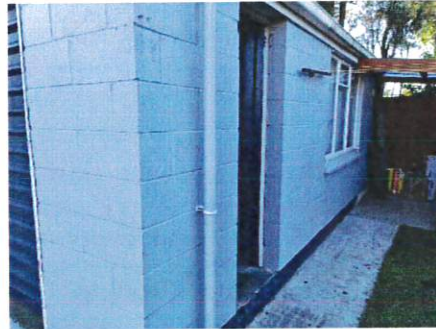
2. Cladding

- Block in good condition

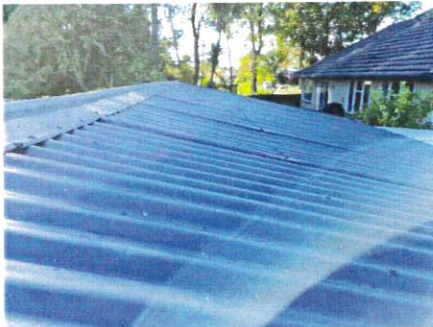
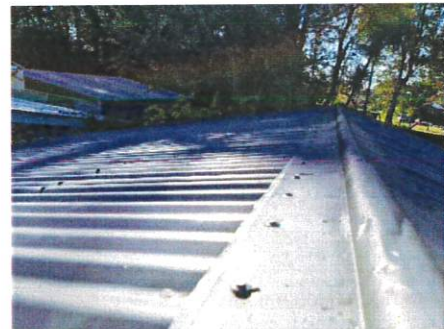
3. Roof and gutters

- Long run iron in good condition

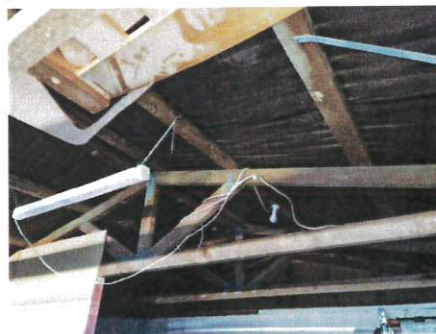
4. Ceiling

- Exposed timber framing in good condition

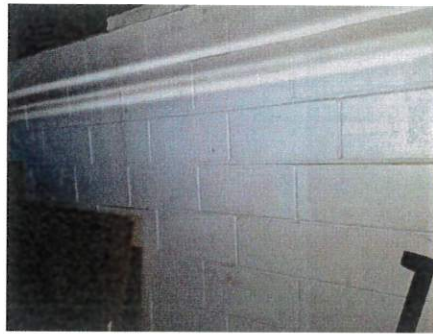
5. Walls

- Block in good condition

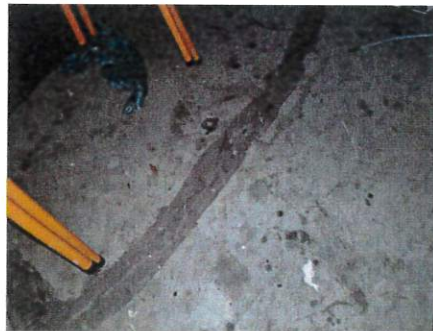
6. Floor

- Concrete floor in good condition, epoxy repair to standard

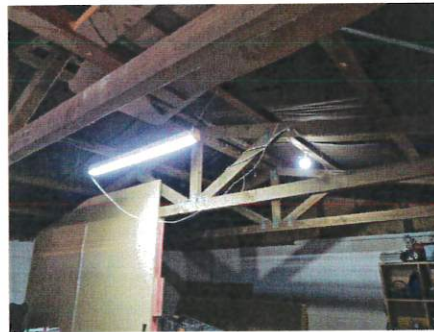
10. Lights and switches

- Tested and functional

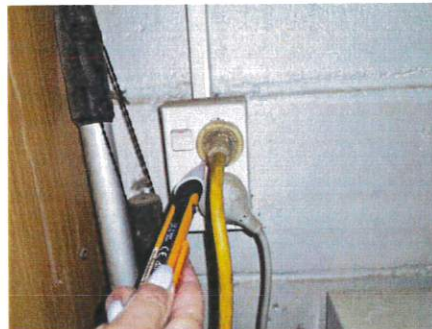
11. Power outlets

- In use therefore assume functional
